# 4-Point Inspection Form

Address Inspected: 302 8th St W. Palmetto, Florida 34221

Date Inspected: 2/8/2022

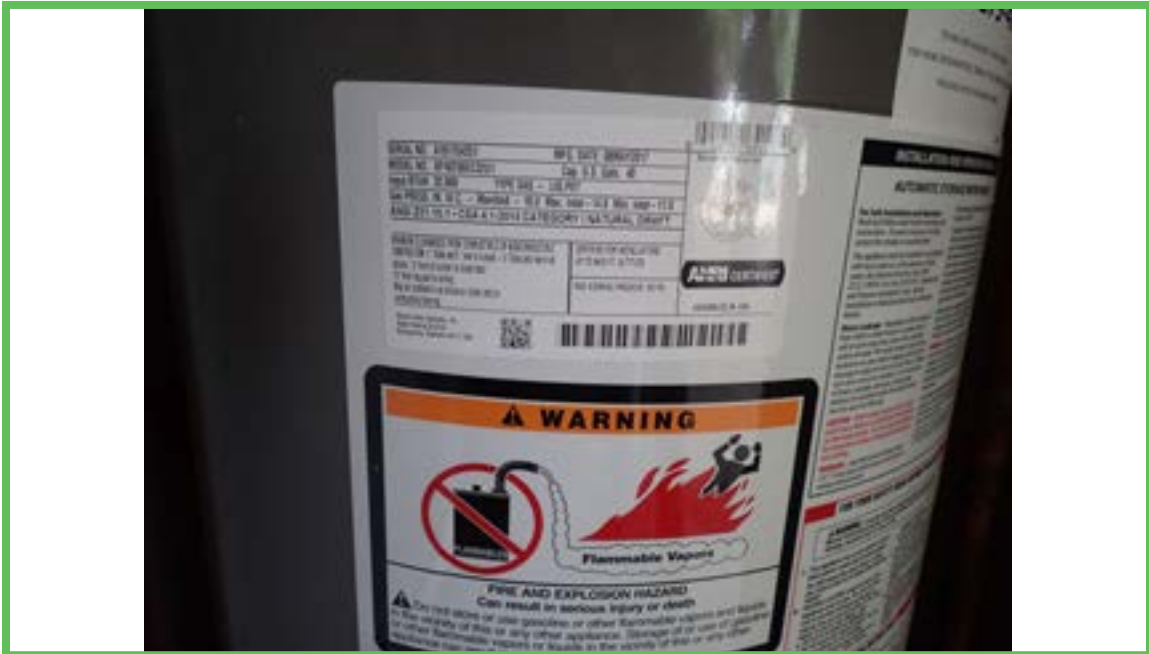
Water Heater Data Plate

Water Heater Manufacture  
Date: 08may2017
