4-Point Inspection Form

Address Inspected: 1511 13th St W. Palmetto, Florida 34221

Date Inspected: 4/21/2022

West Florida Inspections
2311 58th St E Palmetto Florida 34221
HI 3192

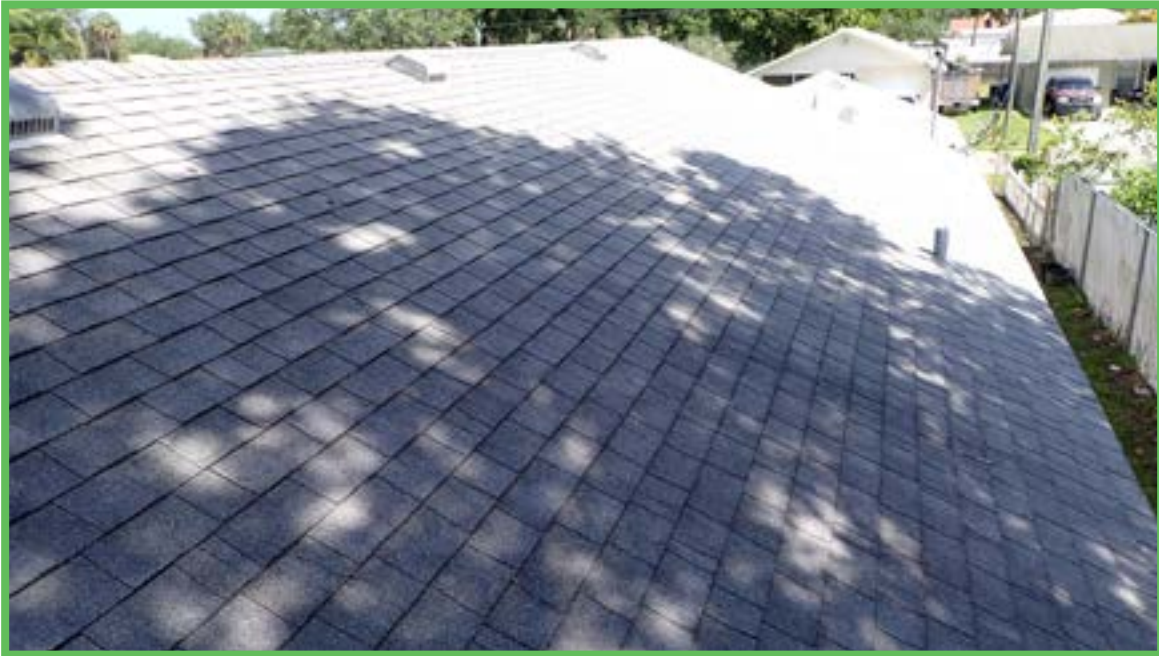
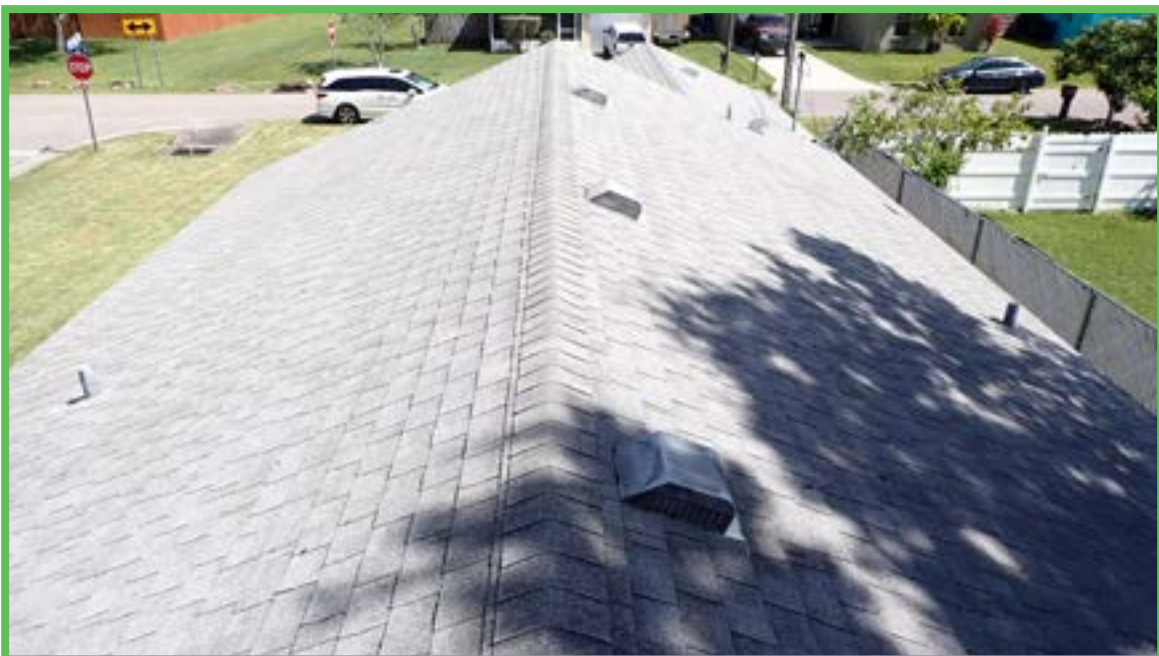
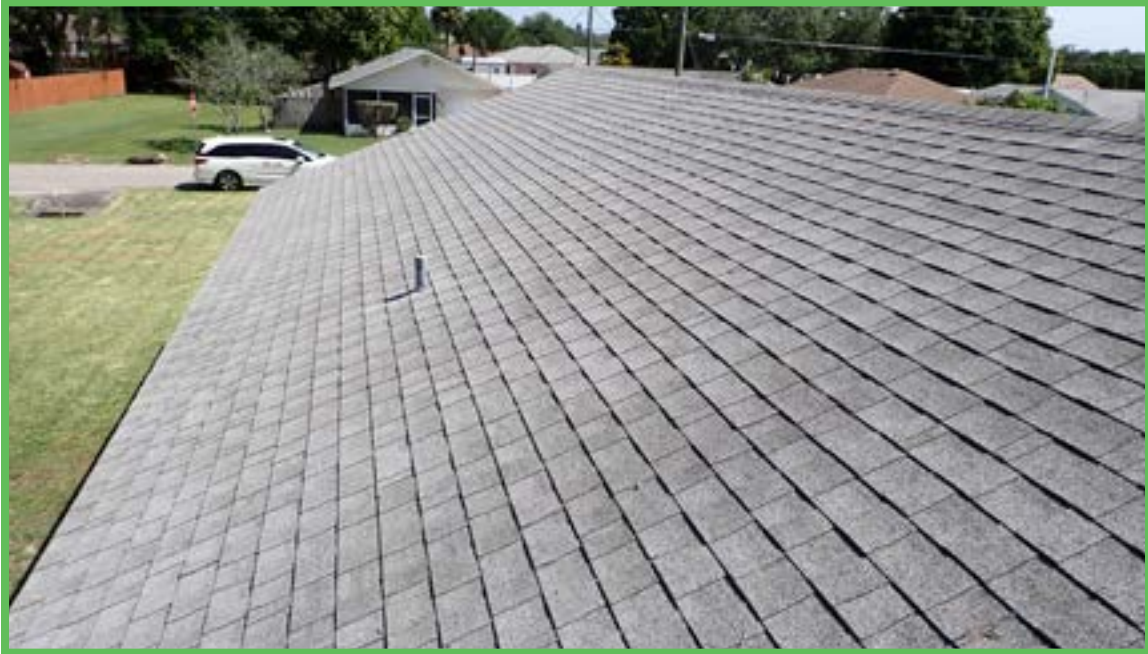
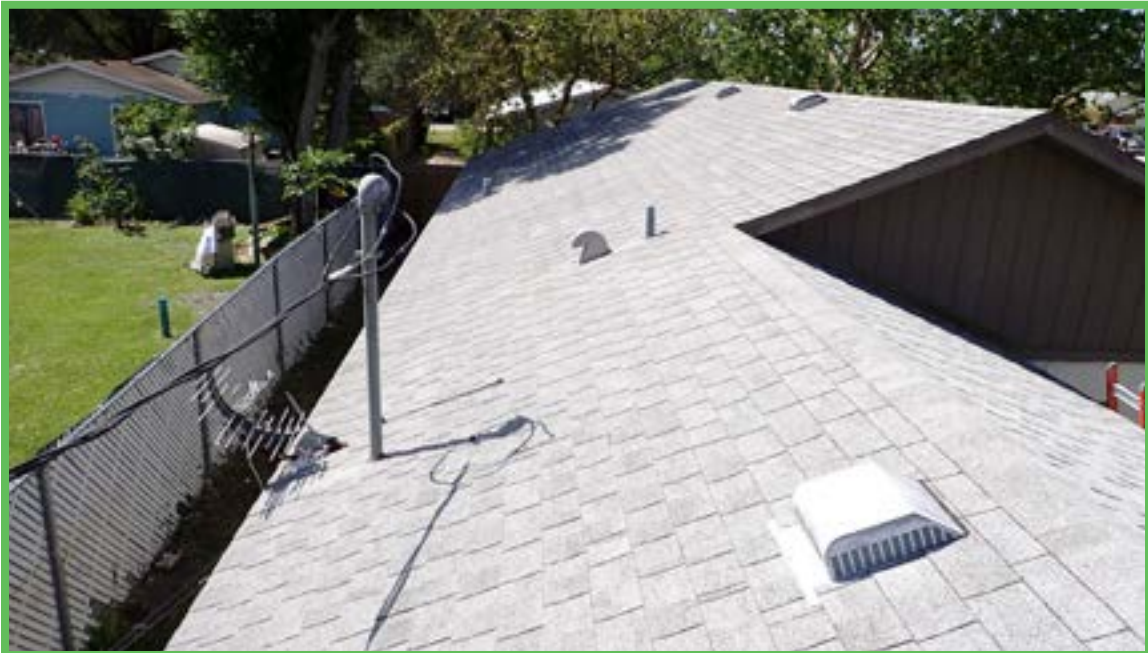
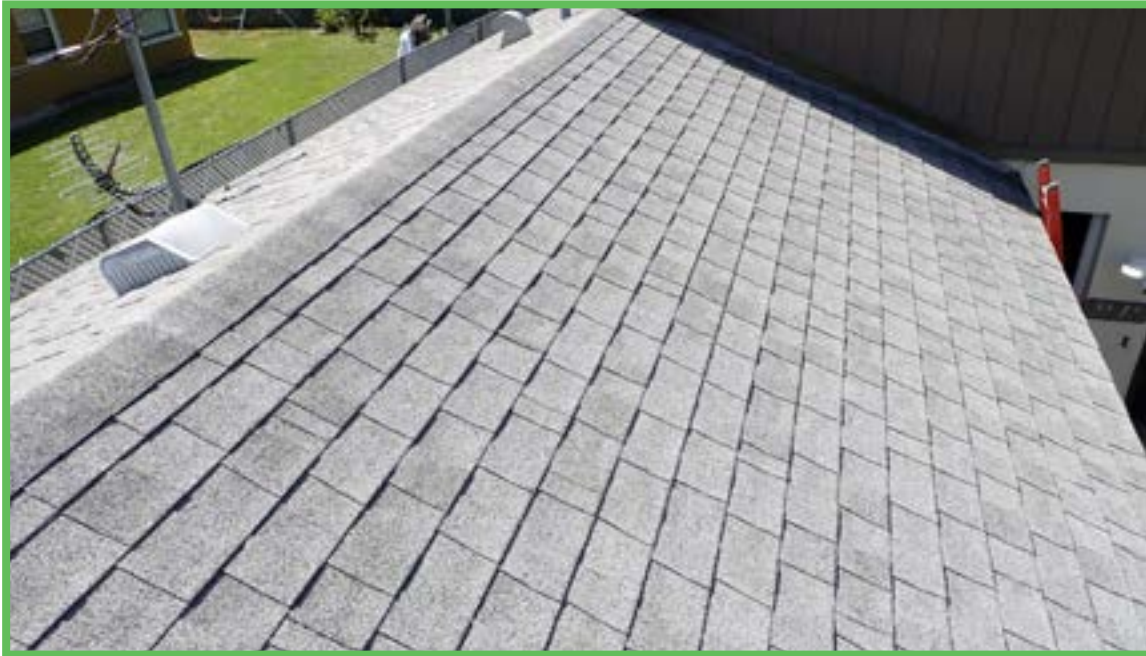
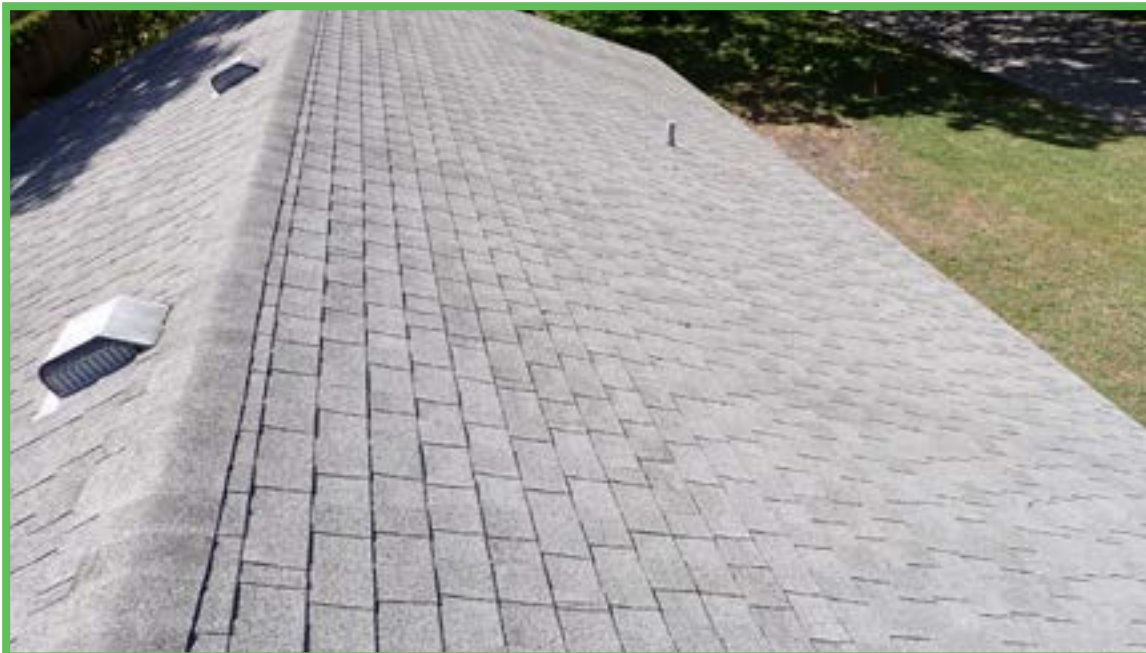
Covering material: Asphalt shingles
 Roof age (years): approx 15 years old
 Remaining useful life (years): 10 years
 Date of last roofing permit: unknown
 Date of last update: unknown

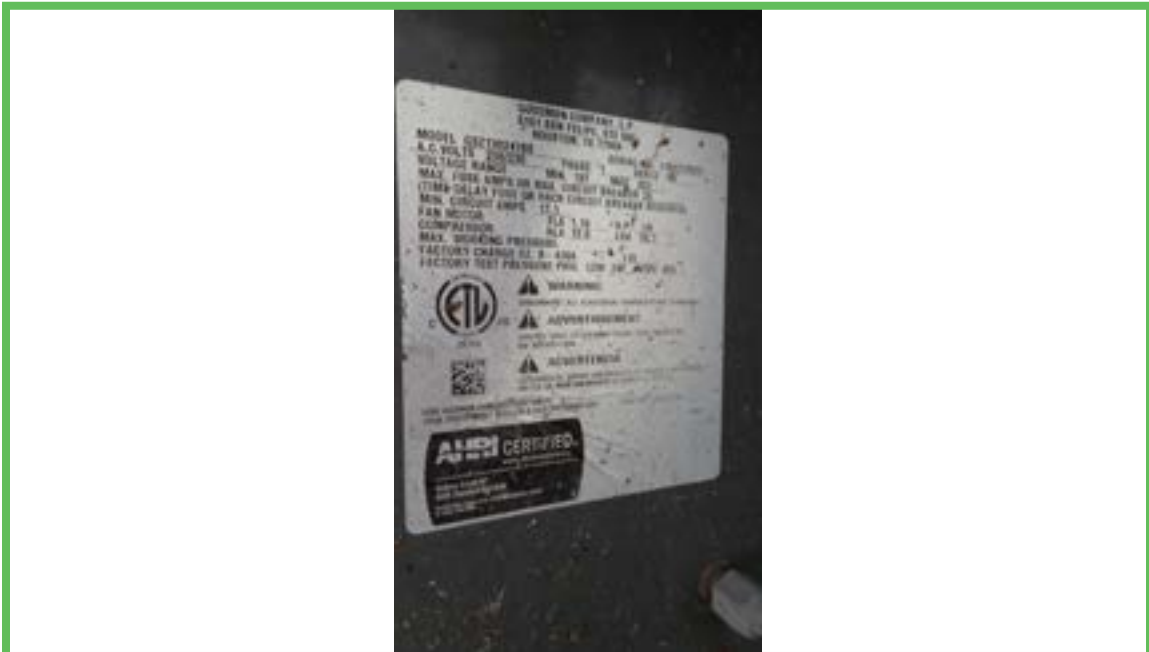
HVAC Condenser Data Plate

Age of system: 4 years

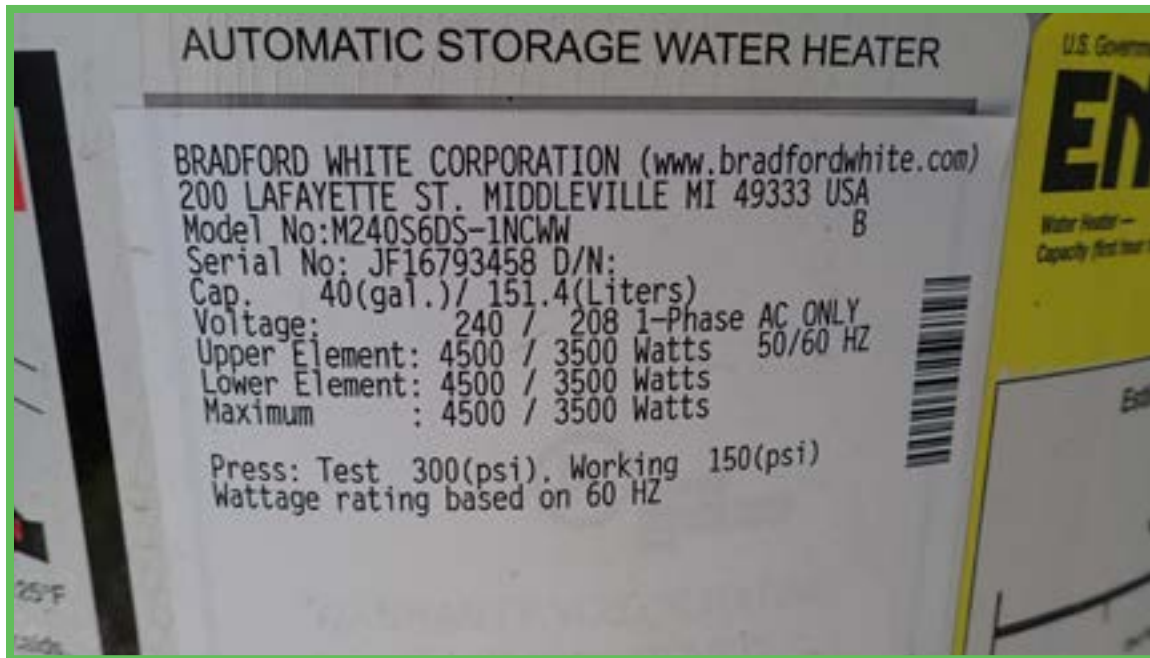
Water Heater Data Plate

Water heater manufacture
Date: 2012

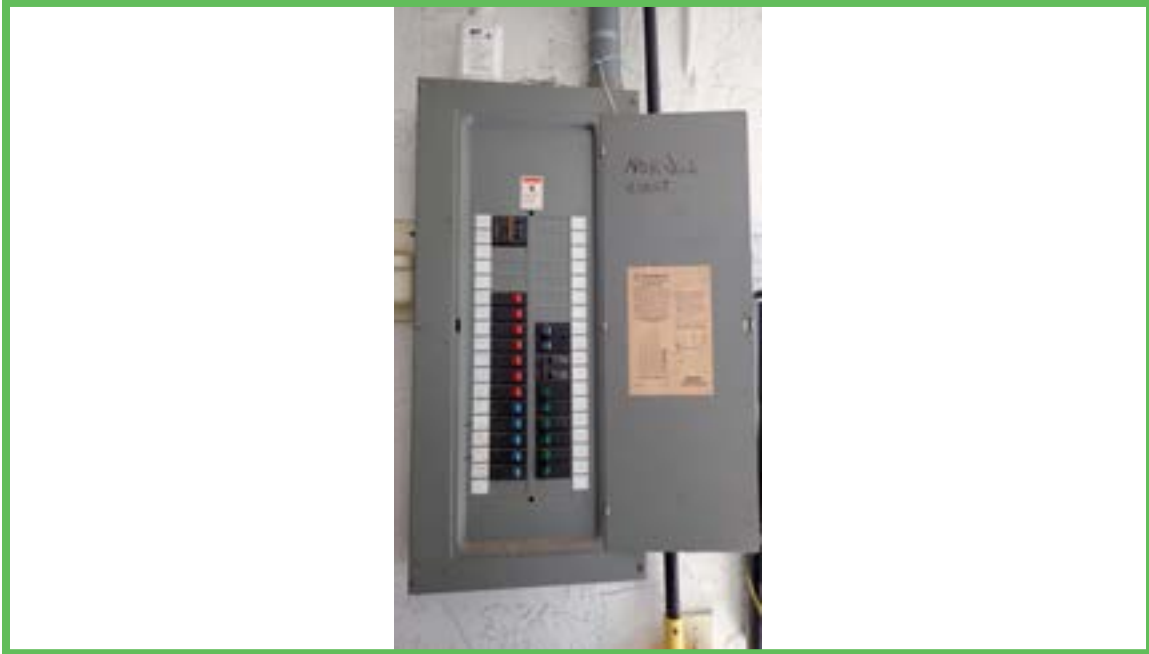
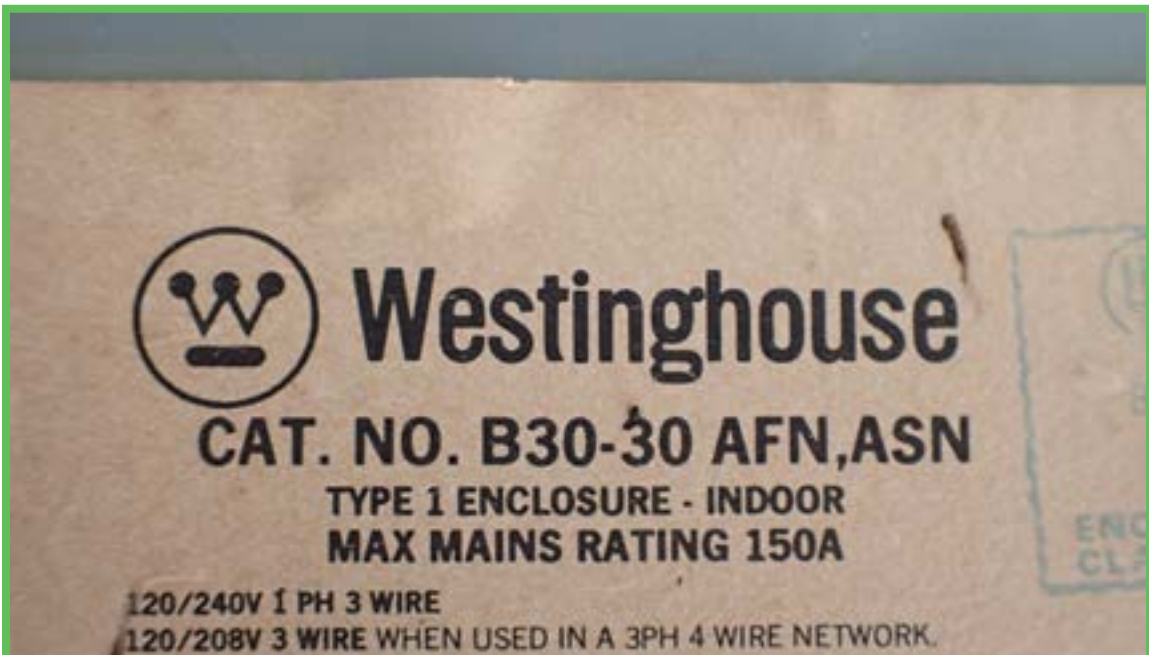
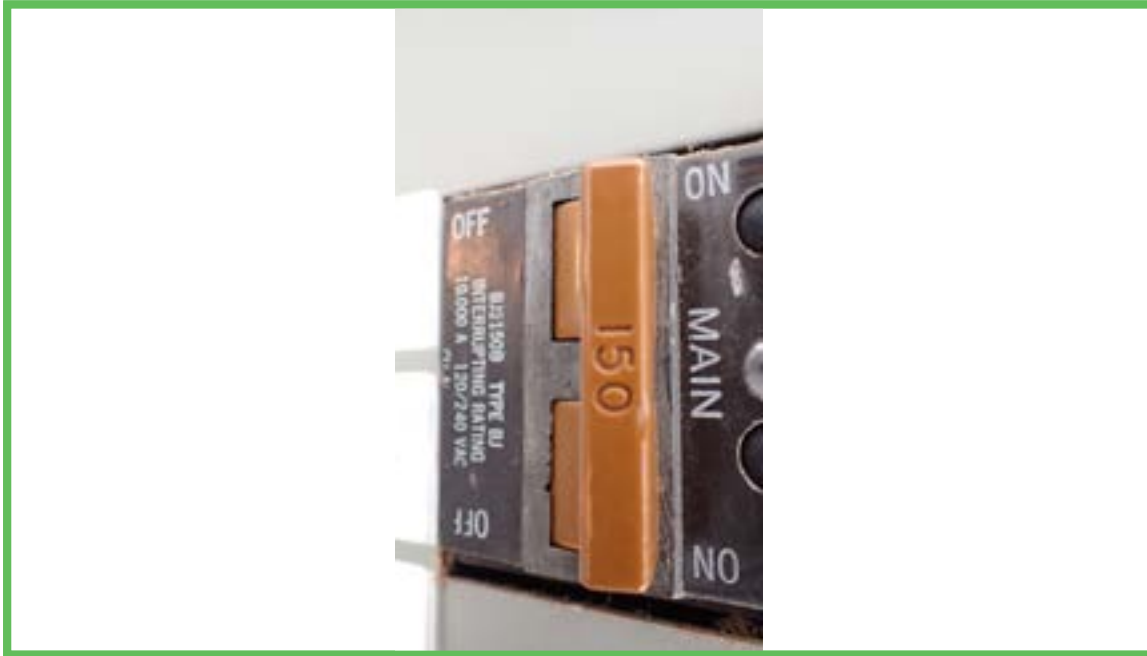
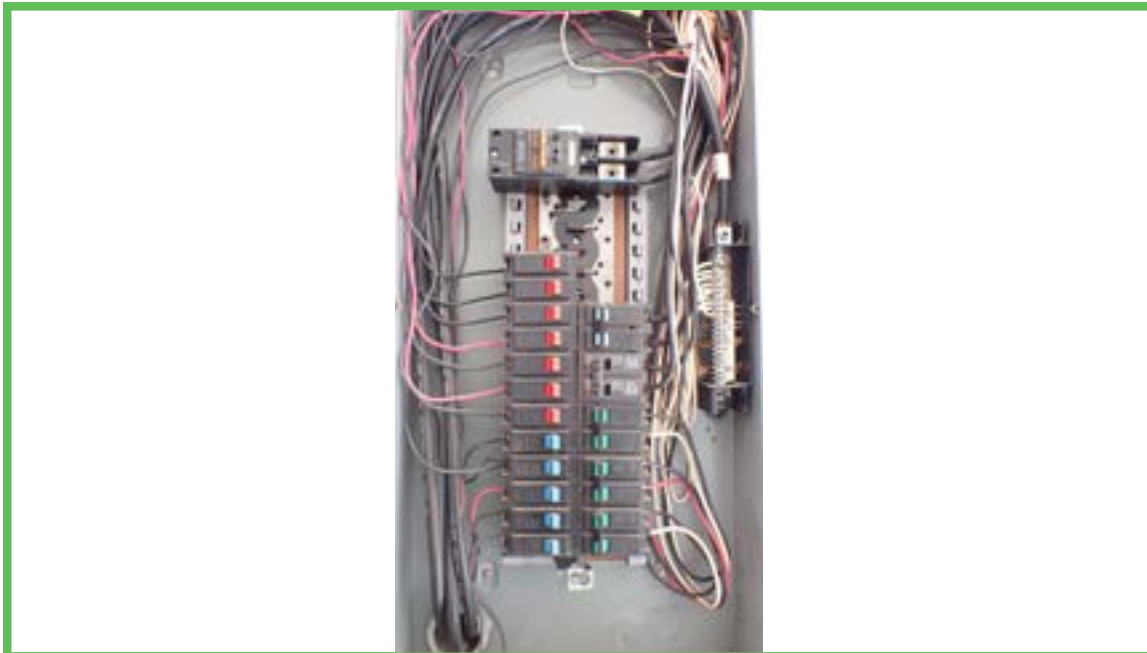
Electric Panel

Panel age: 35 years

Brand/Model: Challenger
