## 4-Point Inspection Form

Address Inspected: 198 Southwinds Dr Sarasota, FL 34231

Date Inspected: 6/7/2022

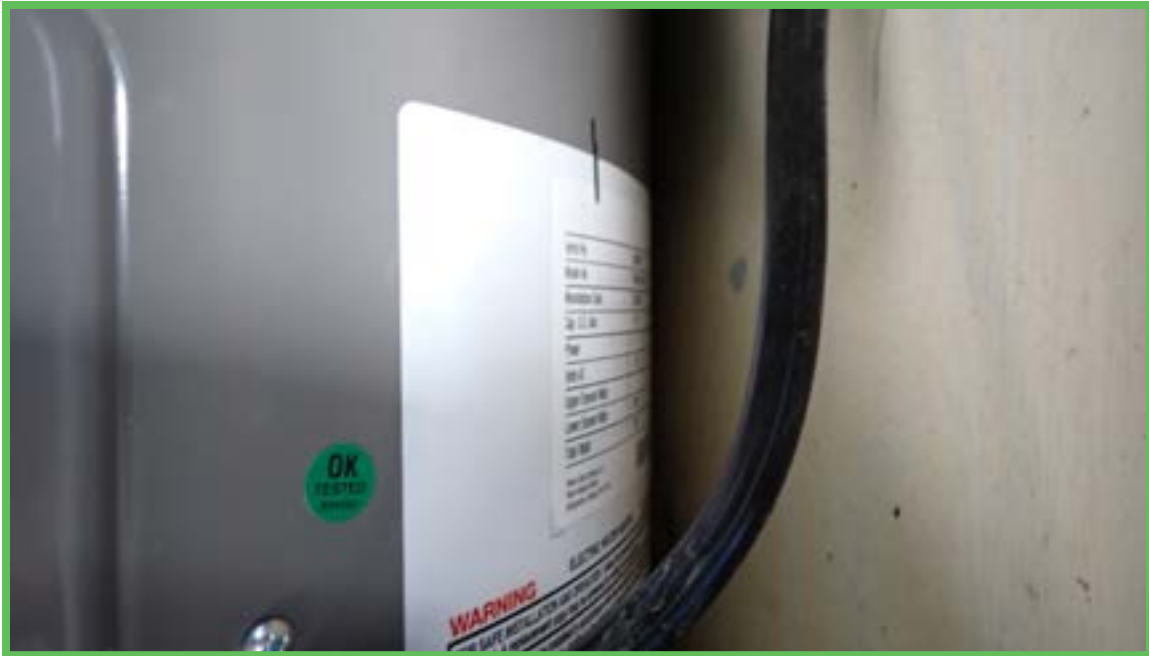
Water Heater Data Plate

Water Heater Manufacture Date: 2020
