4 Point Inspection Report

Inspection Prepared For
Revetia James
923 Goodrich Ave
7/14/2022

Address Inspected: 923 Goodrich Ave Sarasota, FL 34236

Date Inspected: 7/14/2022

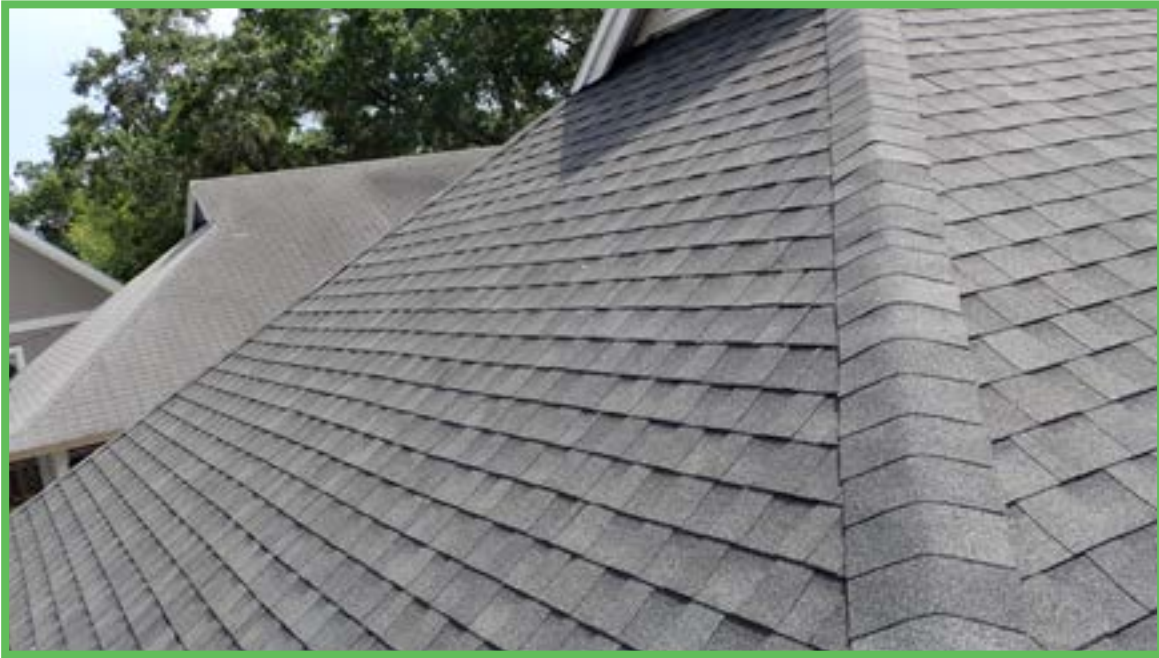
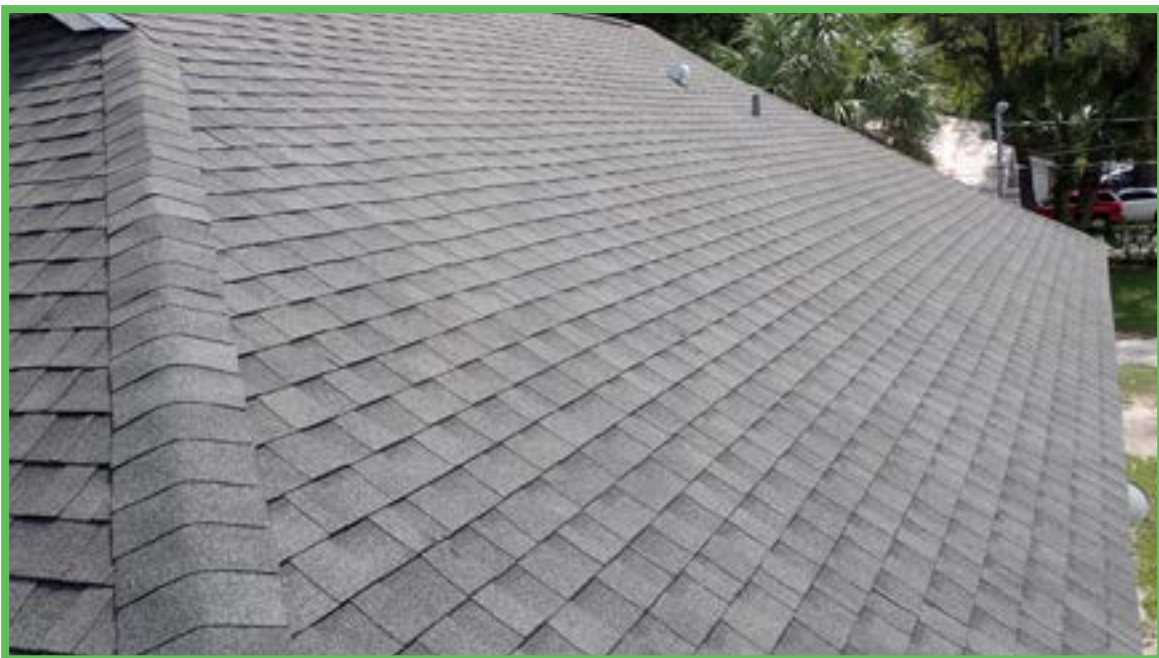
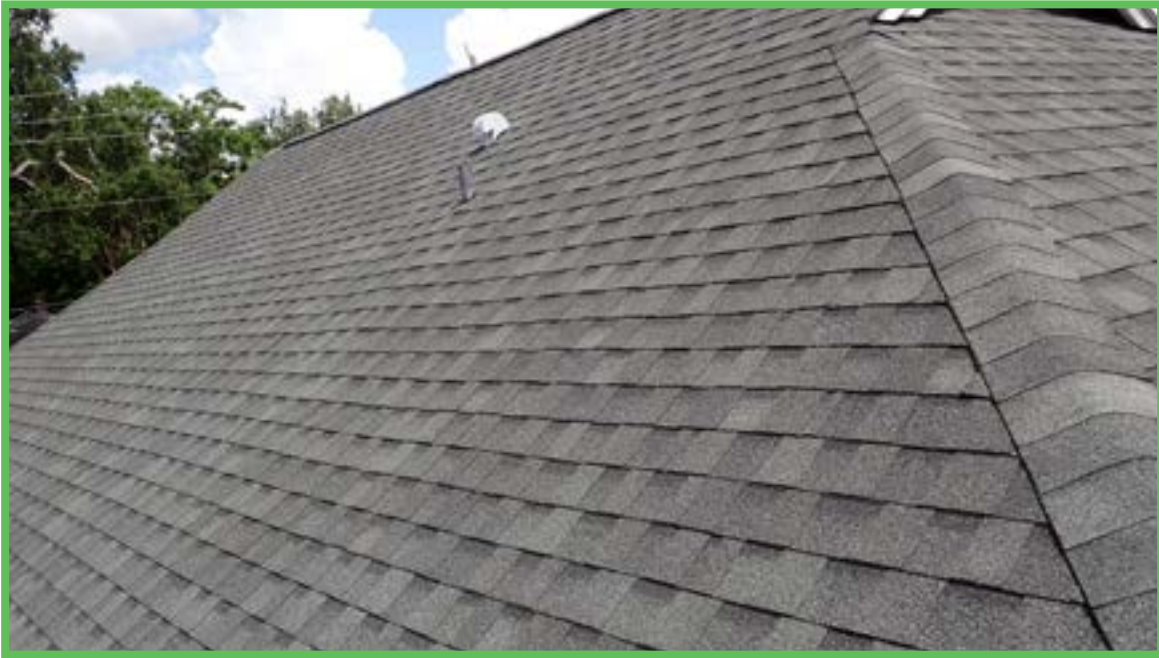
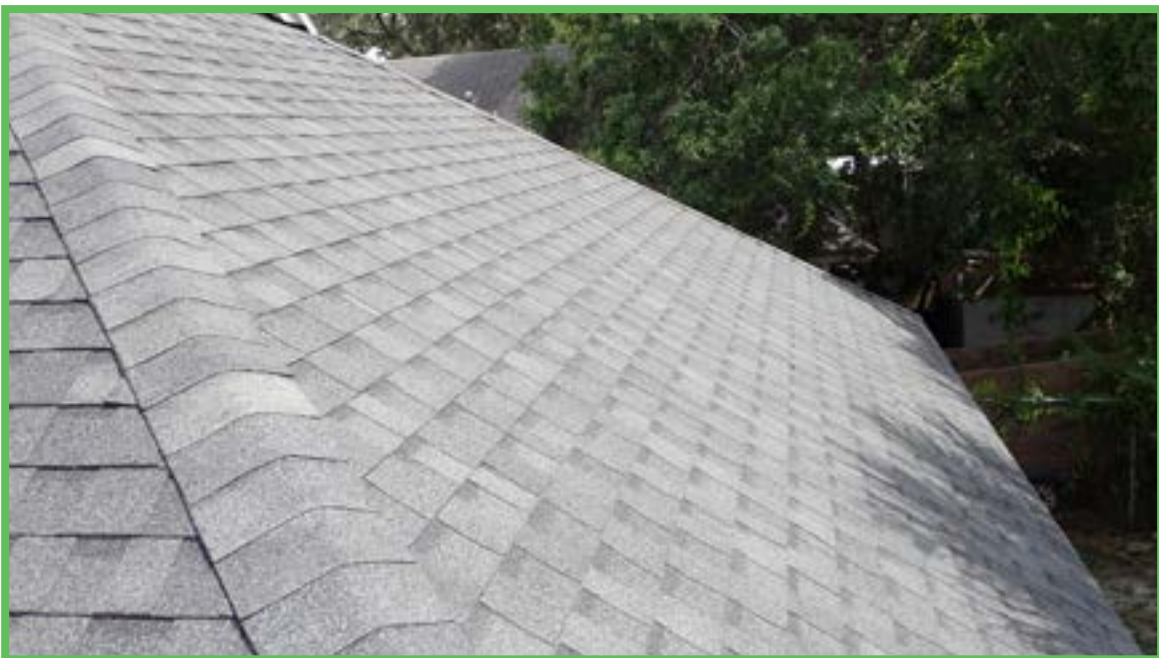
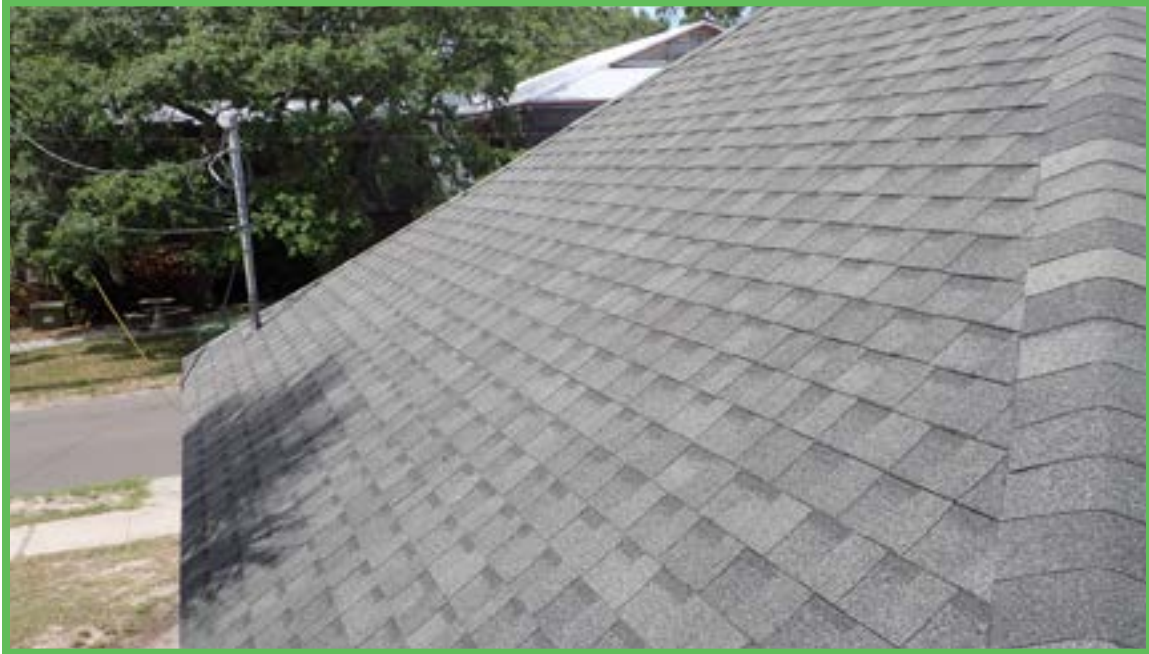
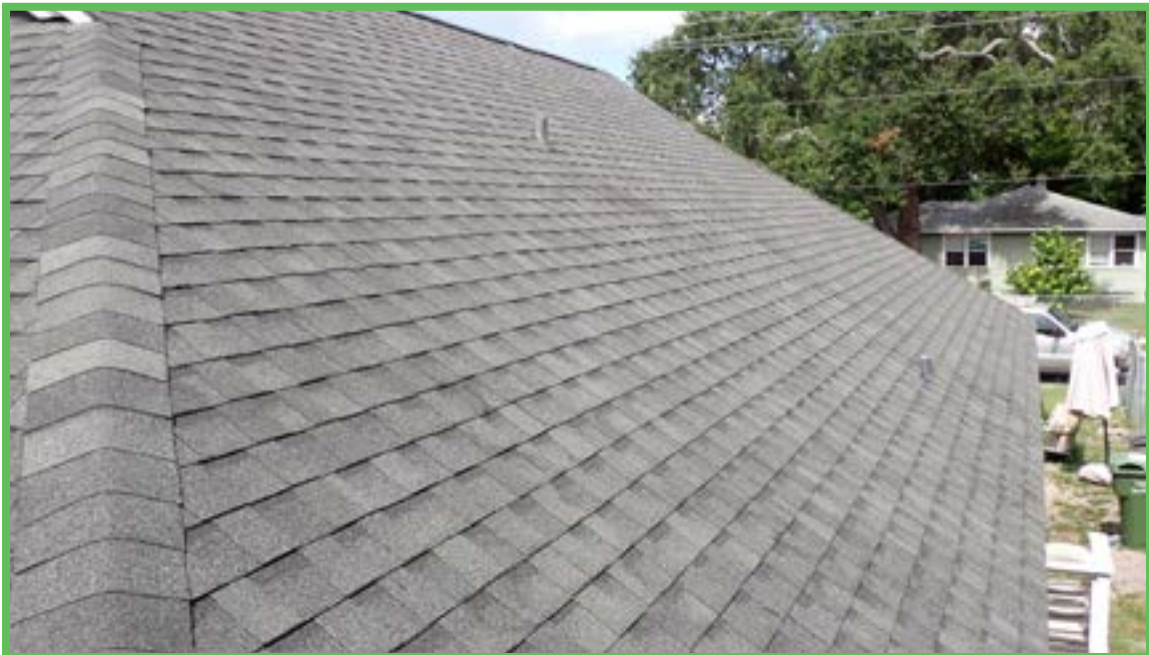
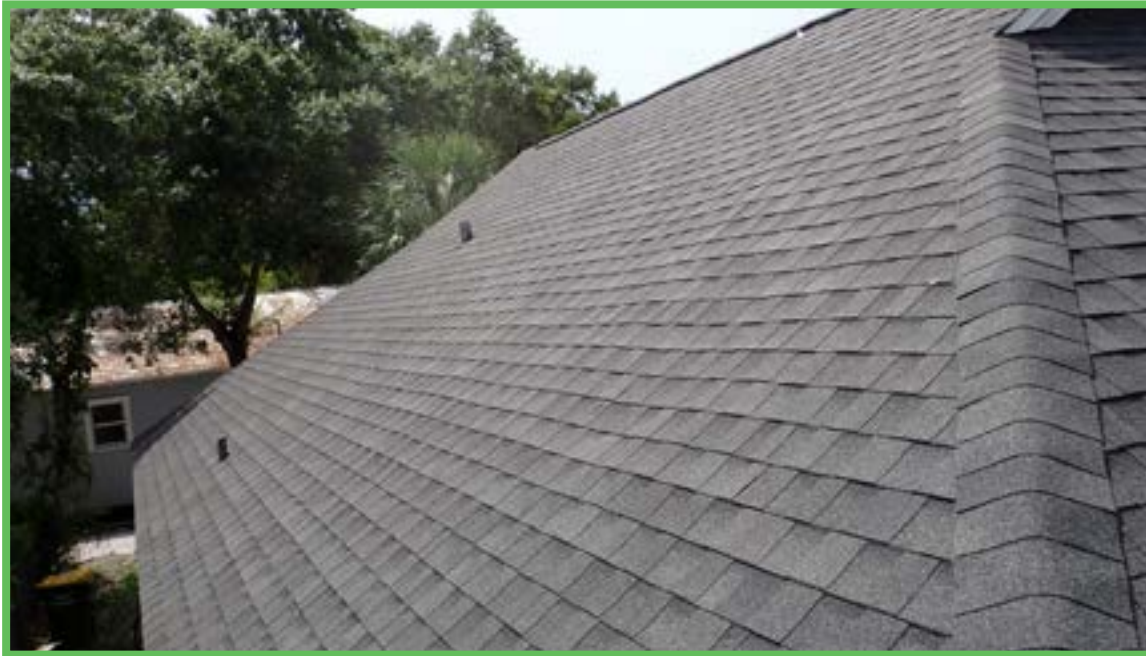
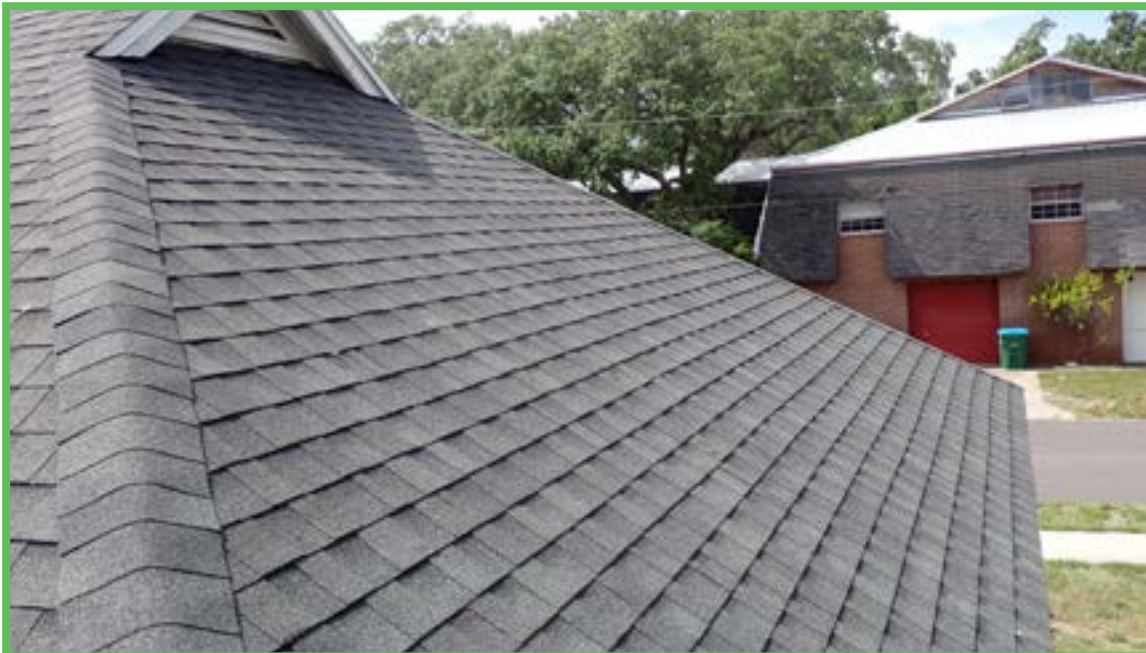
Covering material: Asphalt shingles
 Roof age (years): Less than 1
 Remaining useful life (years): 25 years
 Date of last roofing permit: 5/31/2022
 Date of last update: 2022

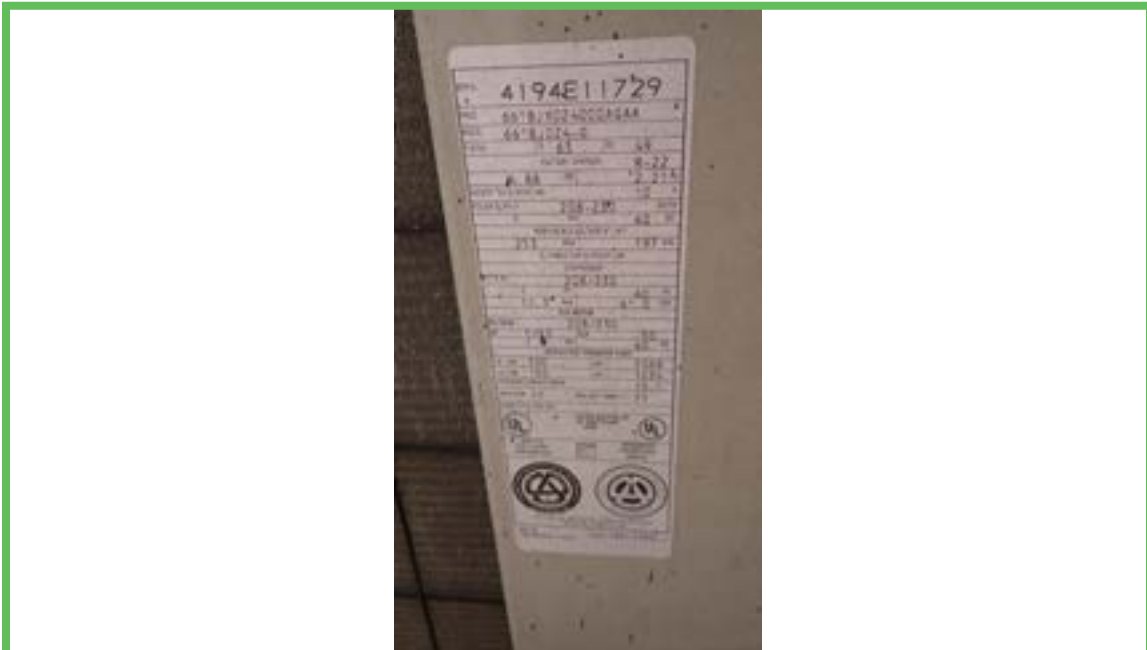
HVAC Condenser Data Plate

Age of system: 28 years
 Year last updated: 1994
 (Please attach photo(s) of HVAC equipment, including dated manufacturer's plate)
