4 Point Inspection Report

Inspection Prepared For
Donald Stockford
2521 W North St
7/14/2022

Address Inspected: 2521 W North St Tampa, FL 33614

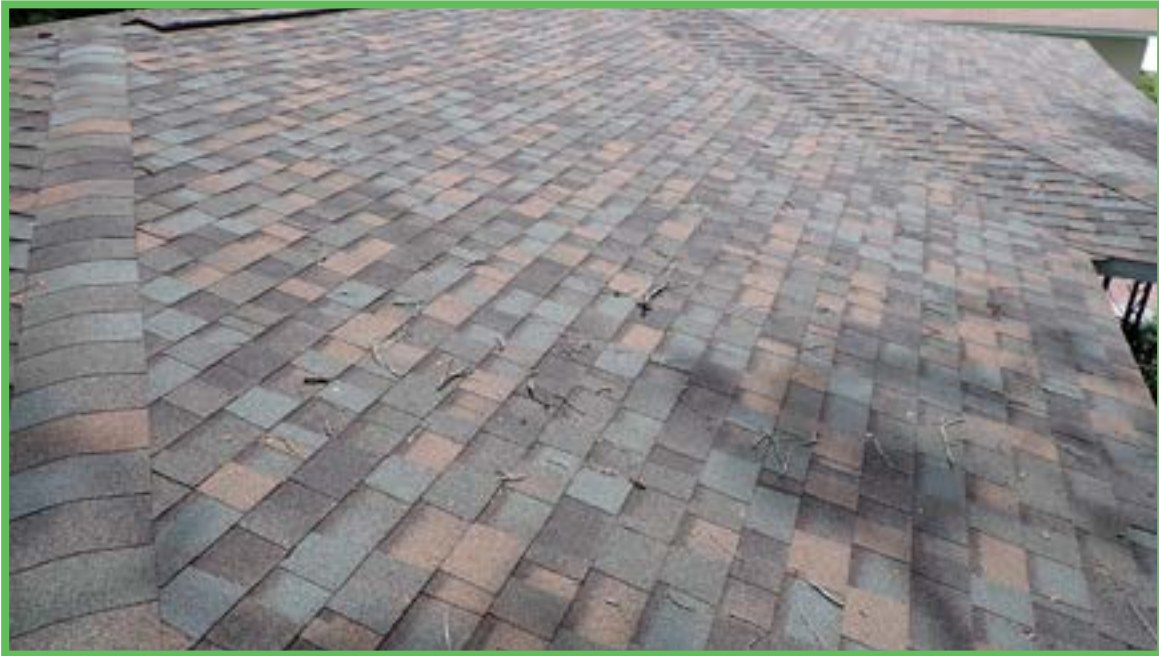
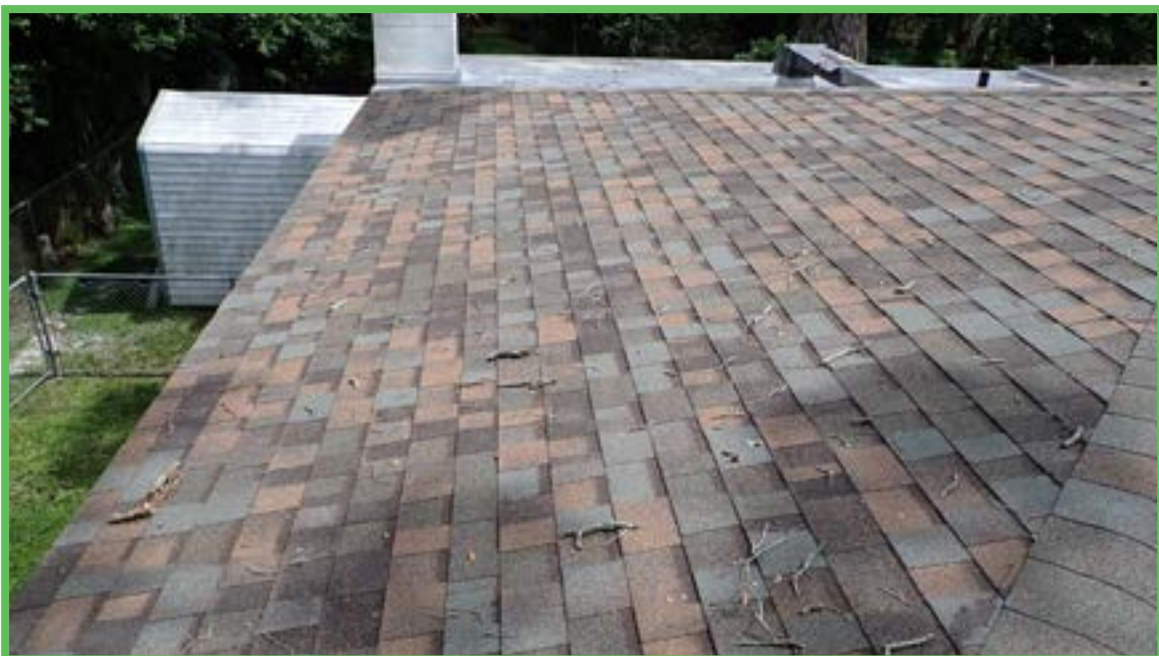
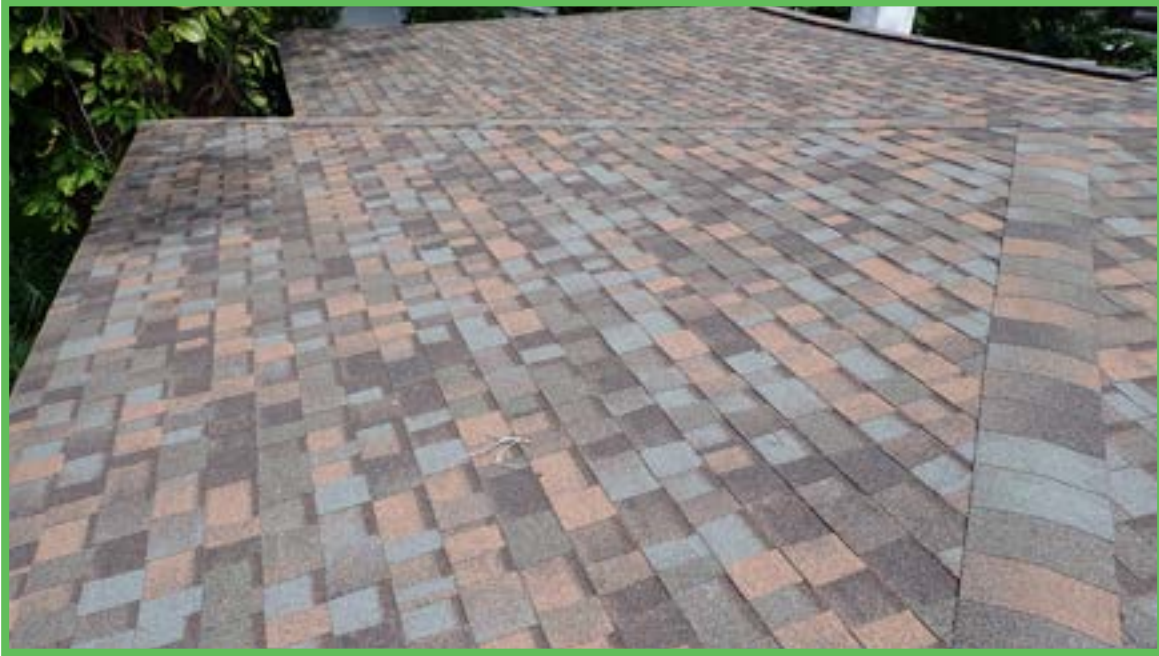
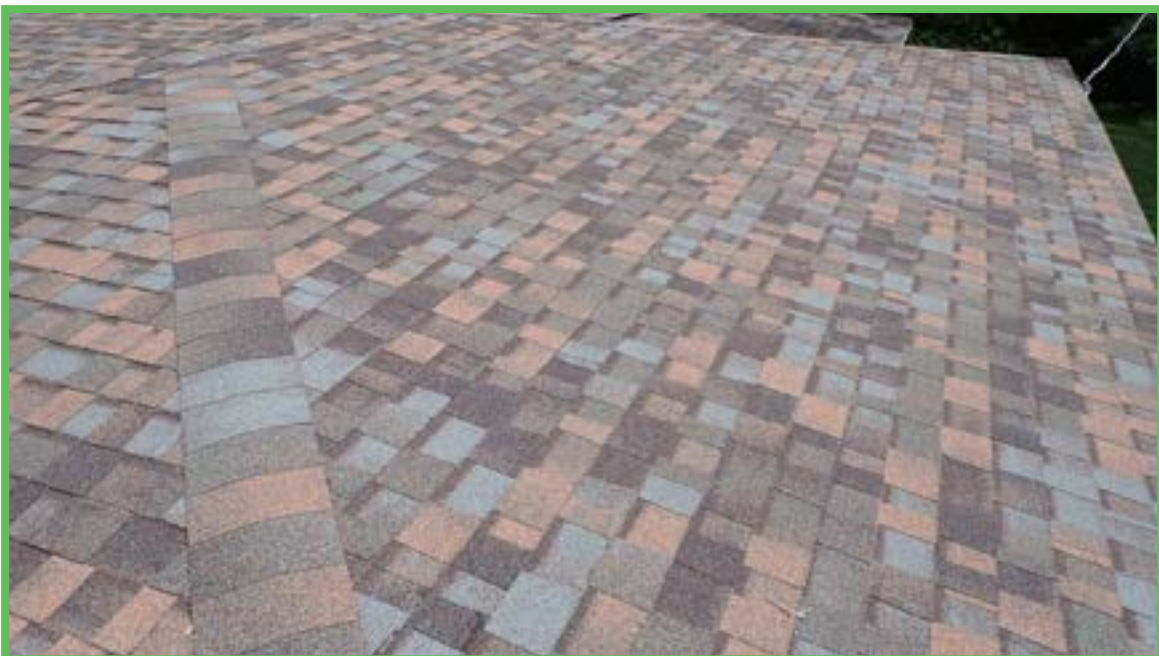
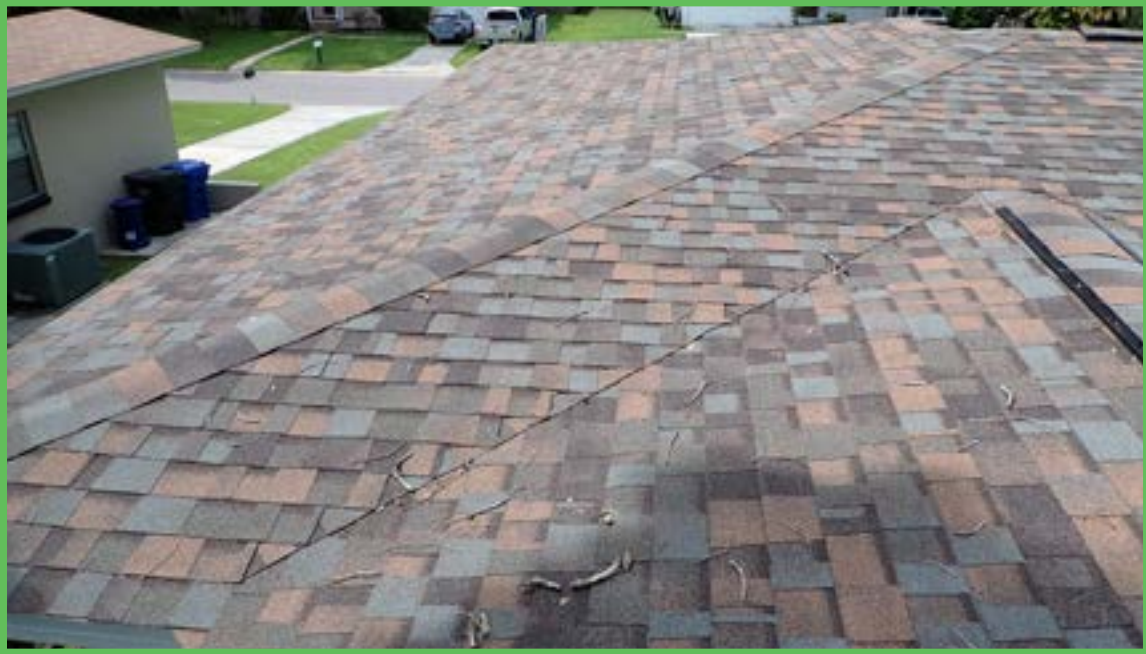
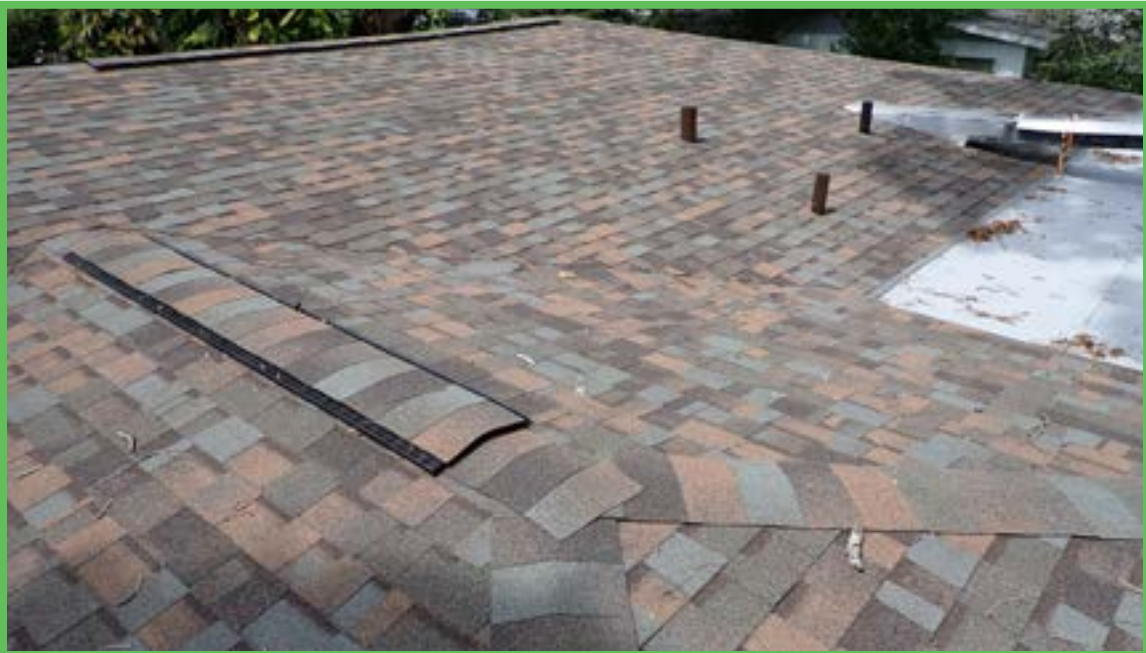
Covering material: Asphalt shingles
 Roof age (years): 1 year
 Remaining useful life (years): 24 years
 Date of last roofing permit: 10/12/2021
 Date of last update: 2021.

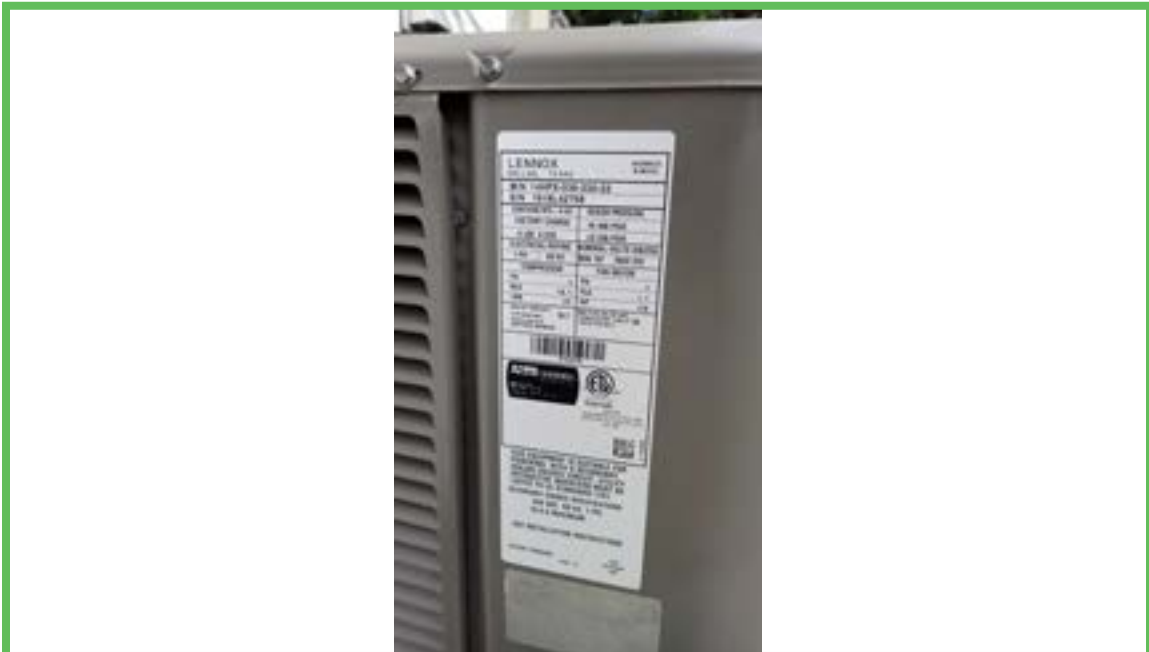
HVAC Condenser Data Plate

Age of system: 4 years _____
 Year last updated: 2018 _____
 (Please attach photo(s) of HVAC equipment, including dated manufacturer's plate)

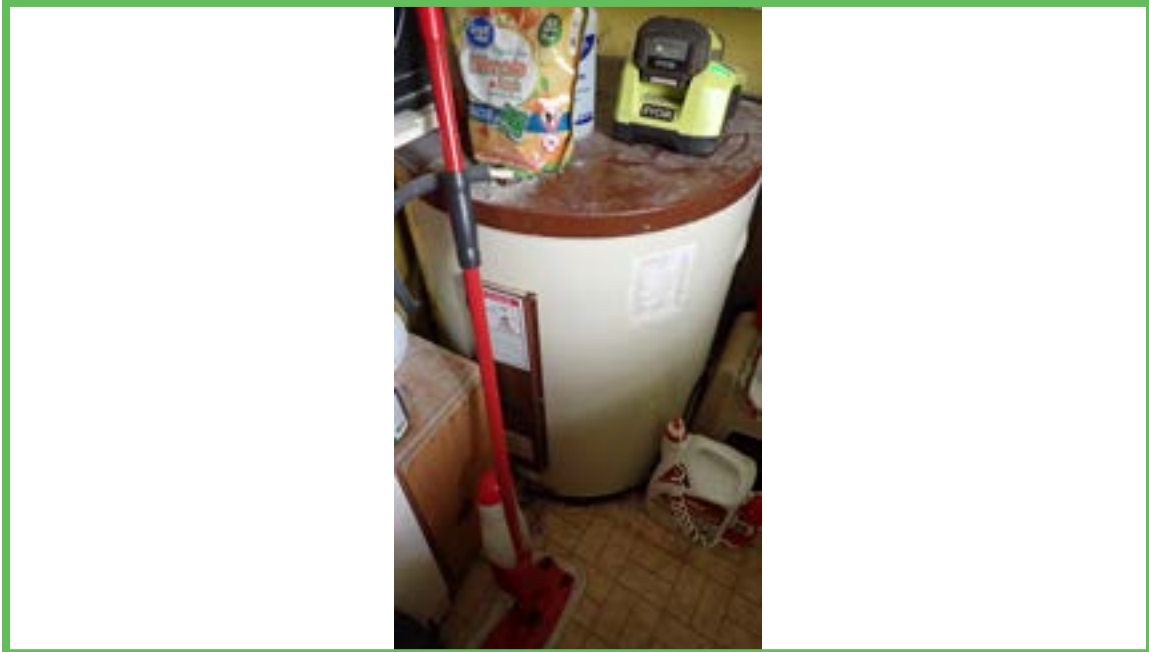
Hot Water Heater

Is there a temperature pressure relief valve on the water heater? Yes No
 Is there any indication of an active leak? Yes No
 Is there any indication of a prior leak? Yes No
 Water heater location: Utility Closet

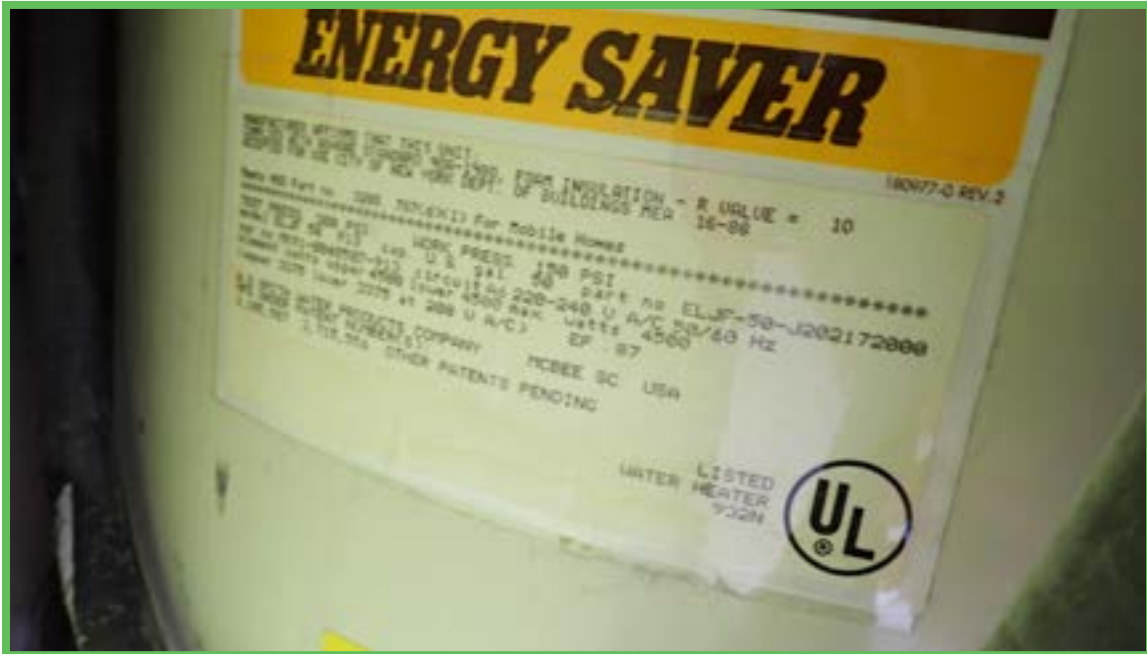
Water Heater Data Plate

Water heater manufacture date: 1991

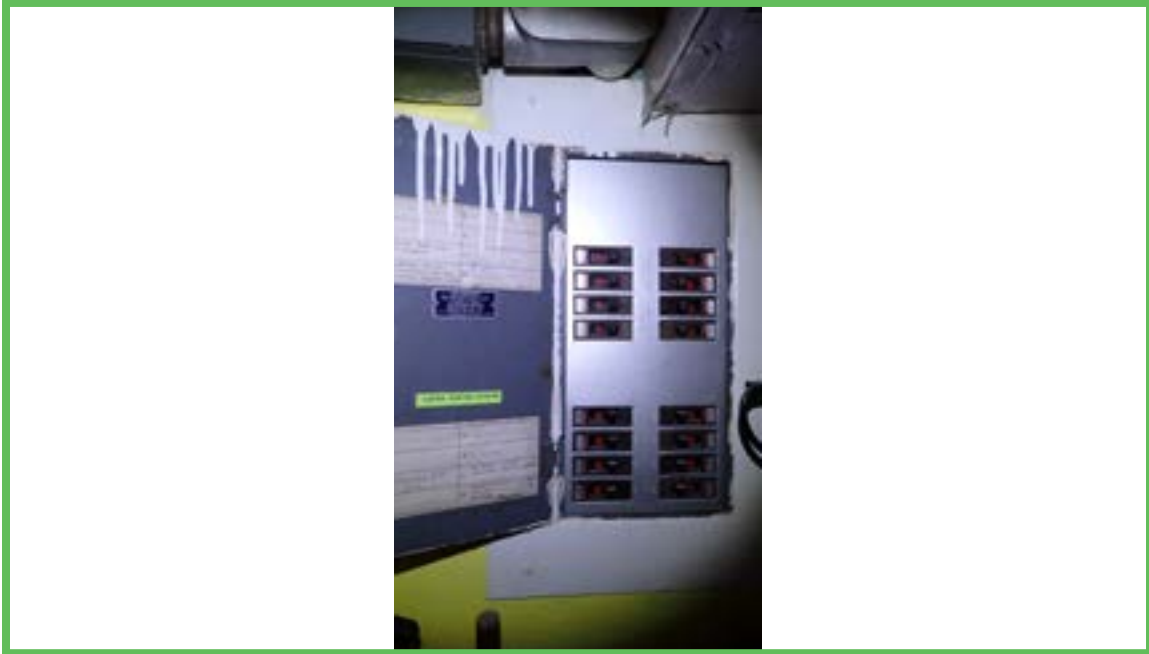
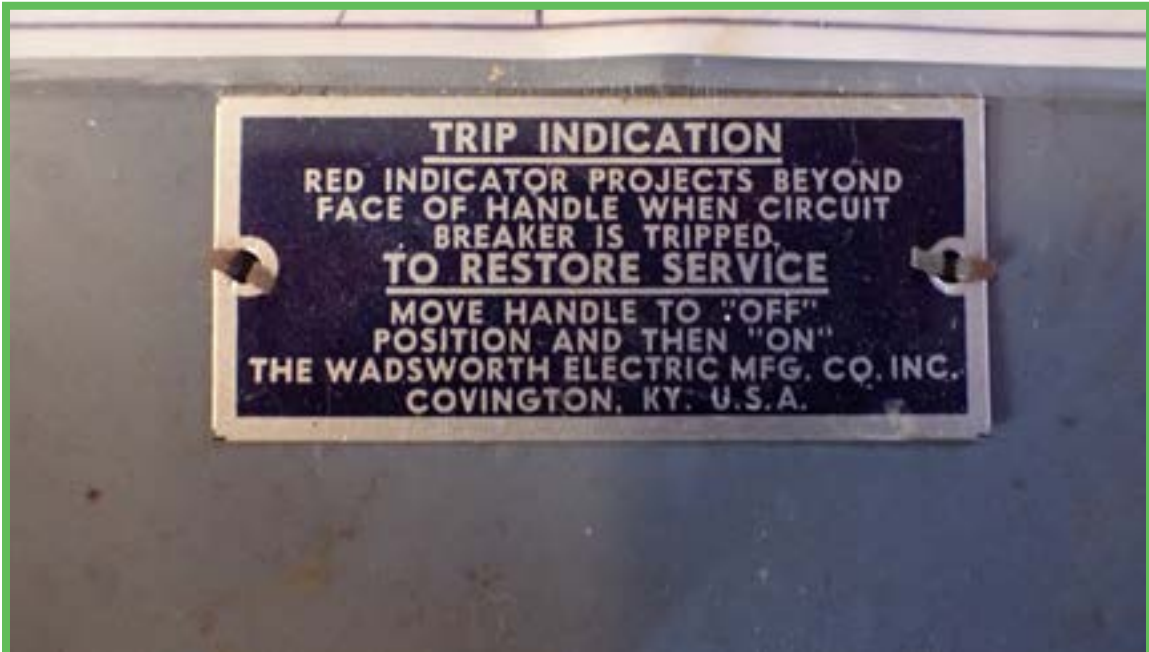
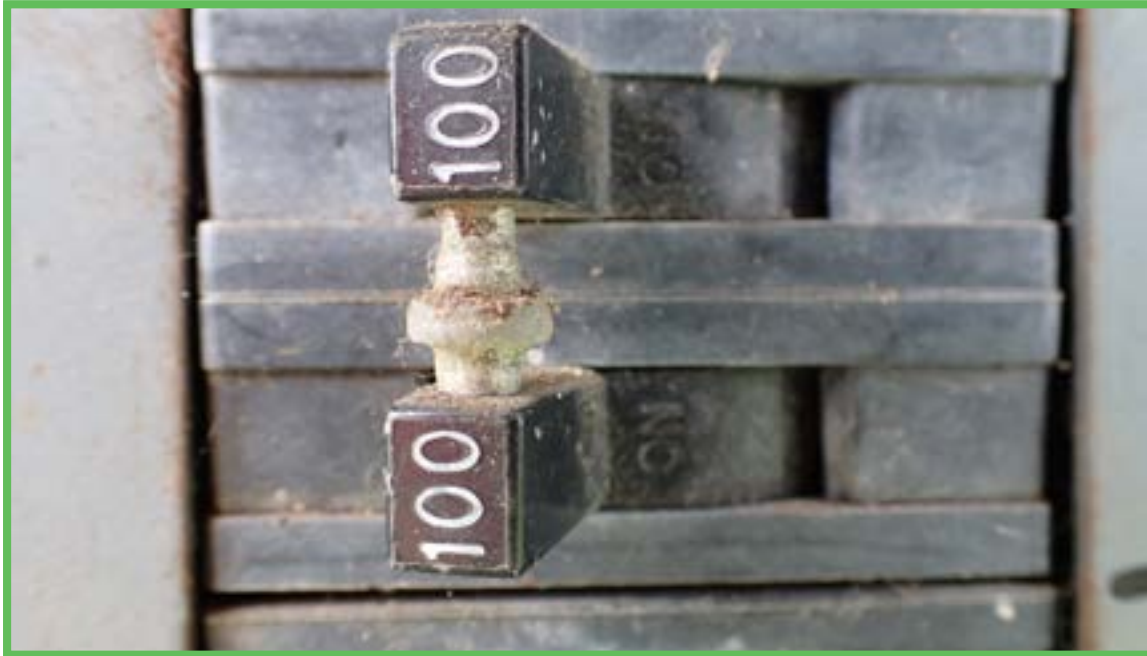
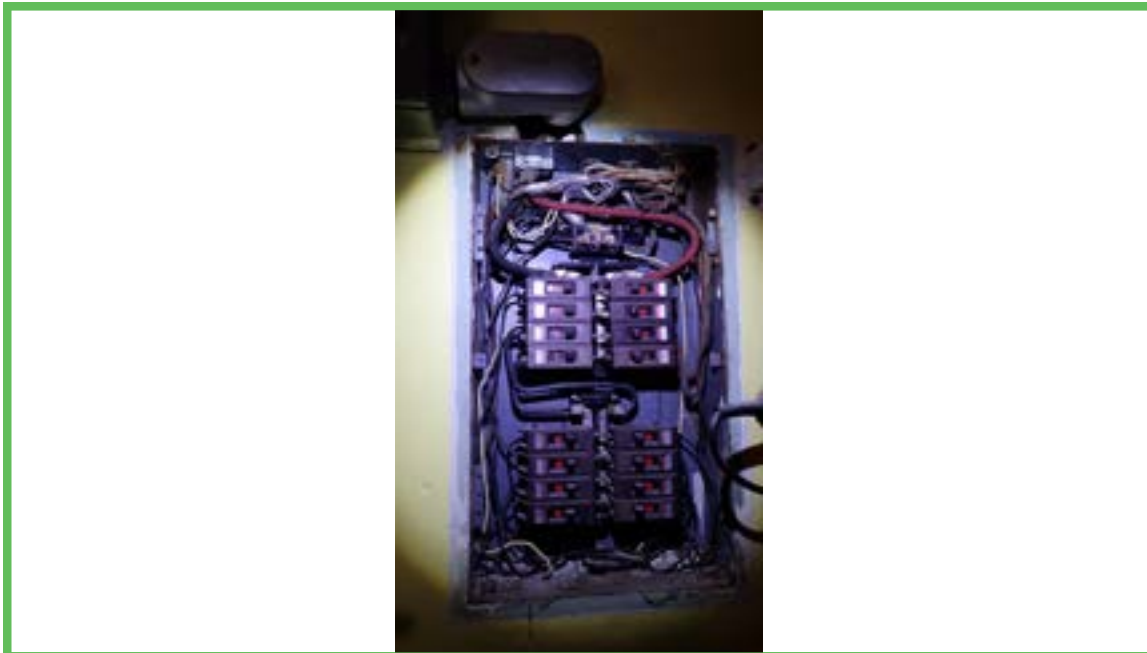
Electric Panel

Panel age: 67 years
 Year last updated: 1955
 Brand/Model: Wadsworth Electric
