# 4 Point Inspection Report

Inspection Prepared For  
Mary Seybert  
3107 51st Ave Terrace W  
11/17/2022

## 4-Point Inspection Form

Address Inspected: 3107 51st Ave Terrace W Bradenton, FL 34207

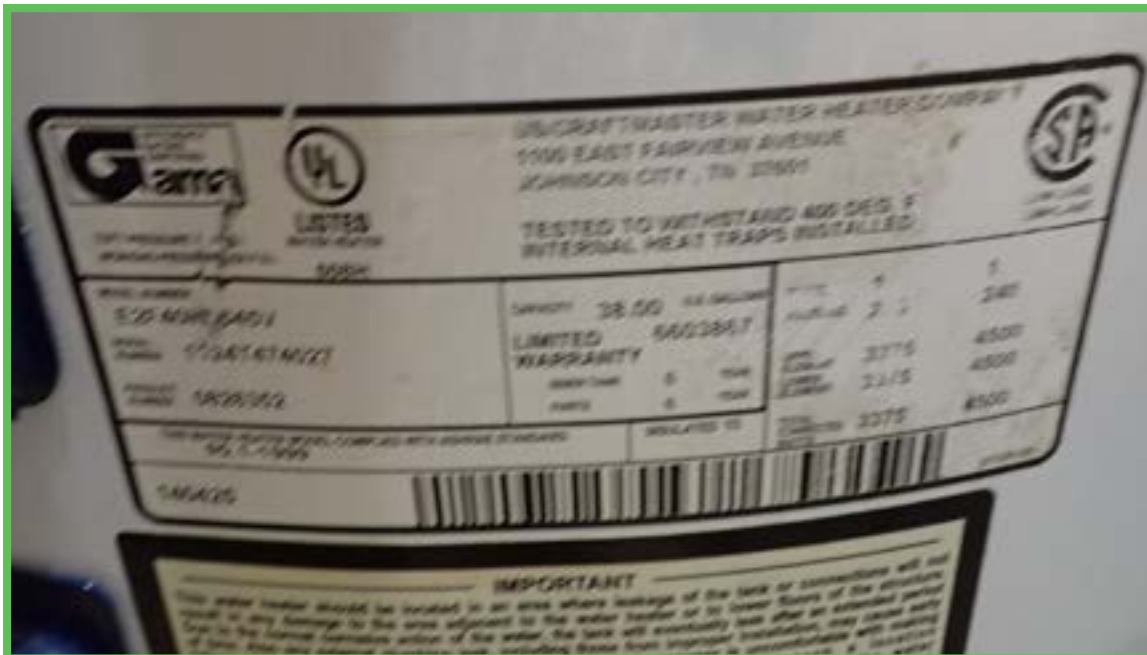
Water Heater Data Plate

Water Heater Manufacture  
Date: 2017
