# PROPERTY INSPECTION REPORT

1521 Music Lane  
Inspection Prepared For: Shawna Wilkins  
Agent

Date of Inspection 4/21/2026  
Year Built 2025 Size 1464

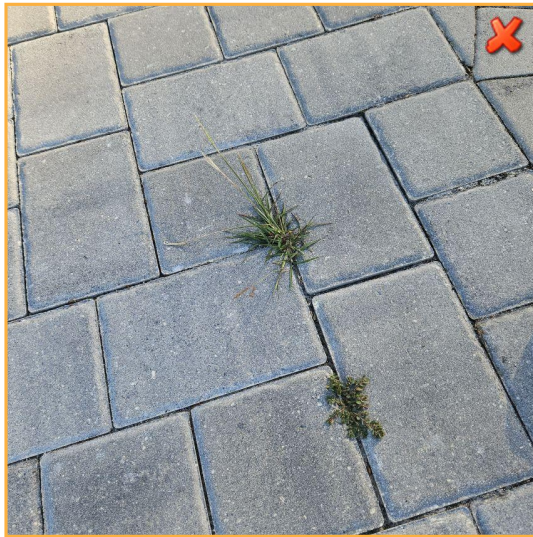
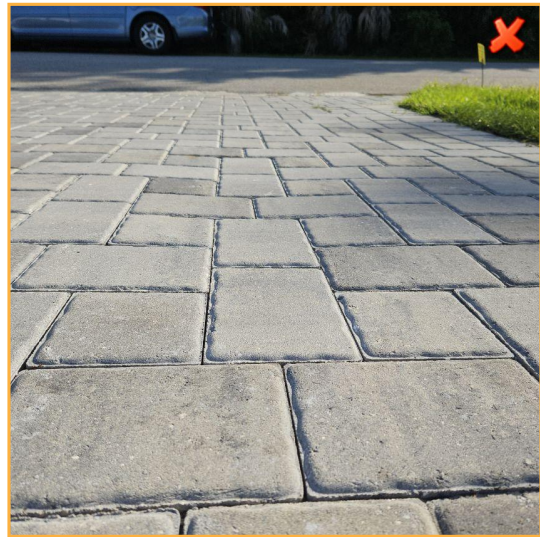
Driveway &  
Walkways

3.3. During the inspection it was observed that a small amount of weed growth is present at the pavers and very minor settling was noted. These conditions are minimal at this time but can worsen if not maintained. Recommendation: Remove the weeds now and monitor the pavers for any increased movement or separation; address if conditions progress.

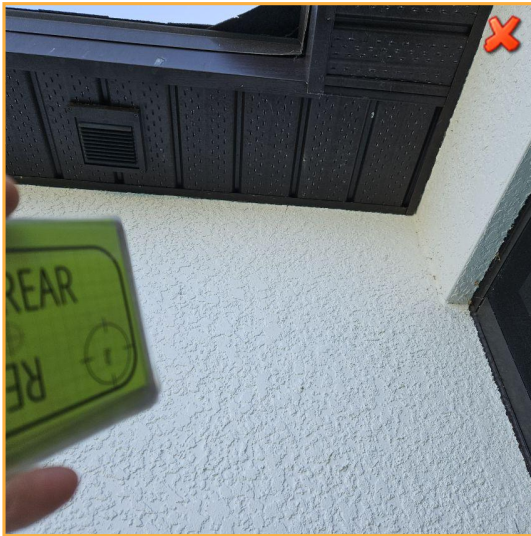
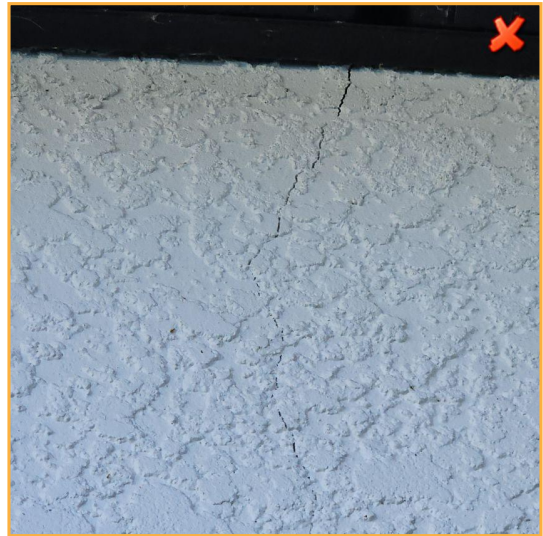
Exterior Wall  
Condition

1.1. During the inspection it was observed that minor settlement cracks were present on one side of the exterior wall. Some appear to have been previously repaired and have reopened slightly. This type of cracking is typical in newer homes but should be touched up to restore the finish and help prevent moisture entry. Recommendation: Have the builder evaluate and repair as needed.

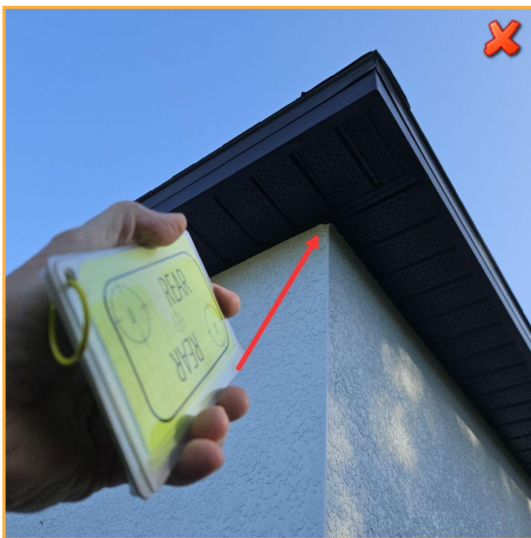
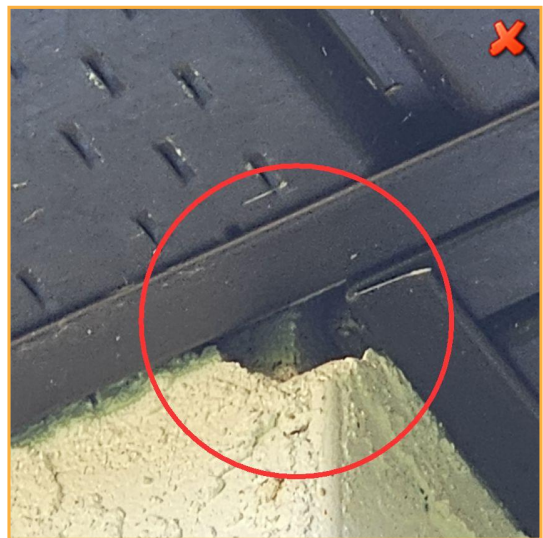
## Stucco Condition

2.2. **Stucco** covering exterior walls of the home had minor damage visible at the time of the inspection. This condition may allow moisture intrusion and possible damage. Recommend sealing with an appropriate **sealant** and repainting by a qualified contractor.

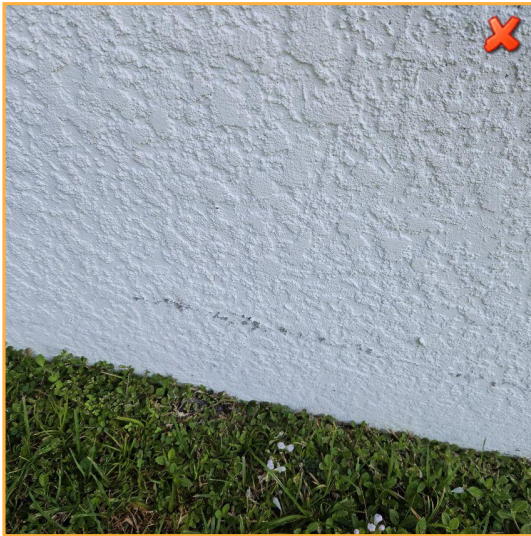
Rear wall

1.1. Walls in the rear of the home exhibited minor damage or deterioration at the time of the inspection.

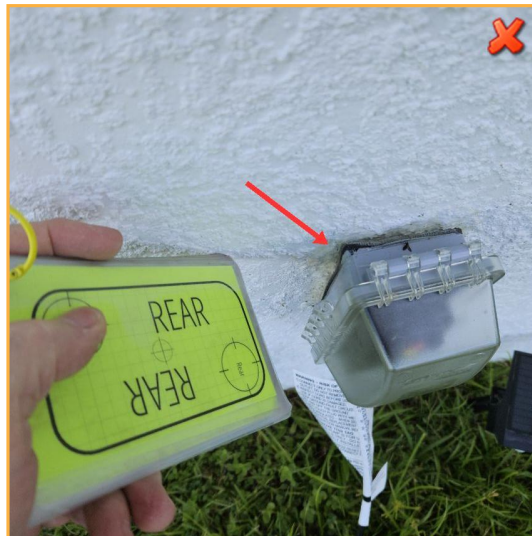
Exterior Electrical  
Receptacles

2.2. During the inspection it was observed that the exterior receptacle box is slightly misaligned and the weatherproof in-use cover does not sit tight against the wall. This can allow water to enter the box if the sealant fails. Sealant was present at the time of the inspection. Recommendation: Maintain and reapply exterior-grade sealant as needed (at least annually) to keep the box properly sealed; have corrected if gaps or leakage are observed.

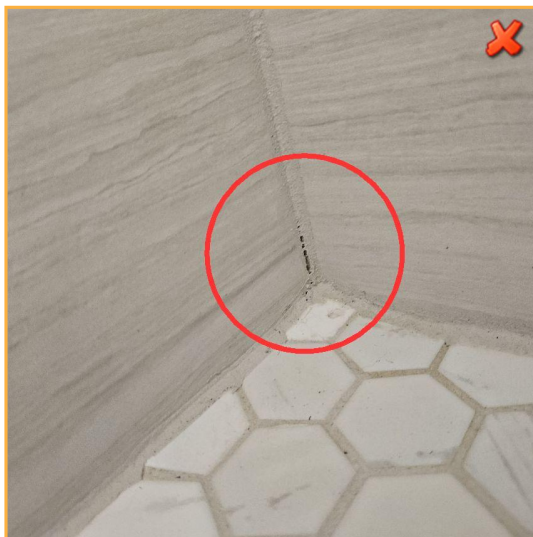
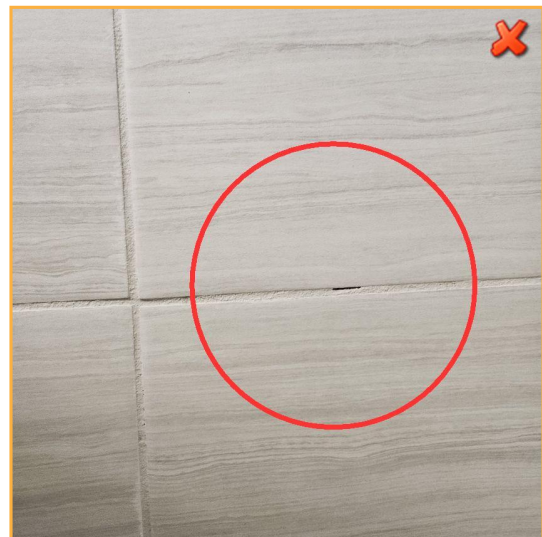
Shower Enclosure

8.1. During the inspection, it was observed that the shower wall grout was cracked or missing in several areas. This condition poses several risks, including moisture intrusion, which can lead to water seeping behind the tiles and causing moisture buildup in the wall cavity. Prolonged moisture **exposure** can also damage the underlying structures, such as **drywall** or backer board, resulting in **warping**, rot, or other degradation that may require costly repairs. Recommend repair by a qualified contractor.

Primary bath shower has areas of missing grout

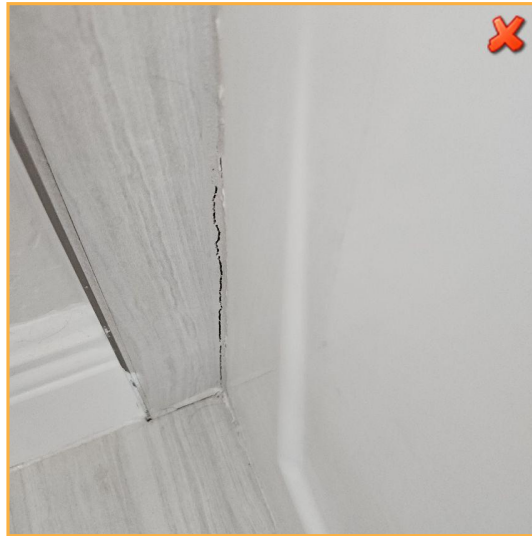
Bath Tubs

7.2. The shower tiles had areas of missing and/or cracked grout or **caulk** that may allow moisture to penetrate the walls.

Cracked grout by guest bath tub

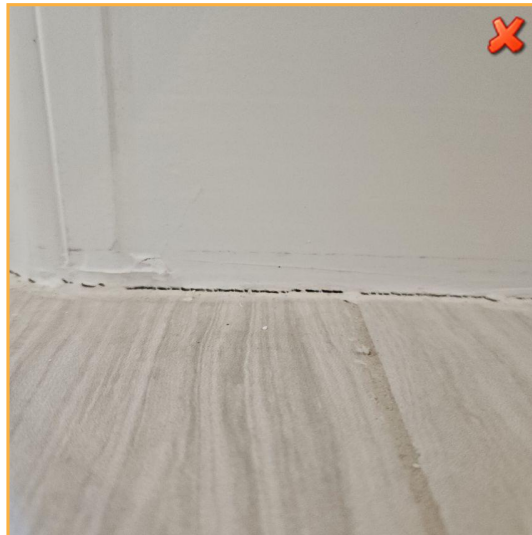
Interior Trim

2.2. At the time of the inspection, the Inspector observed that some **trim** did not fit tightly to the flooring. This condition is cosmetic. Recommend **caulking** and painting gaps below **baseboards** by a qualified contractor.

Gaps visible below baseboard

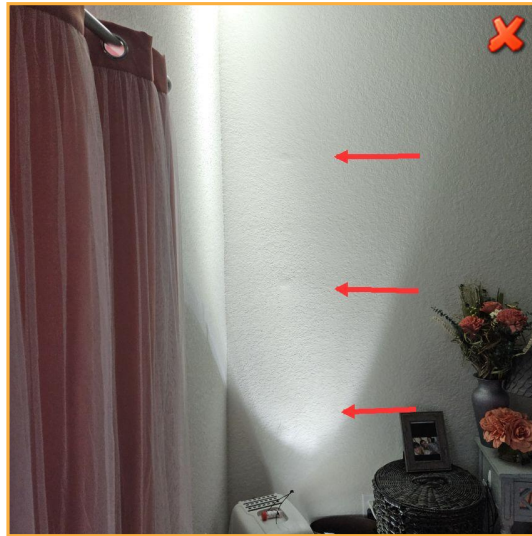
Walls

1.1. During the inspection it was observed that three raised bumps are present in a vertical line on a bedroom wall. This is a minor cosmetic condition. Recommendation: Repair or smooth the affected areas as desired for appearance.

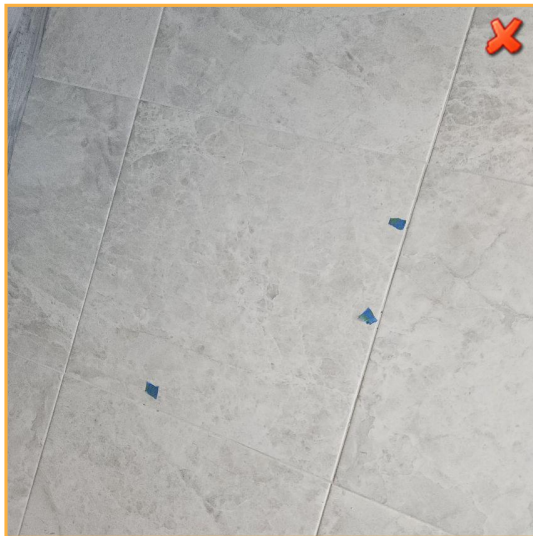
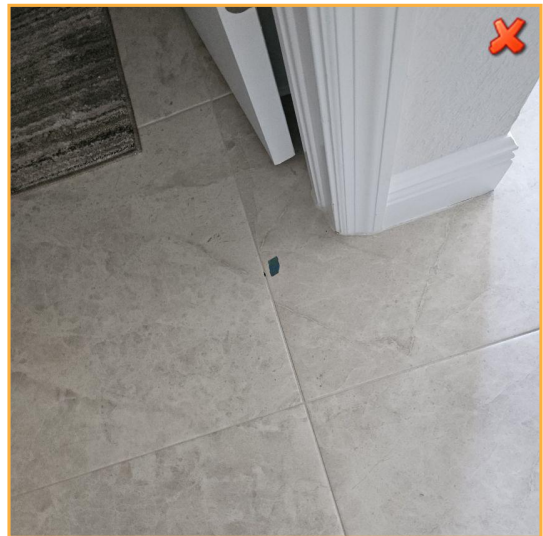
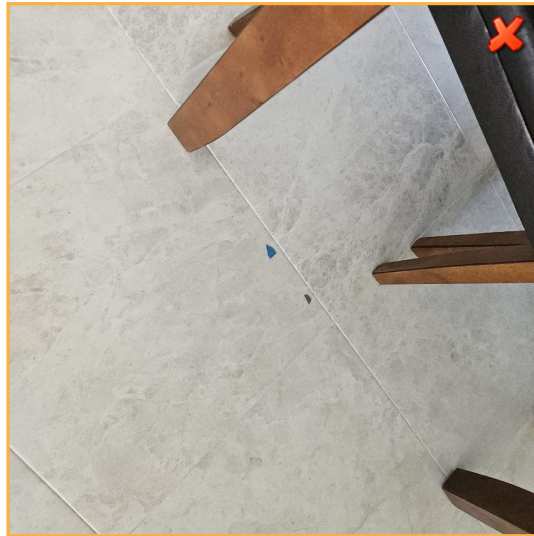
Tile Floors

1.1. During the inspection it was observed that grout is missing in multiple areas of the floor tile. Missing grout can allow moisture and debris to collect and may lead to loosening of tiles over time. Recommendation: Re-grout the affected areas to help protect the underlying material and maintain the floor.

Grout missing in multiple locations through out the home

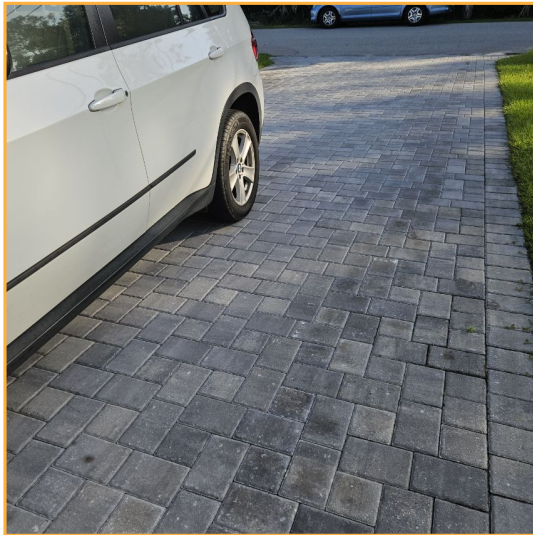
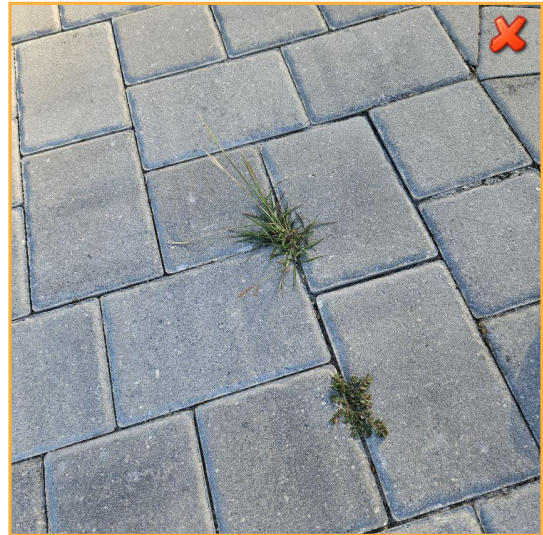
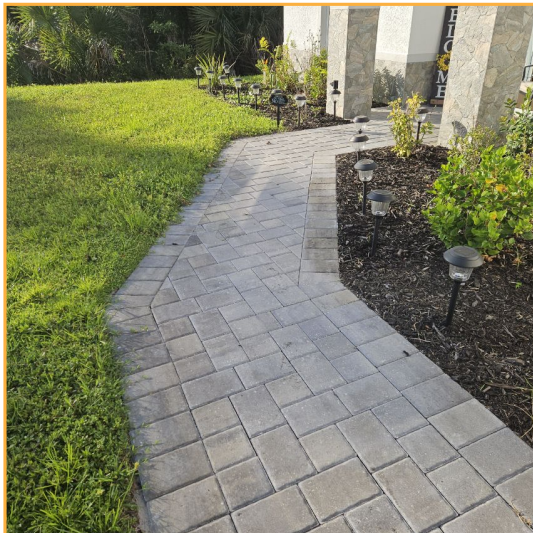
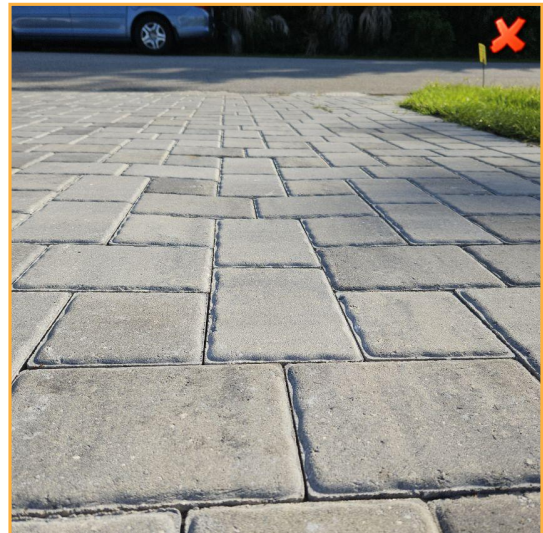
### 3. Driveway & Walkways

3.2. During the inspection it was observed that the pavers do not appear to be sealed. Unsealed pavers are more prone to staining, fading, and weed growth over time. Recommendation: Consider having the pavers professionally cleaned and sealed to help protect the surface and reduce maintenance.

3.3. During the inspection it was observed that a small amount of weed growth is present at the pavers and very minor settling was noted. These conditions are minimal at this time but can worsen if not maintained. Recommendation: Remove the weeds now and monitor the pavers for any increased movement or separation; address if conditions progress.

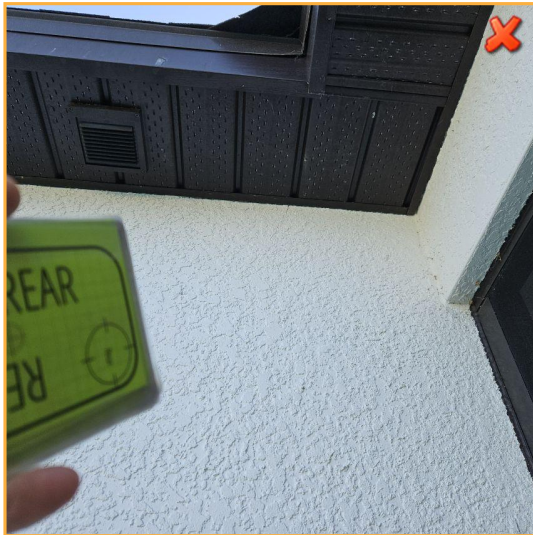
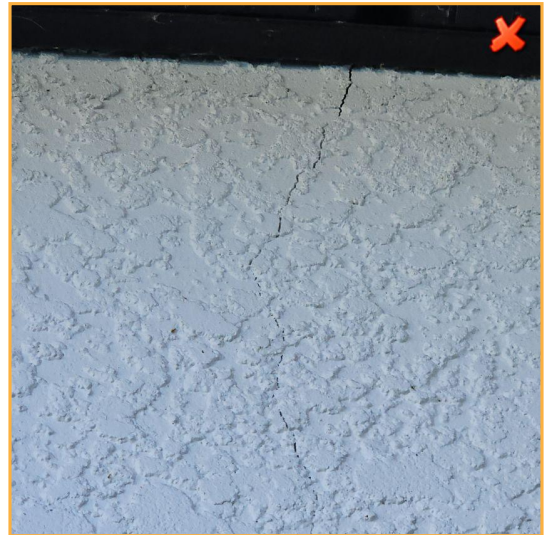
## 1. Exterior Wall Condition

1.1. During the inspection it was observed that minor settlement cracks were present on one side of the exterior wall. Some appear to have been previously repaired and have reopened slightly. This type of cracking is typical in newer homes but should be touched up to restore the finish and help prevent moisture entry. Recommendation: Have the builder evaluate and repair as needed.

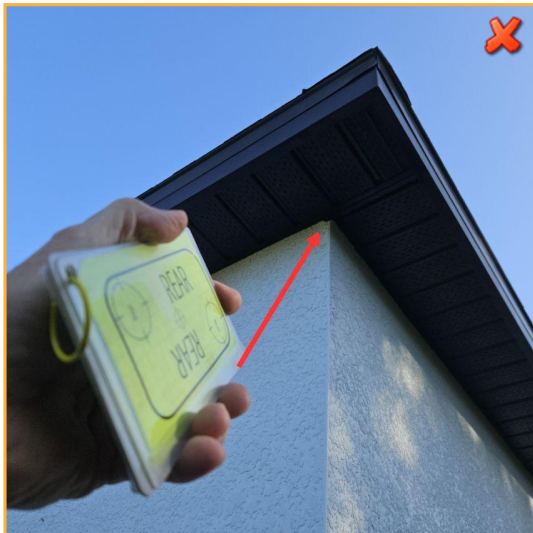
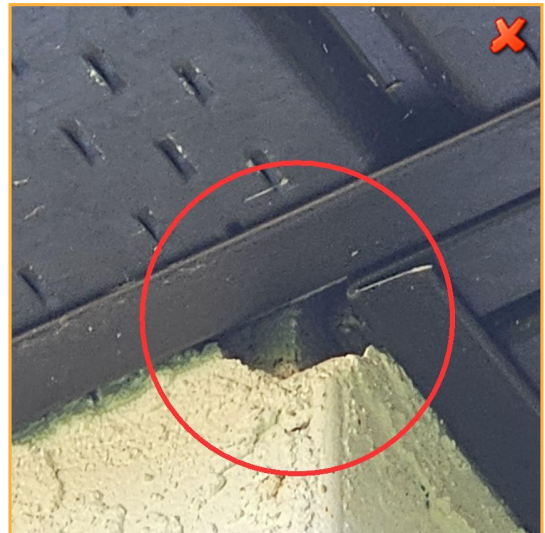
## 2. Stucco Condition

2.2. Stucco covering exterior walls of the home had minor damage visible at the time of the inspection. This condition may allow moisture intrusion and possible damage. Recommend sealing with an appropriate **sealant** and repainting by a qualified contractor.

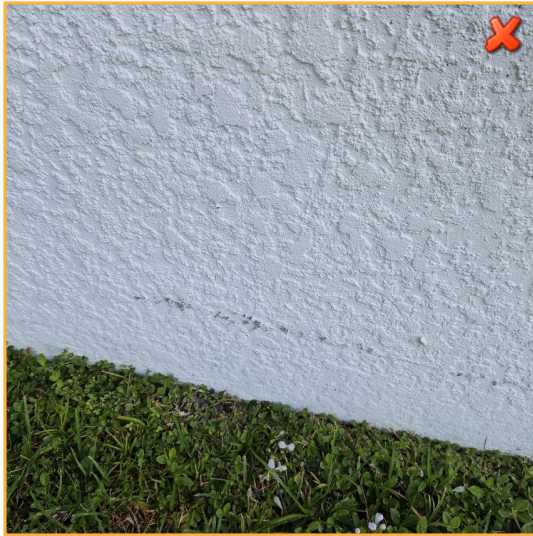
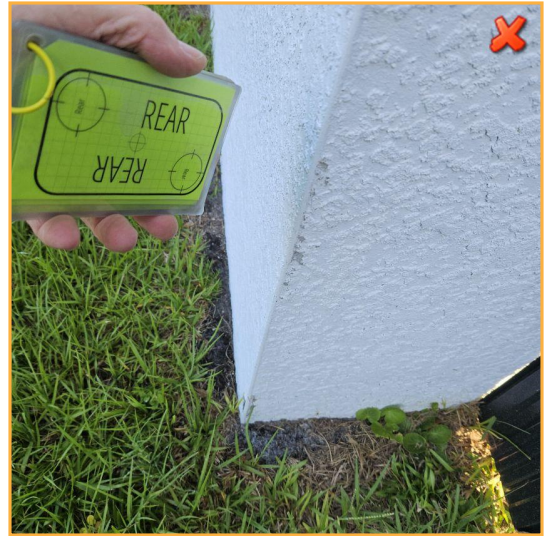
Rear wall

1.1. Walls in the rear of the home exhibited minor damage or deterioration at the time of the inspection.

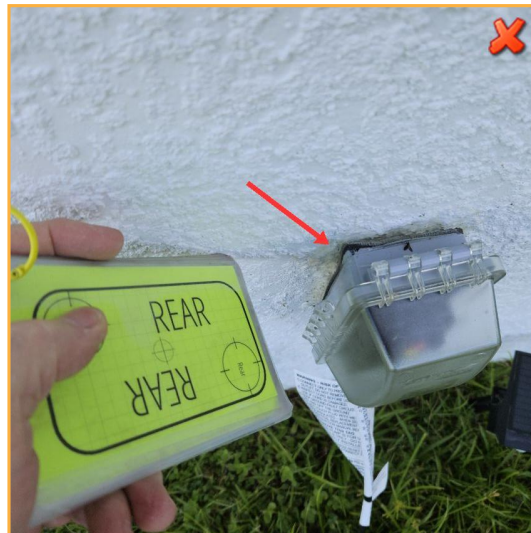
2.2. During the inspection it was observed that the exterior receptacle box is slightly misaligned and the weatherproof in-use cover does not sit tight against the wall. This can allow water to enter the box if the sealant fails. Sealant was present at the time of the inspection. Recommendation: Maintain and reapply exterior-grade sealant as needed (at least annually) to keep the box properly sealed; have corrected if gaps or leakage are observed.

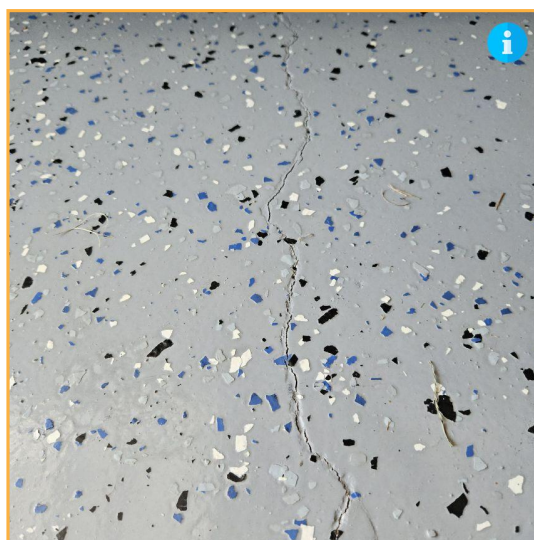
3.2. The garage floor had common shrinkage cracks. These cracks are not a structural concern.

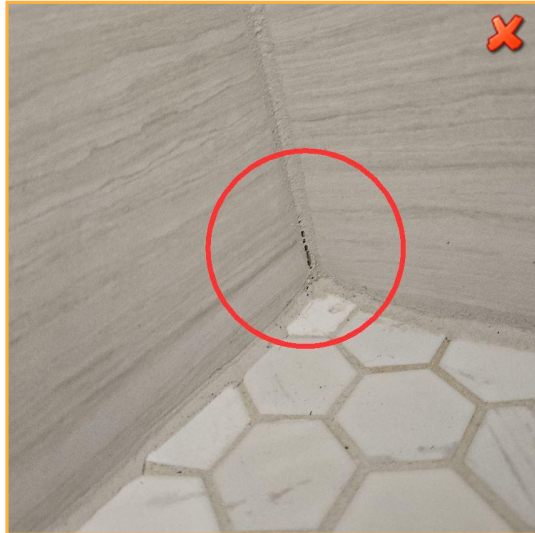
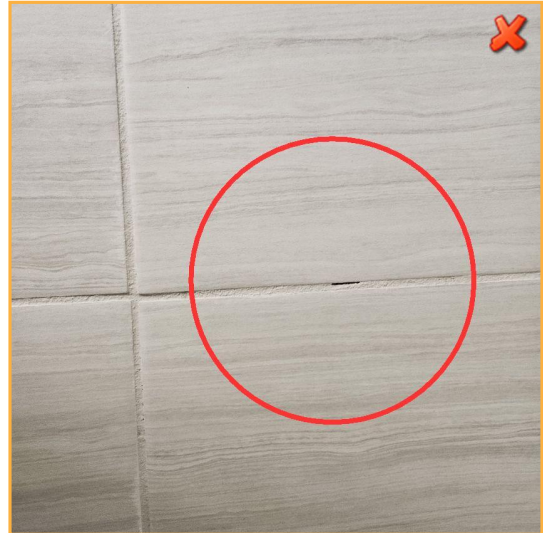
8.1. During the inspection, it was observed that the shower wall grout was cracked or missing in several areas. This condition poses several risks, including moisture intrusion, which can lead to water seeping behind the tiles and causing moisture buildup in the wall cavity. Prolonged moisture exposure can also damage the underlying structures, such as drywall or backer board, resulting in warping, rot, or other degradation that may require costly repairs. Recommend repair by a qualified contractor.

Primary bath shower has areas of missing grout

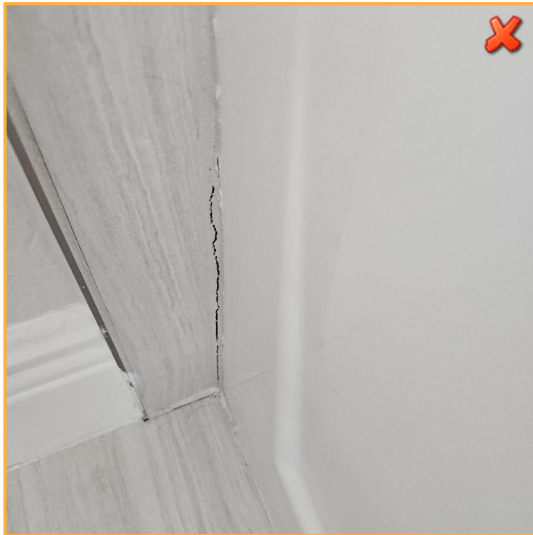
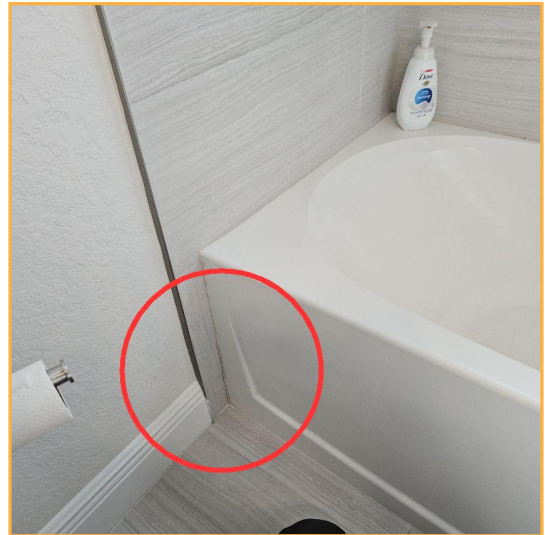
7.2. The shower tiles had areas of missing and/or cracked grout or **caulk** that may allow moisture to penetrate the walls.

*Cracked grout by guest bath tub*

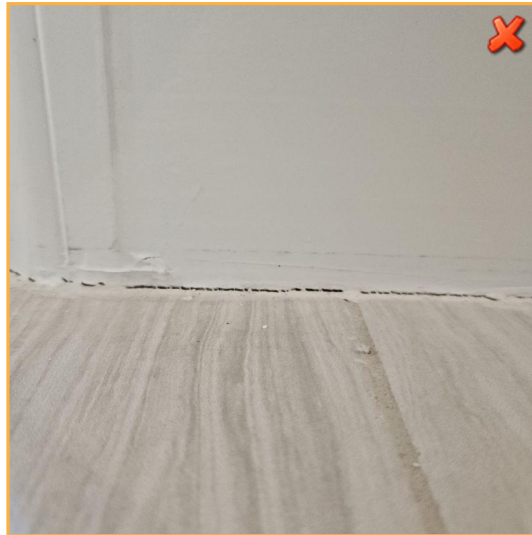
2.2. At the time of the inspection, the Inspector observed that some trim did not fit tightly to the flooring. This condition is cosmetic. Recommend **caulking** and painting gaps below baseboards by a qualified contractor.

*Gaps visible below baseboard*

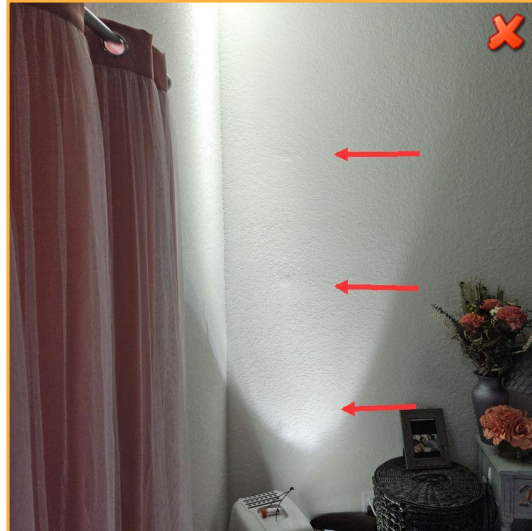
1.1. During the inspection it was observed that three raised bumps are present in a vertical line on a bedroom wall. This is a minor cosmetic condition. Recommendation: Repair or smooth the affected areas as desired for appearance.

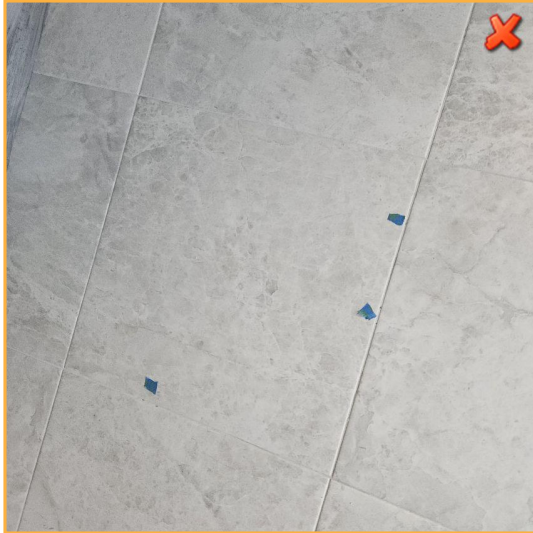
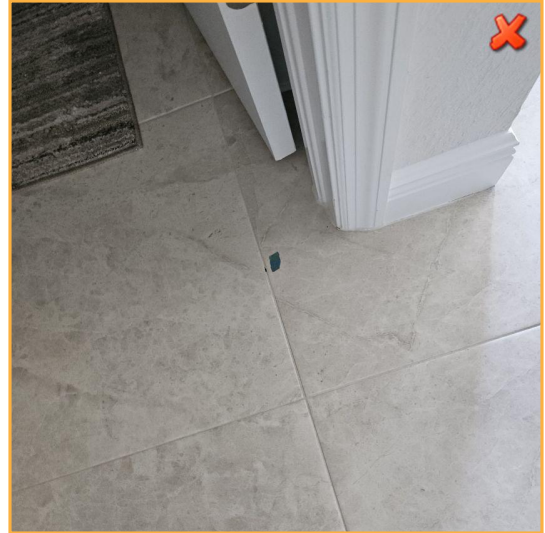
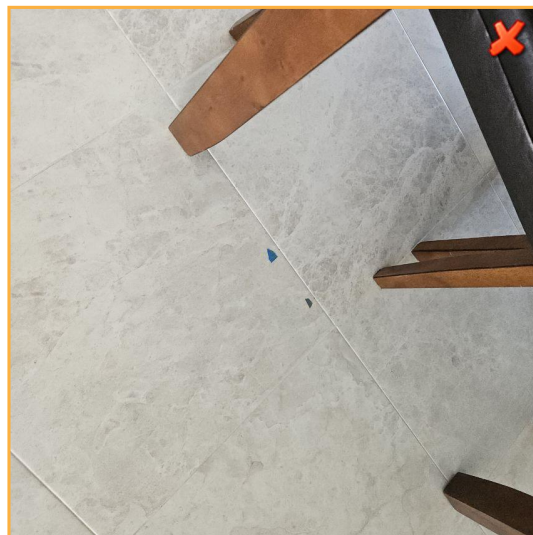
## 1. Tile Floors

1.1. During the inspection it was observed that grout is missing in multiple areas of the floor tile. Missing grout can allow moisture and debris to collect and may lead to loosening of tiles over time. Recommendation: Re-grout the affected areas to help protect the underlying material and maintain the floor.

Grout missing in multiple locations through out the home
