# Uniform Mitigation Verification Inspection Form

Inspection Date: 1/27/2021		
<b>Owner Information</b>		
Owner Name: Loi Thai		Contact Person:
Address: 3755 59Th Ave Cir E		Home Phone: 770-655-0157
City: Ellenton	Zip: 34222	Work Phone:
County: Manatee		Cell Phone:
Insurance Company:		Policy #:
Year of Home: 2001	# of Stories: 2	Email:

# West Florida Inspections

3755 59th Ave Cir E. Ellenton, Fl 34222

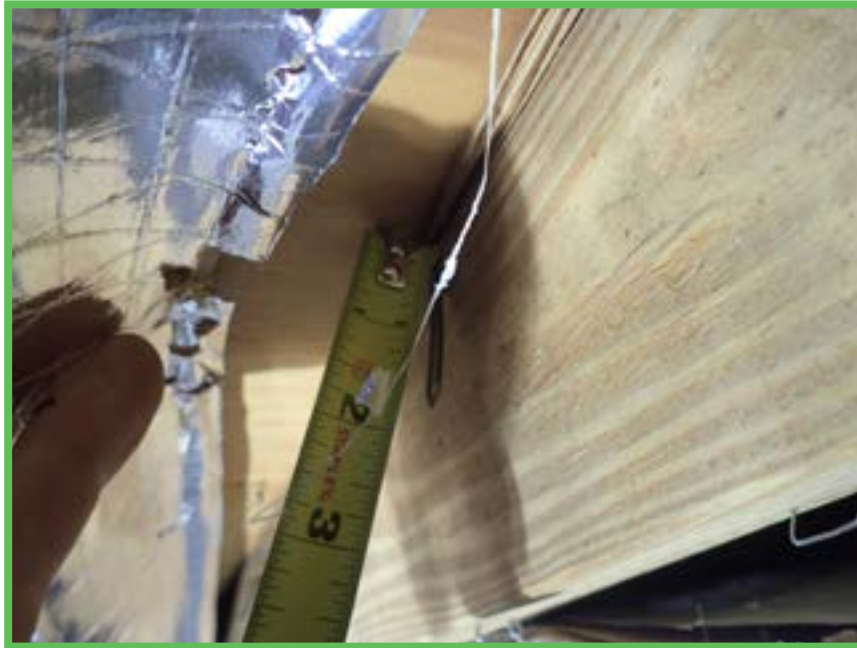
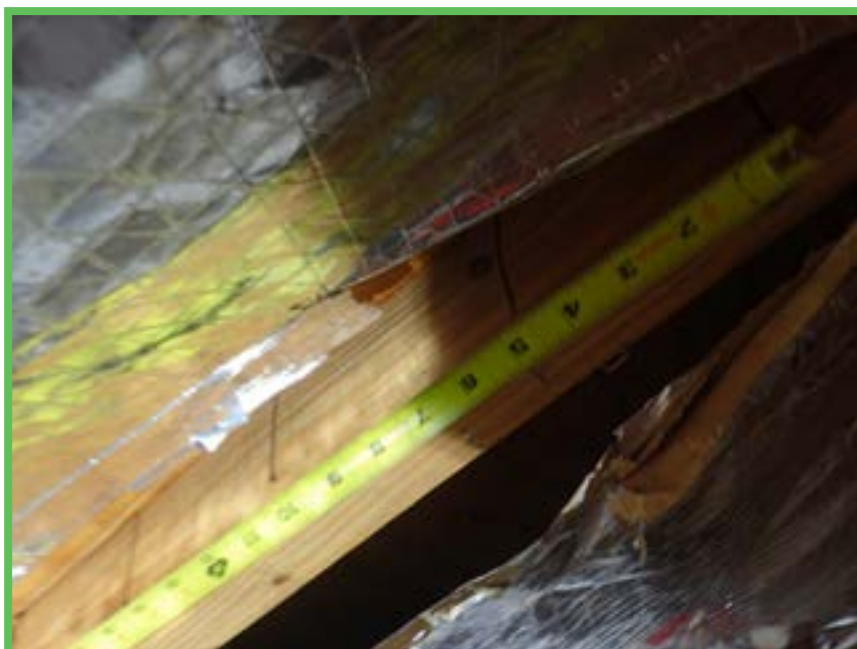
Roof Deck Attachment

- Roof Deck Attachment:** What is the weakest form of roof deck attachment?
  - A. Plywood/Oriented strand board (OSB) roof sheathing attached to the roof truss/rafter (spaced a maximum of 24" inches o.c.) by staples or 6d nails spaced at 6" along the edge and 12" in the field. -OR- Batten decking supporting wood shakes or wood shingles. -OR- Any system of screws, nails, adhesives, other deck fastening system or truss/rafter spacing that has an equivalent mean uplift less than that required for Options B or C below.

- B. Plywood/OSB roof sheathing with a minimum thickness of 7/16" inch attached to the roof truss/rafter (spaced a maximum of 24" inches o.c.) by 8d common nails spaced a maximum of 12" inches in the field. -OR- Any system of screws, nails, adhesives, other deck fastening system or truss/rafter spacing that is shown to have an equivalent or greater resistance 8d nails spaced a maximum of 12 inches in the field or has a mean uplift resistance of at least 103 psf.

- C. Plywood/OSB roof sheathing with a minimum thickness of 7/16" inch attached to the roof truss/rafter (spaced a maximum of 24" inches o.c.) by 8d common nails spaced a maximum of 6" inches in the field. -OR- Dimensional lumber/Tongue & Groove decking with a minimum of 2 nails per board (or 1 nail per board if each board is equal to or less than 6 inches in width). -OR- Any system of screws, nails, adhesives, other deck fastening system or truss/rafter spacing that is shown to have an equivalent

or greater resistance than 8d common nails spaced a maximum of 6 inches in the field or has a mean uplift resistance of at least 182 psf.

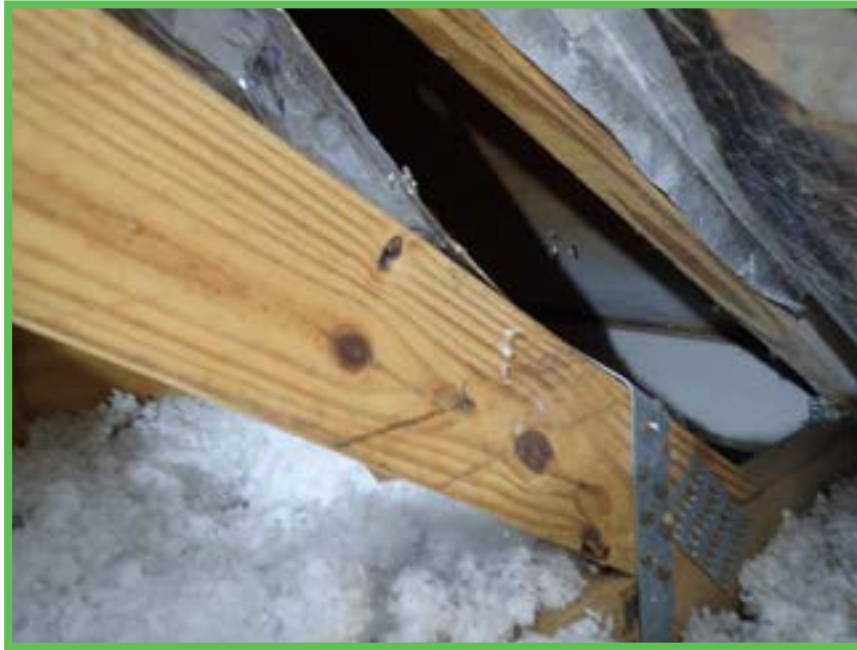
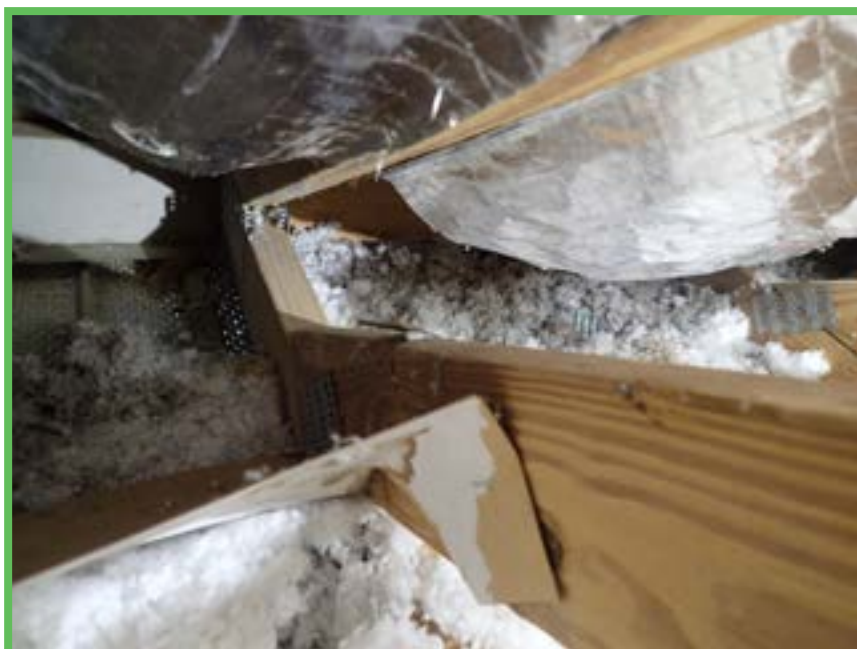
Roof to Wall Attachment

4. **Roof to Wall Attachment:** What is the **WEAKEST** roof to wall connection? (Do not include attachment of hip/valley jacks within 5 feet of the inside or outside corner of the roof in determination of WEAKEST type)

- A. Toe Nails
  - Truss/rafter anchored to top plate of wall using nails driven at an angle through the truss/rafter and attached to the top plate of the wall, or
  - Metal connectors that do not meet the minimal conditions or requirements of B, C, or D

**Minimal conditions to qualify for categories B, C, or D. All visible metal connectors are:**

- Secured to truss/rafter with a minimum of three (3) nails, **and**
- Attached to the wall top plate of the wall framing, or embedded in the bond beam, with less than a 1/2" gap from the blocking or truss/rafter **and** blocked no more than 1.5" of the truss/rafter, **and** free of visible severe corrosion.

- B. Clips
  - Metal connectors that do not wrap over the top of the truss/rafter, **or**
  - Metal connectors with a minimum of 1 strap that wraps over the top of the truss/rafter and does not meet the nail position requirements of C or D, but is secured with a minimum of 3 nails.

- C. Single Wraps
  - Metal connectors consisting of a single strap that wraps over the top of the truss/rafter and is secured with a minimum of 2 nails on the front side and a minimum of 1 nail on the opposing side.

- D. Double Wraps
  - Metal Connectors consisting of 2 separate straps that are attached to the wall frame, or embedded in the bond beam, on either side of the truss/rafter where each strap wraps over the top of the truss/rafter and is secured with a minimum of 2 nails on the front side, and a minimum of 1 nail on the opposing side, **or**

- Metal connectors consisting of a single strap that wraps over the top of the truss/rafter, is secured to the wall on both sides, and is secured to the top plate with a minimum of three nails on each side.

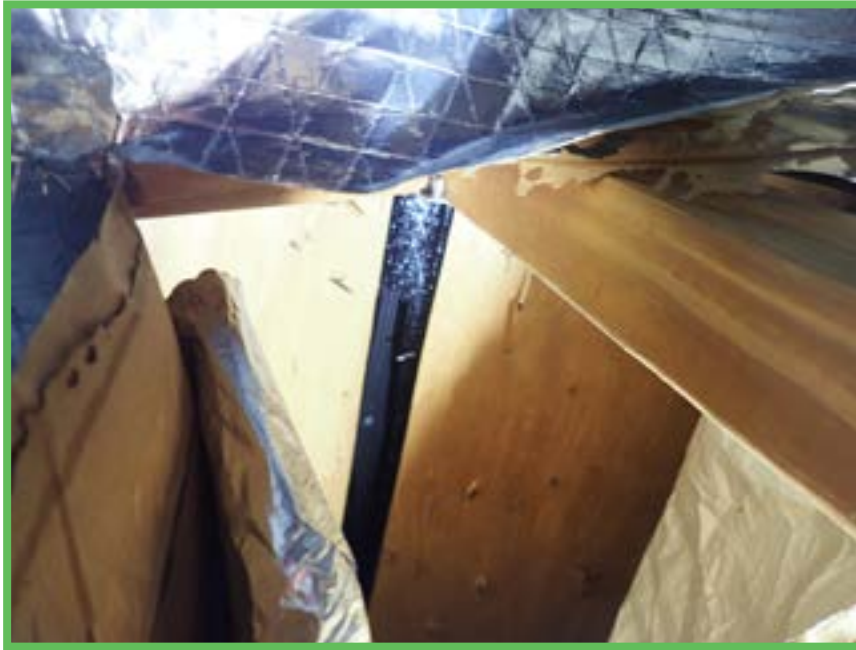
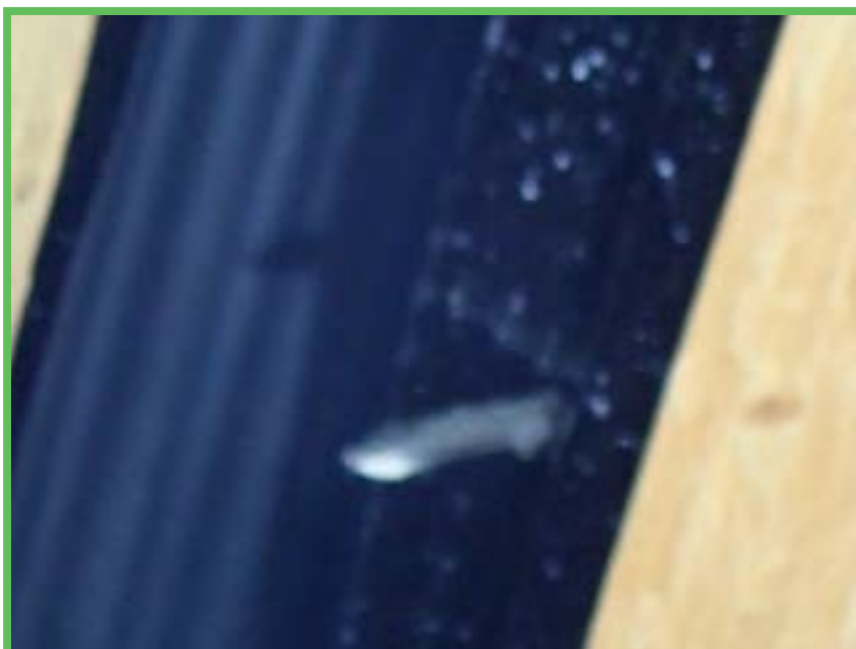
Secondary Water Resistance (SWR)

6. **Secondary Water Resistance (SWR):** (standard underlayments or hot-mopped felts do not qualify as an SWR)

- A. SWR (also called Sealed Roof Deck) Self-adhering polymer modified-bitumen roofing underlayment applied directly to the sheathing or foam adhesive SWR barrier (not foamed-on insulation) applied as a supplemental means to protect the dwelling from water intrusion in the event of roof covering loss.
- B. No SWR.
- C. Unknown or undetermined.
