# Uniform Mitigation Verification Inspection Form

Inspection Date: 04/07/2021		
<b>Owner Information</b>		
Owner Name: Janet Russell		Contact Person:
Address: 8032 65th Way N		Home Phone: 727-252-6368
City: Pinellas Park	Zip: 33781	Work Phone:
County: Pinellas		Cell Phone:
Insurance Company:		Policy #:
Year of Home: 1964	# of Stories: 1	Email: janet.russell.fl@gmail.com

Property Inspected:  
8032 65th Way N. Pinellas Park, 33781

Inspection Date: 4/7/2021

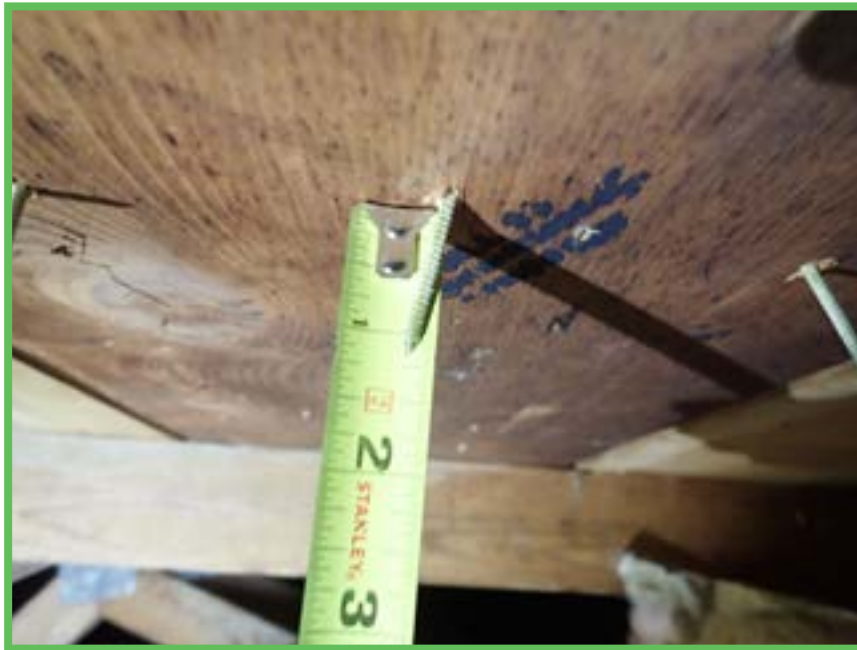
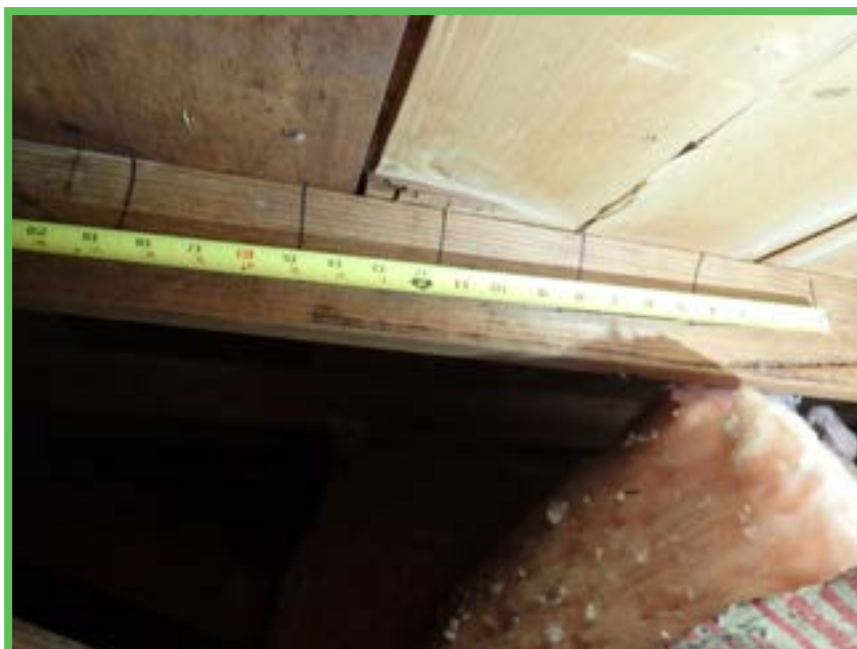
Roof Deck Attachment

- Roof Deck Attachment:** What is the weakest form of roof deck attachment? "
  - ""A. Plywood/Oriented strand board (OSB) roof sheathing attached to the roof truss/rafter (spaced a maximum of 24" inches o.c.) by staples or 6d nails spaced at 6" along the edge and 12" in the field. -OR- Batten decking supporting wood shakes or wood shingles. -OR- Any system of screws, nails, adhesives, other deck fastening system or truss/rafter spacing that has an equivalent mean uplift less than that required for Options B or C below.

- ""B. Plywood/OSB roof sheathing with a minimum thickness of 7/16" inch attached to the roof truss/rafter (spaced a maximum of 24" inches o.c.) by 8d common nails spaced a maximum of 12" inches in the field. -OR- Any system of screws, nails, adhesives, other deck fastening system or truss/rafter spacing that is shown to have an equivalent or greater resistance 8d nails spaced a maximum of 12 inches in the field or has a mean uplift resistance of at least 103 psf.

- ""C. Plywood/OSB roof sheathing with a minimum thickness of 7/16" inch attached to the roof truss/rafter (spaced a maximum of 24" inches o.c.) by 8d common nails spaced a maximum of 6" inches in the field. -OR- Dimensional lumber/Tongue & Groove decking with a minimum of 2 nails per board (or 1 nail per board if each board is equal to or less than 6 inches in width). -OR- Any system of screws, nails, adhesives, other deck fastening system or truss/rafter spacing that is shown to have an equivalent

or greater resistance than 8d common nails spaced a maximum of 6 inches in the field or has a mean uplift resistance of at least 182 psf.

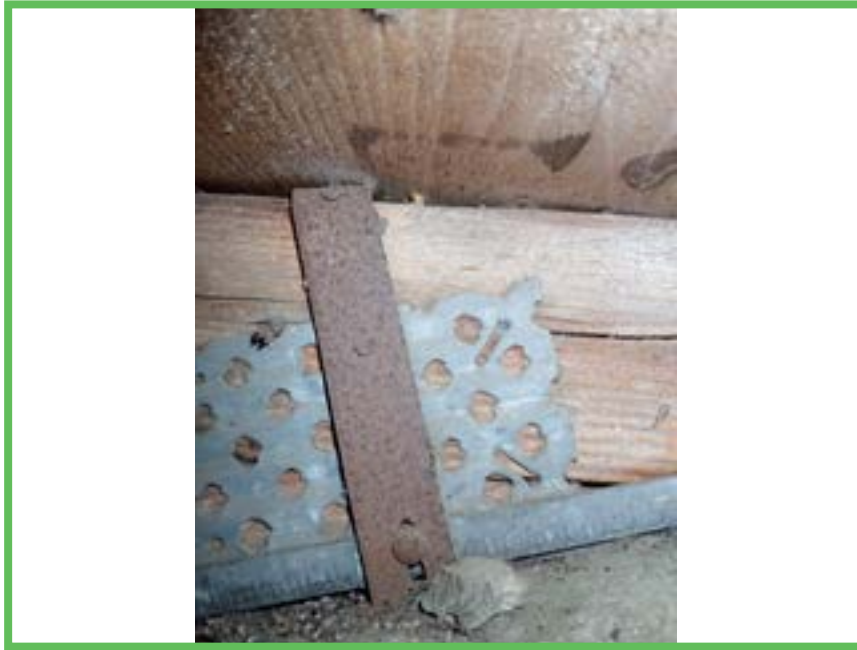
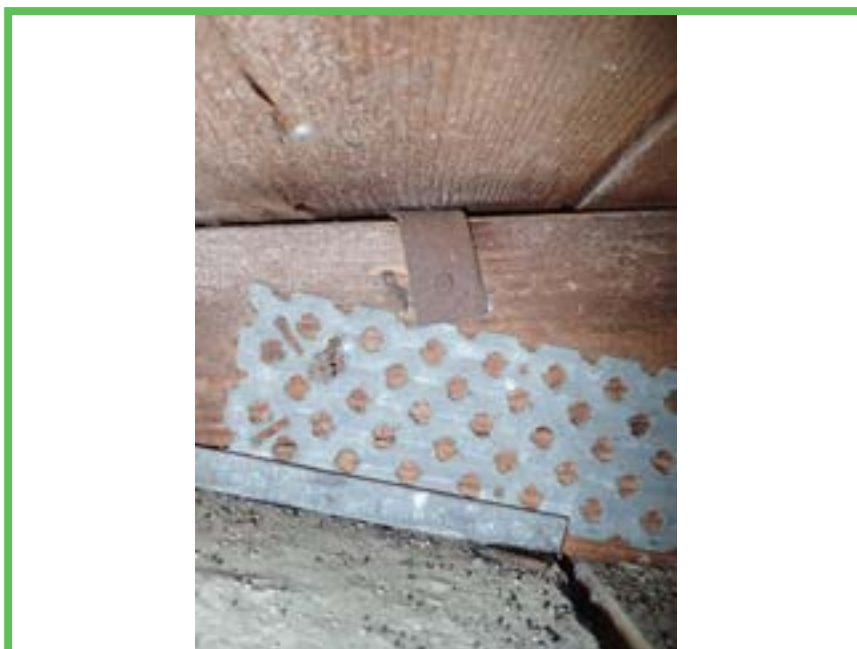
Roof to Wall Attachment

4. **Roof to Wall Attachment:** What is the **WEAKEST** roof to wall connection? (Do not include attachment of hip/valley jacks within 5 feet of the inside or outside corner of the roof in determination of WEAKEST type)

- A. Toe Nails
  - Truss/rafter anchored to top plate of wall using nails driven at an angle through the truss/rafter and attached to the top plate of the wall, or
  - Metal connectors that do not meet the minimal conditions or requirements of B, C, or D

- Secured to truss/rafter with a minimum of three (3) nails, **and**
- Attached to the wall top plate of the wall framing, or embedded in the bond beam, with less than a 1/2" gap from the blocking or truss/rafter **and** blocked no more than 1.5" of the truss/rafter, **and** free of visible severe corrosion.

- B. Clips
  - Metal connectors that do not wrap over the top of the truss/rafter, **or**
  - Metal connectors with a minimum of 1 strap that wraps over the top of the truss/rafter and does not meet the nail position requirements of C or D, but is secured with a minimum of 3 nails.

- C. Single Wraps
  - Metal connectors consisting of a single strap that wraps over the top of the truss/rafter and is secured with a minimum of 2 nails on the front side and a minimum of 1 nail on the opposing side.

- D. Double Wraps
  - Metal Connectors consisting of 2 separate straps that are attached to the wall frame, or embedded in the bond beam, on either side of the truss/rafter where each strap wraps over the top of the truss/rafter and is secured with a minimum of 2 nails on the front side, and a minimum of 1 nail on the opposing side, **or**

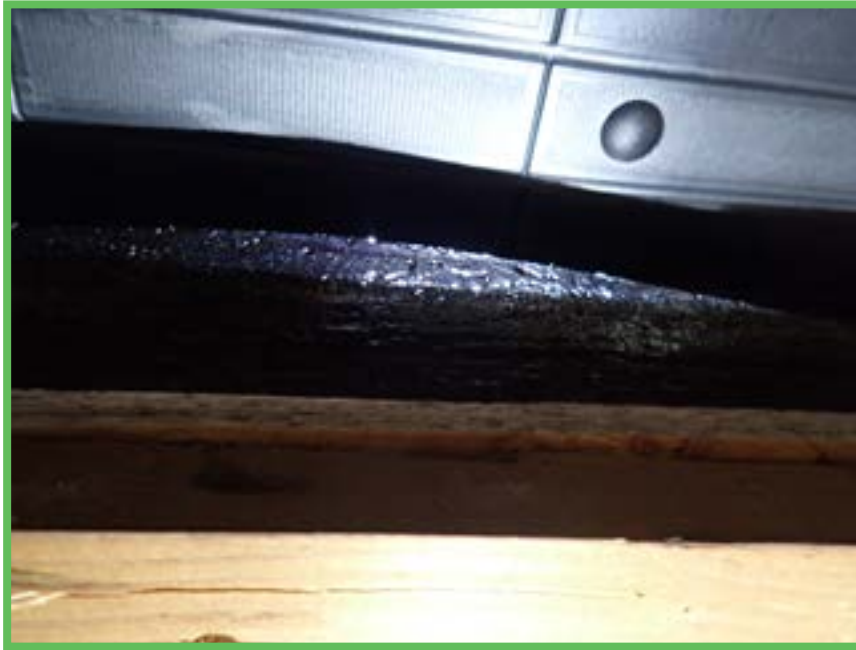
Secondary Water Resistance (SWR)

6. **Secondary Water Resistance (SWR):** (standard underlayments or hot-mopped felts do not qualify as an SWR)

- A. SWR (also called Sealed Roof Deck) Self-adhering polymer modified-bitumen roofing underlayment applied directly to the sheathing or foam adhesive SWR barrier (not foamed-on insulation) applied as a supplemental means to protect the dwelling from water intrusion in the event of roof covering loss.
- B. No SWR.
- C. Unknown or undetermined.
