# Uniform Mitigation Verification Inspection Form

Inspection Date: 07/17/2021		
<b>Owner Information</b>		
Owner Name: Christina Erb		Contact Person:
Address: 2800 Poplar St		Home Phone:
City: Sarasota	Zip: 34237	Work Phone:
County: Sarasota		Cell Phone: 941-960-5685
Insurance Company:		Policy #:
Year of Home: 1953	# of Stories: 1	Email: cmerb1973@gmail.com

Property Inspected:  
2800 Poplar St. Sarasota, Fl 34237

Inspection Date: 7/17/2021

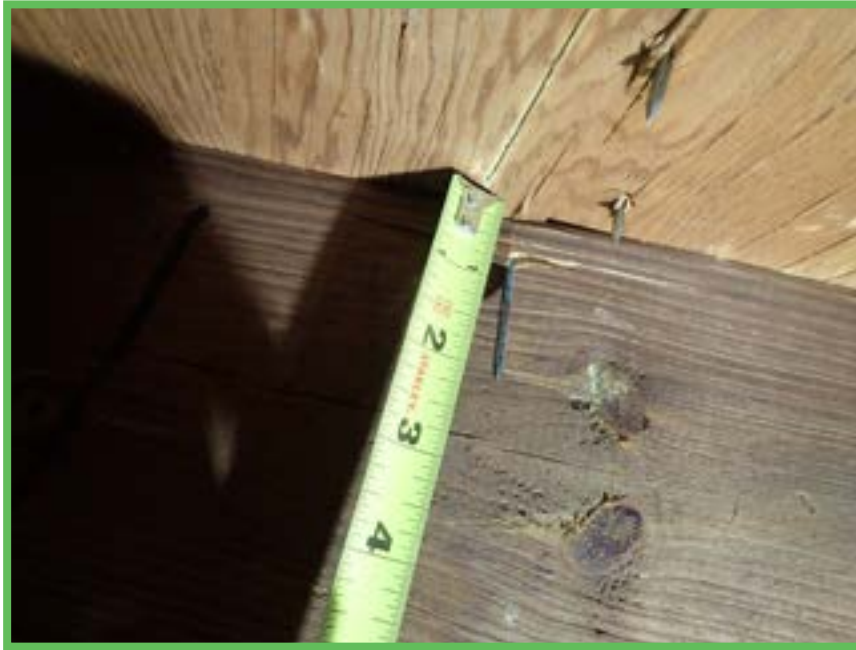
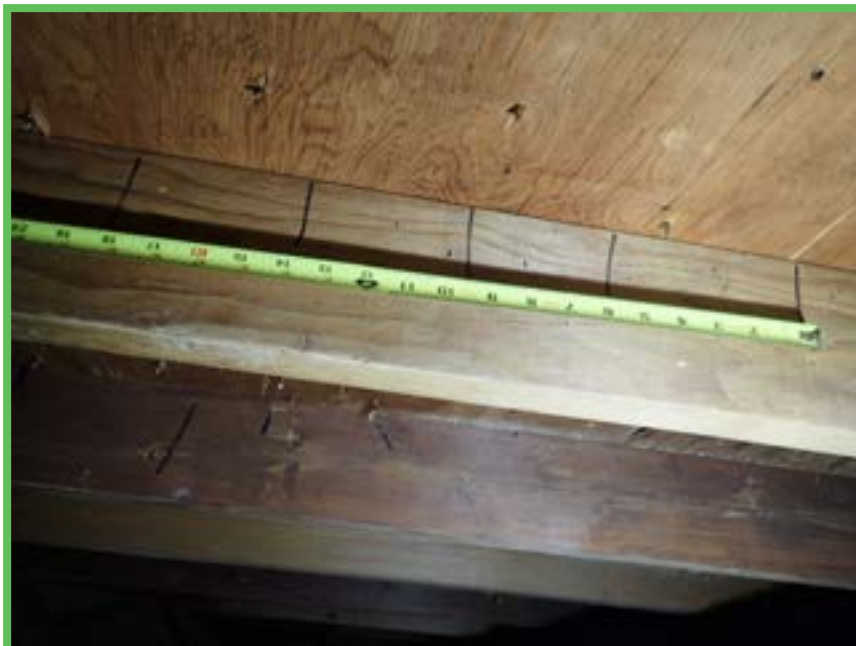
Roof Deck Attachment

- Roof Deck Attachment:** What is the weakest form of roof deck attachment? "
  - ""A. Plywood/Oriented strand board (OSB) roof sheathing attached to the roof truss/rafter (spaced a maximum of 24" inches o.c.) by staples or 6d nails spaced at 6" along the edge and 12" in the field. -OR- Batten decking supporting wood shakes or wood shingles. -OR- Any system of screws, nails, adhesives, other deck fastening system or truss/rafter spacing that has an equivalent mean uplift less than that required for Options B or C below.

- ""B. Plywood/OSB roof sheathing with a minimum thickness of 7/16" inch attached to the roof truss/rafter (spaced a maximum of 24" inches o.c.) by 8d common nails spaced a maximum of 12" inches in the field. -OR- Any system of screws, nails, adhesives, other deck fastening system or truss/rafter spacing that is shown to have an equivalent or greater resistance 8d nails spaced a maximum of 12 inches in the field or has a mean uplift resistance of at least 103 psf.

- ""C. Plywood/OSB roof sheathing with a minimum thickness of 7/16" inch attached to the roof truss/rafter (spaced a maximum of 24" inches o.c.) by 8d common nails spaced a maximum of 6" inches in the field. -OR- Dimensional lumber/Tongue & Groove decking with a minimum of 2 nails per board (or 1 nail per board if each board is equal to or less than 6 inches in width). -OR- Any system of screws, nails, adhesives, other deck fastening system or truss/rafter spacing that is shown to have an equivalent

or greater resistance than 8d common nails spaced a maximum of 6 inches in the field or has a mean uplift resistance of at least 182 psf.

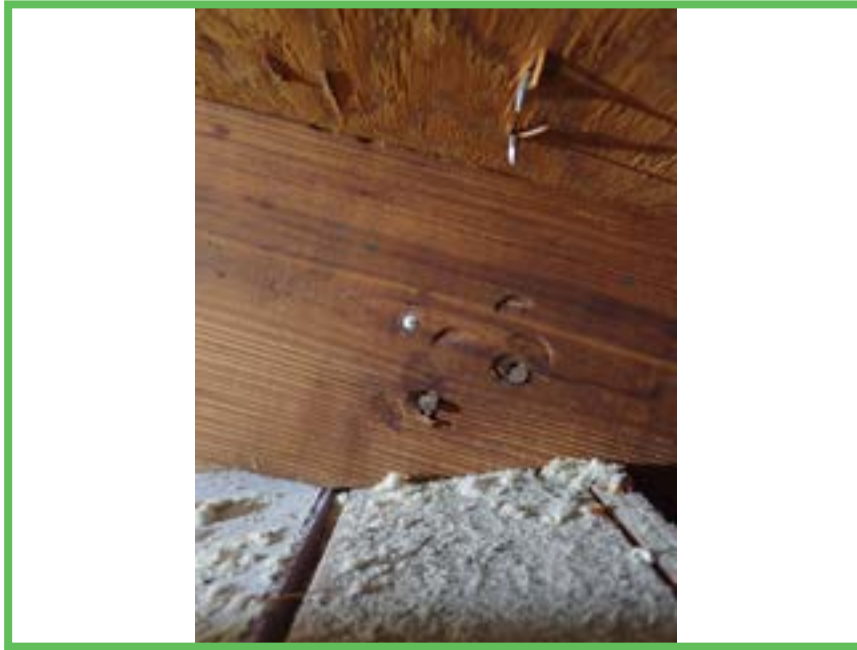
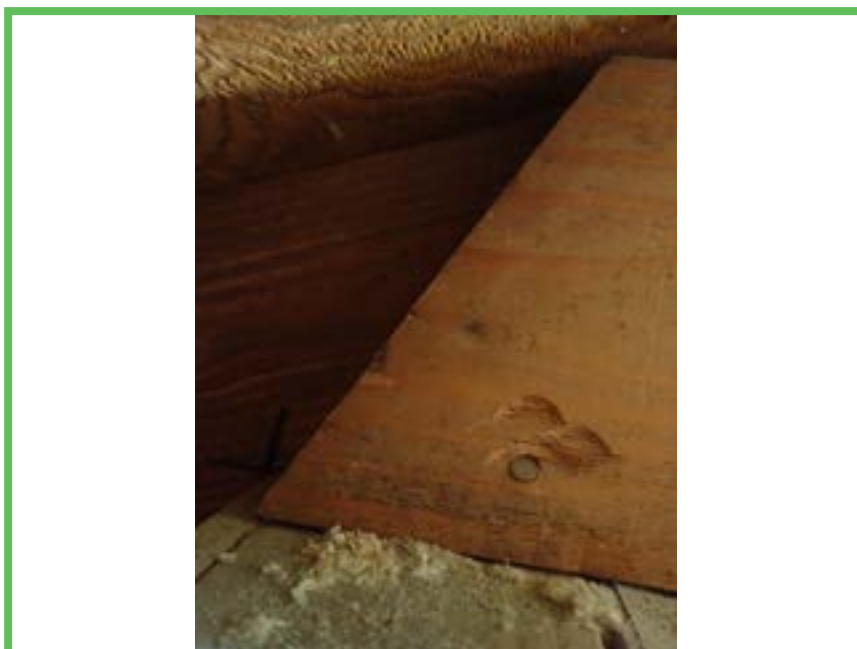
Roof to Wall Attachment

4. **Roof to Wall Attachment:** What is the **WEAKEST** roof to wall connection? (Do not include attachment of hip/valley jacks within 5 feet of the inside or outside corner of the roof in determination of WEAKEST type)

- A. Toe Nails
  - Truss/rafter anchored to top plate of wall using nails driven at an angle through the truss/rafter and attached to the top plate of the wall, or
  - Metal connectors that do not meet the minimal conditions or requirements of B, C, or D

**Minimal conditions to qualify for categories B, C, or D. All visible metal connectors are:**

- Secured to truss/rafter with a minimum of three (3) nails, **and**
- Attached to the wall top plate of the wall framing, or embedded in the bond beam, with less than a 1/2" gap from the blocking or truss/rafter **and** blocked no more than 1.5" of the truss/rafter, **and** free of visible severe corrosion.

- B. Clips
  - Metal connectors that do not wrap over the top of the truss/rafter, **or**
  - Metal connectors with a minimum of 1 strap that wraps over the top of the truss/rafter and does not meet the nail position requirements of C or D, but is secured with a minimum of 3 nails.

- C. Single Wraps
  - Metal connectors consisting of a single strap that wraps over the top of the truss/rafter and is secured with a minimum of 2 nails on the front side and a minimum of 1 nail on the opposing side.

- D. Double Wraps
  - Metal Connectors consisting of 2 separate straps that are attached to the wall frame, or embedded in the bond beam, on either side of the truss/rafter where each strap wraps over the top of the truss/rafter and is secured with a minimum of 2 nails on the front side, and a minimum of 1 nail on the opposing side, **or**

- Metal connectors consisting of a single strap that wraps over the top of the truss/rafter, is secured to the wall on both sides, and is secured to the top plate with a minimum of three nails on each side.

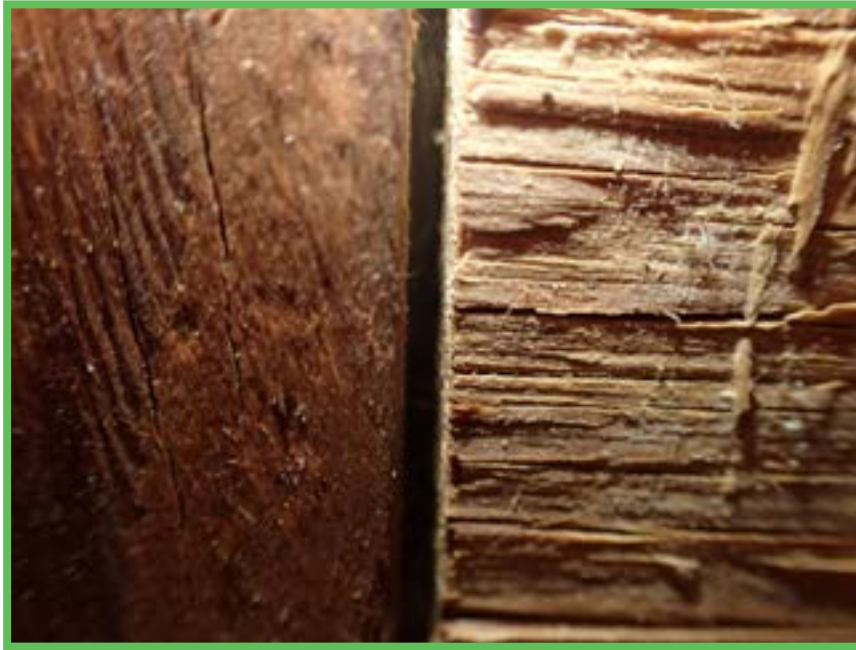
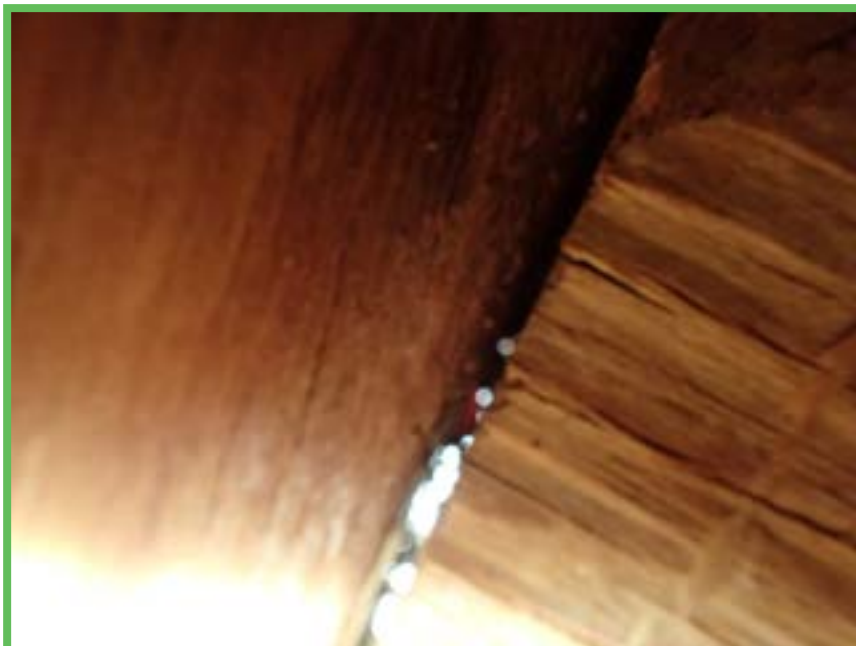
Secondary Water Resistance (SWR)

6. **Secondary Water Resistance (SWR):** (standard underlayments or hot-mopped felts do not qualify as an SWR)

- A. SWR (also called Sealed Roof Deck) Self-adhering polymer modified-bitumen roofing underlayment applied directly to the sheathing or foam adhesive SWR barrier (not foamed-on insulation) applied as a supplemental means to protect the dwelling from water intrusion in the event of roof covering loss.
- B. No SWR.
- C. Unknown or undetermined.
