# Uniform Mitigation Verification Inspection Form

Inspection Date: 07/01/2021		
<b>Owner Information</b>		
Owner Name: Bob Noonan		Contact Person:
Address: 13531 Romford Ave		Home Phone: 941-830-0888
City: Port Charlotte	Zip: 33981	Work Phone:
County: Charlotte		Cell Phone:
Insurance Company:		Policy #:
Year of Home: 1978	# of Stories: 1	Email: bnoonan66@yahoo.com

Property Inspected:  
13531 Romford Ave, Port Charlotte, FL 33981

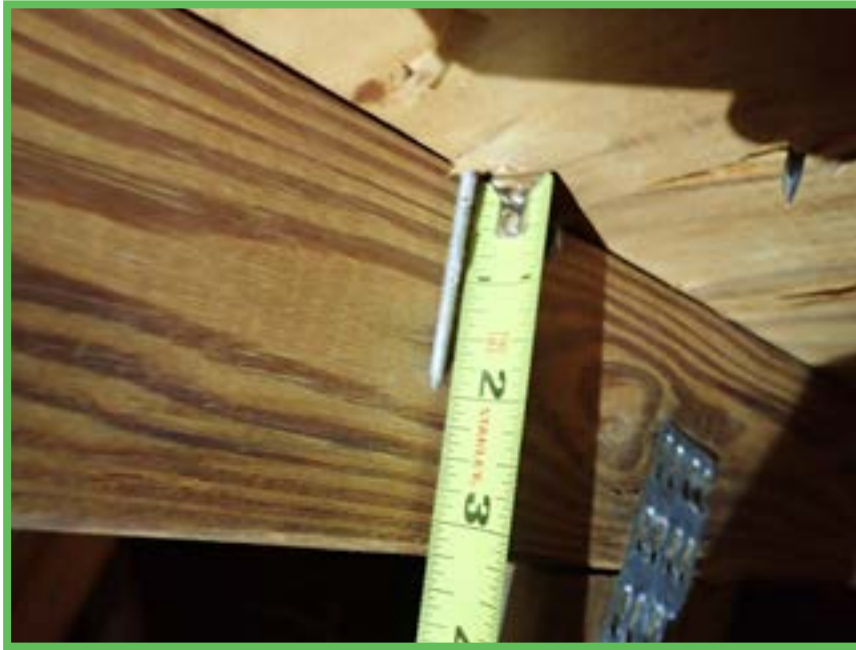
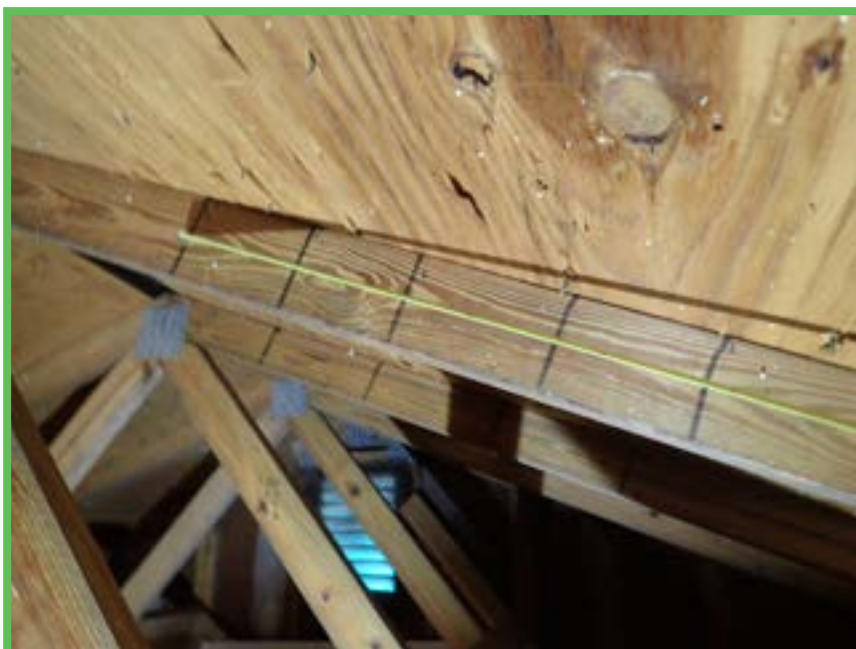
Roof Deck Attachment

- Roof Deck Attachment:** What is the weakest form of roof deck attachment? "
  - ""A. Plywood/Oriented strand board (OSB) roof sheathing attached to the roof truss/rafter (spaced a maximum of 24" inches o.c.) by staples or 6d nails spaced at 6" along the edge and 12" in the field. -OR- Batten decking supporting wood shakes or wood shingles. -OR- Any system of screws, nails, adhesives, other deck fastening system or truss/rafter spacing that has an equivalent mean uplift less than that required for Options B or C below.

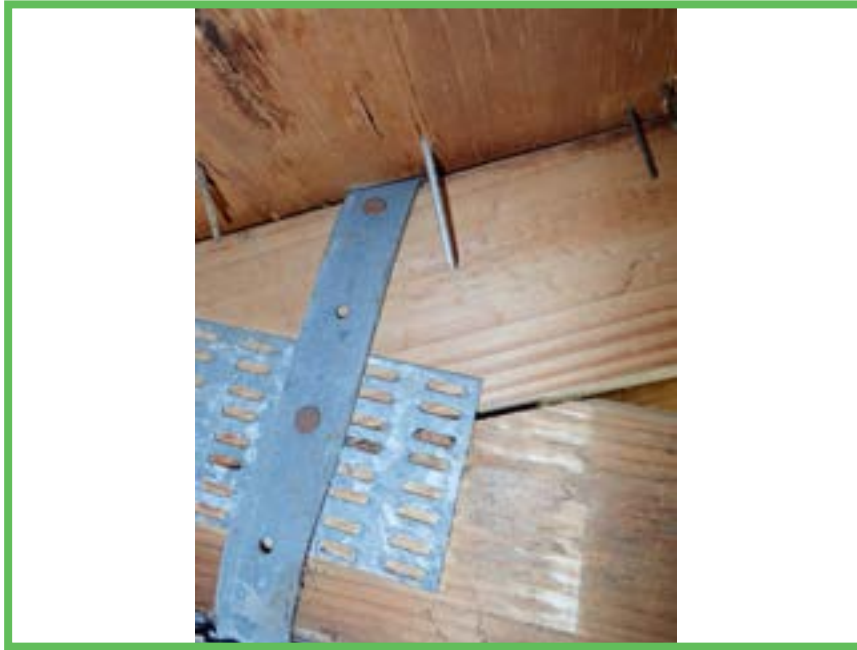
Roof to Wall Attachment

4. **Roof to Wall Attachment:** What is the **WEAKEST** roof to wall connection? (Do not include attachment of hip/valley jacks within 5 feet of the inside or outside corner of the roof in determination of WEAKEST type)

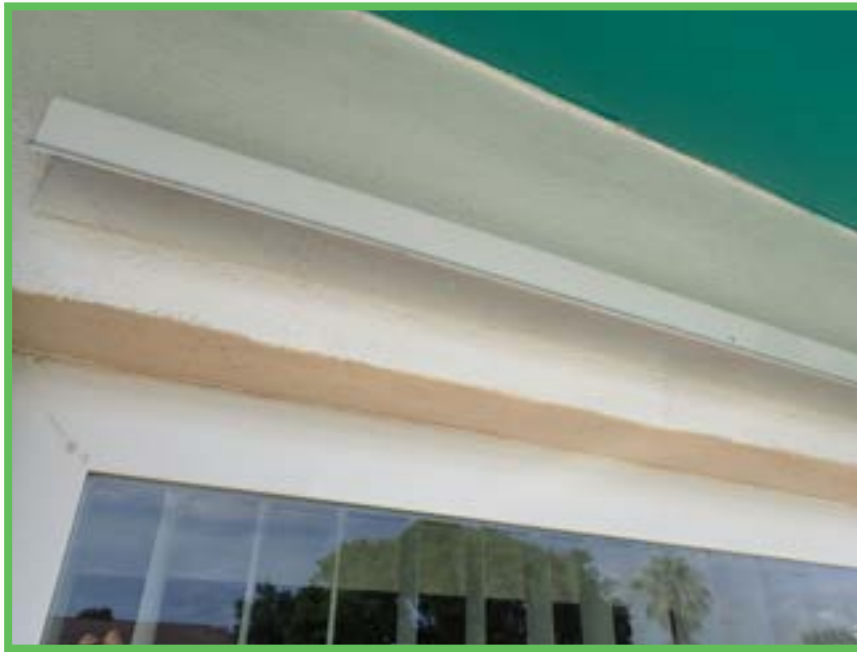
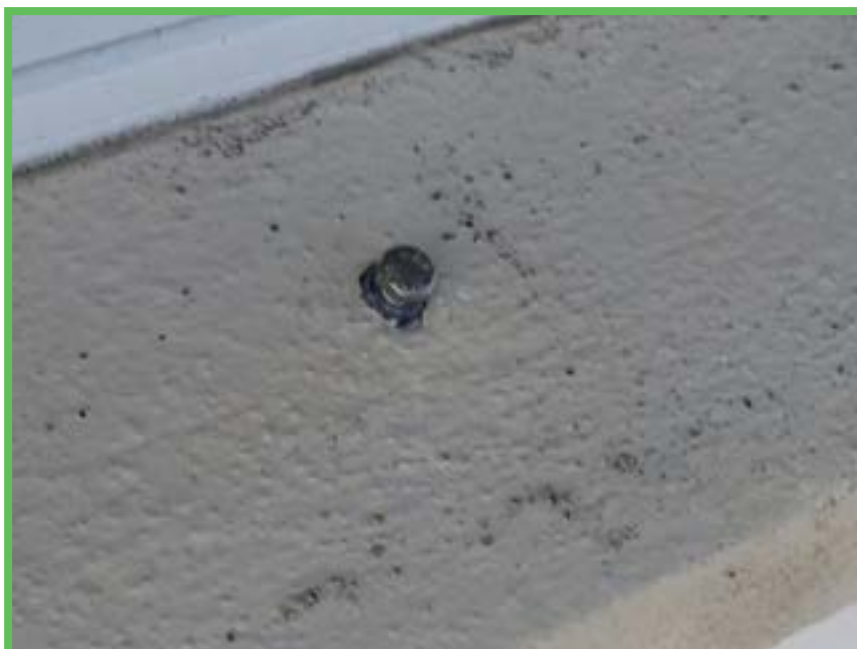
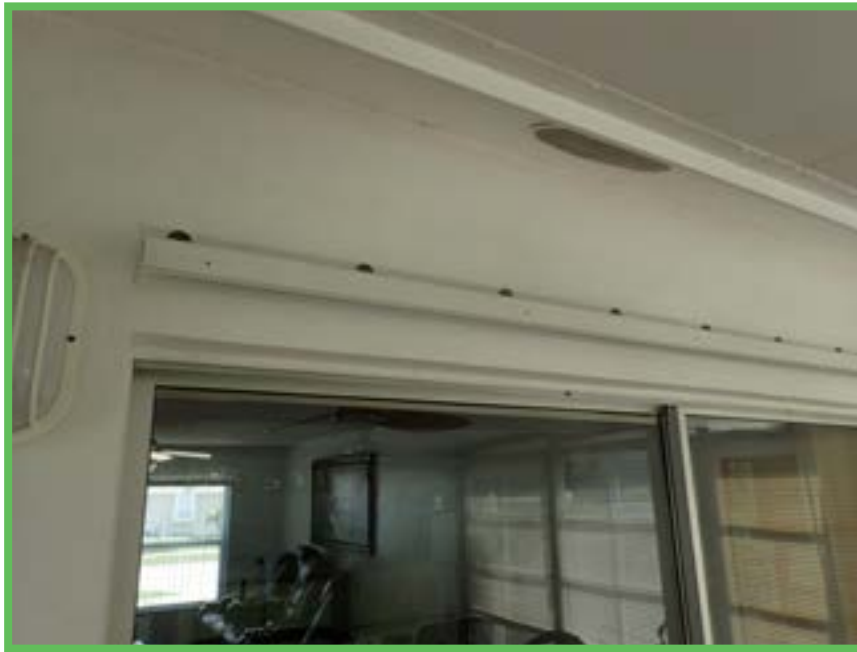
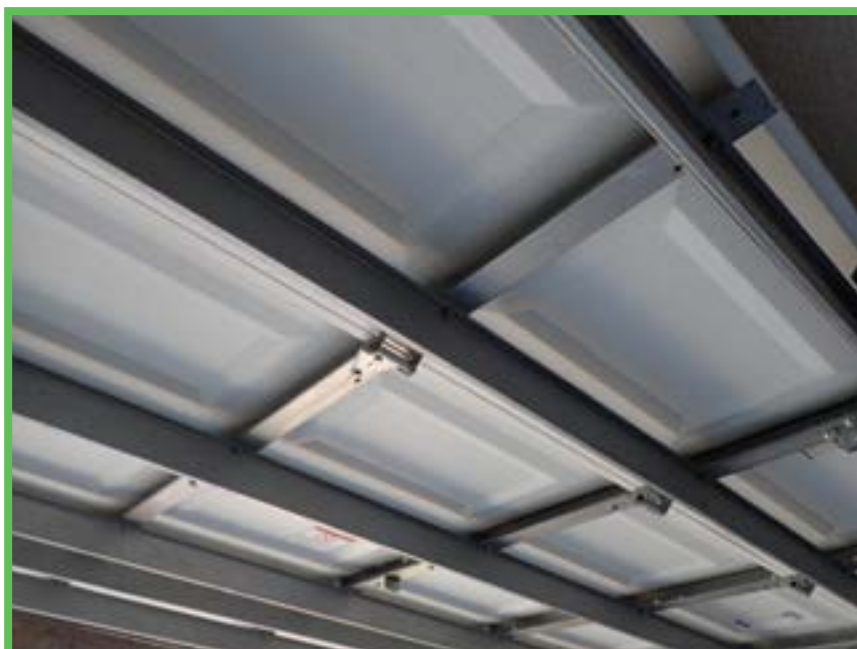
Opening Protection

7. **Opening Protection:** What is the **weakest** form of wind borne debris protection installed on the structure? **First**, use the table to determine the weakest form of protection for each category of opening. **Second**, (a) check one answer below (A, B, C, N, or X) based upon the lowest protection level for ALL Glazed openings **and** (b) check the protection level for all Non-Glazed openings (.1, .2, or .3) as applicable.
