# Uniform Mitigation Verification Inspection Form

Inspection Date: 08/14/2021		
<b>Owner Information</b>		
Owner Name: Leo Dasilva		Contact Person:
Address: 6115 39Th Ct E		Home Phone:
City: Bradenton	Zip: 34203	Work Phone:
County: Manatee		Cell Phone: 941-504-7585
Insurance Company:		Policy #:
Year of Home: 2005	# of Stories: 2	Email: lpdzca@yahoo.com

Property Inspected:  
6115 39th Ct E. Bradenton, Fl 34203

Inspection Date: 8/14/2021

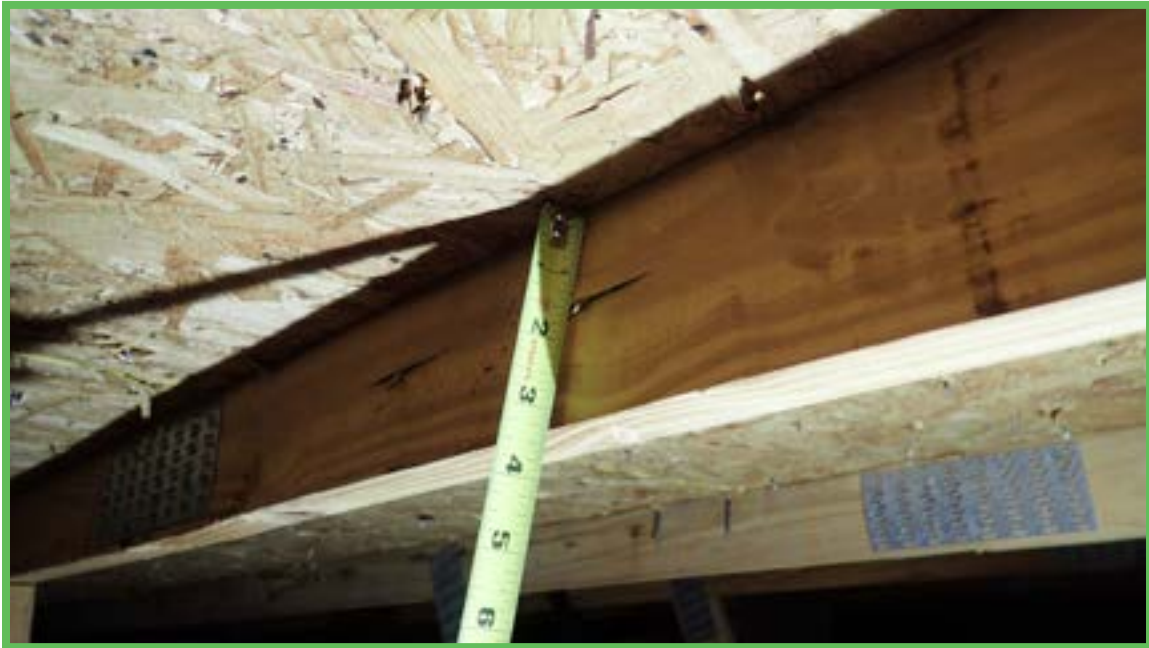
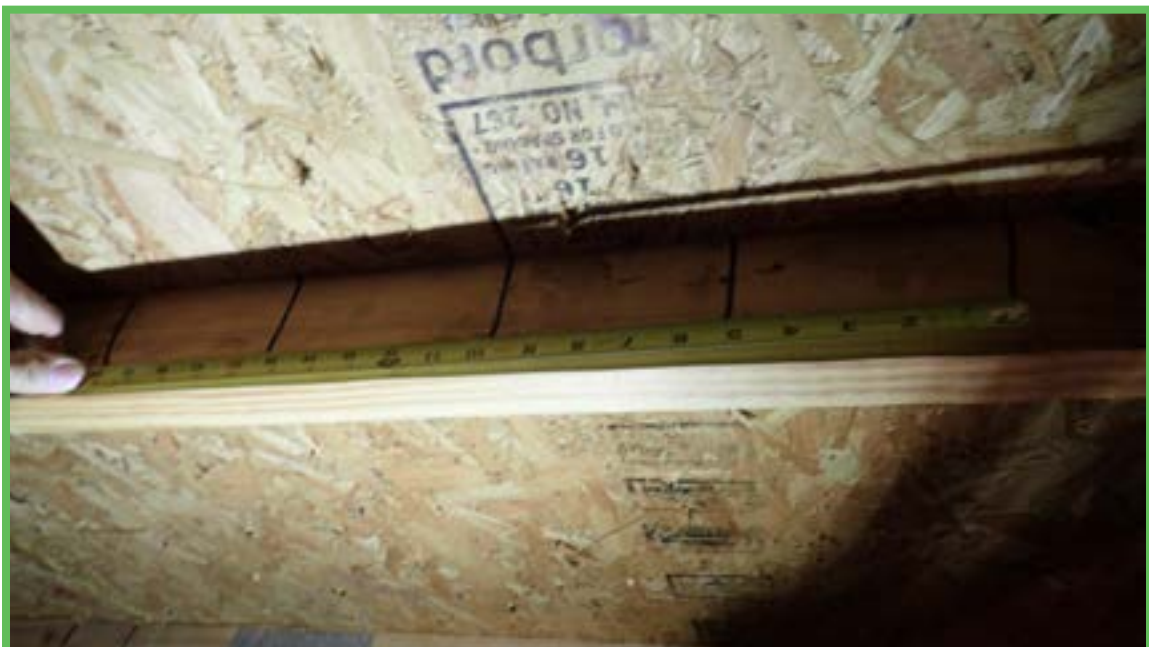
Roof Deck Attachment

- Roof Deck Attachment:** What is the weakest form of roof deck attachment? "
  - ""A. Plywood/Oriented strand board (OSB) roof sheathing attached to the roof truss/rafter (spaced a maximum of 24" inches o.c.) by staples or 6d nails spaced at 6" along the edge and 12" in the field. -OR- Batten decking supporting wood shakes or wood shingles. -OR- Any system of screws, nails, adhesives, other deck fastening system or truss/rafter spacing that has an equivalent mean uplift less than that required for Options B or C below.

- ""B. Plywood/OSB roof sheathing with a minimum thickness of 7/16" inch attached to the roof truss/rafter (spaced a maximum of 24" inches o.c.) by 8d common nails spaced a maximum of 12" inches in the field. -OR- Any system of screws, nails, adhesives, other deck fastening system or truss/rafter spacing that is shown to have an equivalent or greater resistance 8d nails spaced a maximum of 12 inches in the field or has a mean uplift resistance of at least 103 psf.

- ""C. Plywood/OSB roof sheathing with a minimum thickness of 7/16" inch attached to the roof truss/rafter (spaced a maximum of 24" inches o.c.) by 8d common nails spaced a maximum of 6" inches in the field. -OR- Dimensional lumber/Tongue & Groove decking with a minimum of 2 nails per board (or 1 nail per board if each board is equal to or less than 6 inches in width). -OR- Any system of screws, nails, adhesives, other deck fastening system or truss/rafter spacing that is shown to have an equivalent

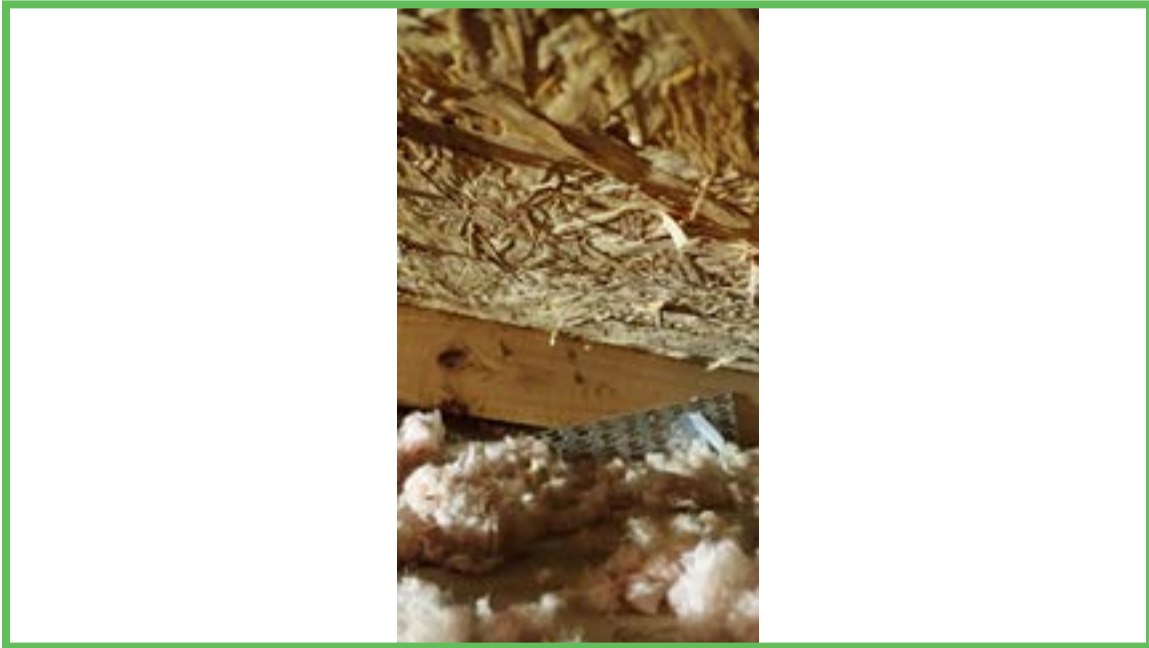
Roof to Wall Attachment

4. **Roof to Wall Attachment:** What is the **WEAKEST** roof to wall connection? (Do not include attachment of hip/valley jacks within 5 feet of the inside or outside corner of the roof in determination of WEAKEST type)

- A. Toe Nails
  - Truss/rafter anchored to top plate of wall using nails driven at an angle through the truss/rafter and attached to the top plate of the wall, or
  - Metal connectors that do not meet the minimal conditions or requirements of B, C, or D

- Secured to truss/rafter with a minimum of three (3) nails, **and**
- Attached to the wall top plate of the wall framing, or embedded in the bond beam, with less than a 1/2" gap from the blocking or truss/rafter **and** blocked no more than 1.5" of the truss/rafter, **and** free of visible severe corrosion.

- B. Clips
  - Metal connectors that do not wrap over the top of the truss/rafter, **or**
  - Metal connectors with a minimum of 1 strap that wraps over the top of the truss/rafter and does not meet the nail position requirements of C or D, but is secured with a minimum of 3 nails.

- C. Single Wraps
  - Metal connectors consisting of a single strap that wraps over the top of the truss/rafter and is secured with a minimum of 2 nails on the front side and a minimum of 1 nail on the opposing side.

- D. Double Wraps
  - Metal Connectors consisting of 2 separate straps that are attached to the wall frame, or embedded in the bond beam, on either side of the truss/rafter where each strap wraps over the top of the truss/rafter and is secured with a minimum of 2 nails on the front side, and a minimum of 1 nail on the opposing side, **or**

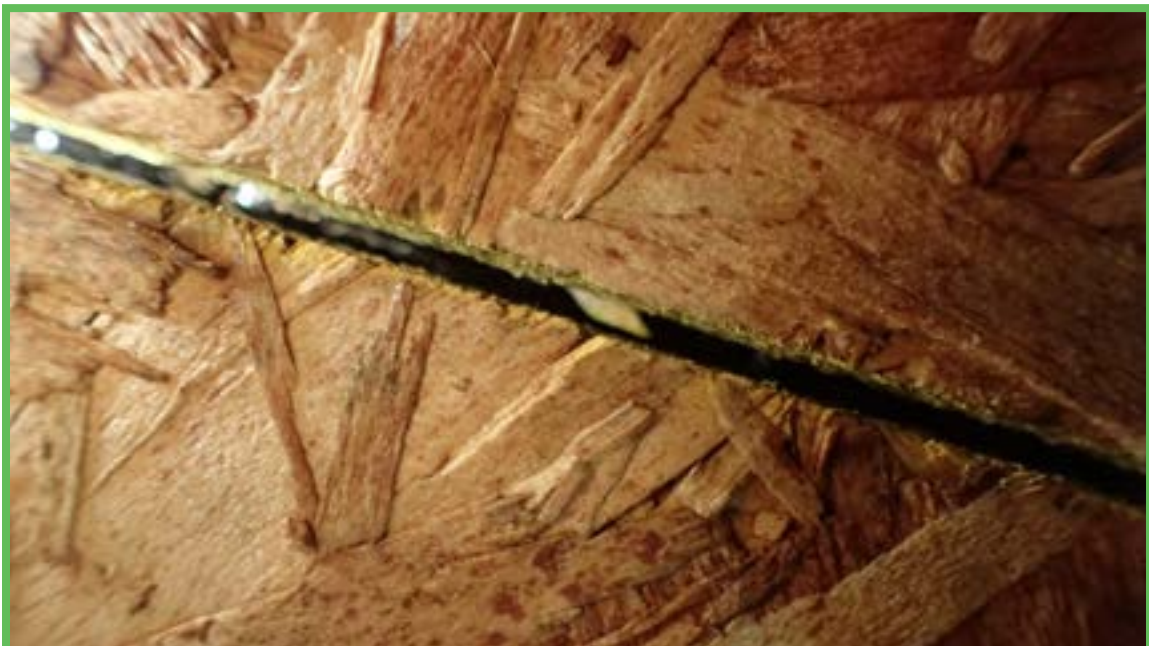
Secondary Water Resistance (SWR)

6. **Secondary Water Resistance (SWR):** (standard underlayments or hot-mopped felts do not qualify as an SWR)

- A. SWR (also called Sealed Roof Deck) Self-adhering polymer modified-bitumen roofing underlayment applied directly to the sheathing or foam adhesive SWR barrier (not foamed-on insulation) applied as a supplemental means to protect the dwelling from water intrusion in the event of roof covering loss.
- B. No SWR.
- C. Unknown or undetermined.
