Uniform Mitigation Verification Inspection Form

Inspection Date: 11/26/2021		
Owner Information		
Owner Name: David Carson		Contact Person:
Address: 5862 63rd Ave N		Home Phone:
City: Pinellas Park	Zip: 33781	Work Phone:
County: Pinellas		Cell Phone: 727-543-5905
Insurance Company:		Policy #:
Year of Home: 1968	# of Stories: 1	Email: minutus@gmail.com

Property Inspected:
5862 63rd Ave N, Pinellas Park, Florida 33781

Inspection Date: 11/26/2021

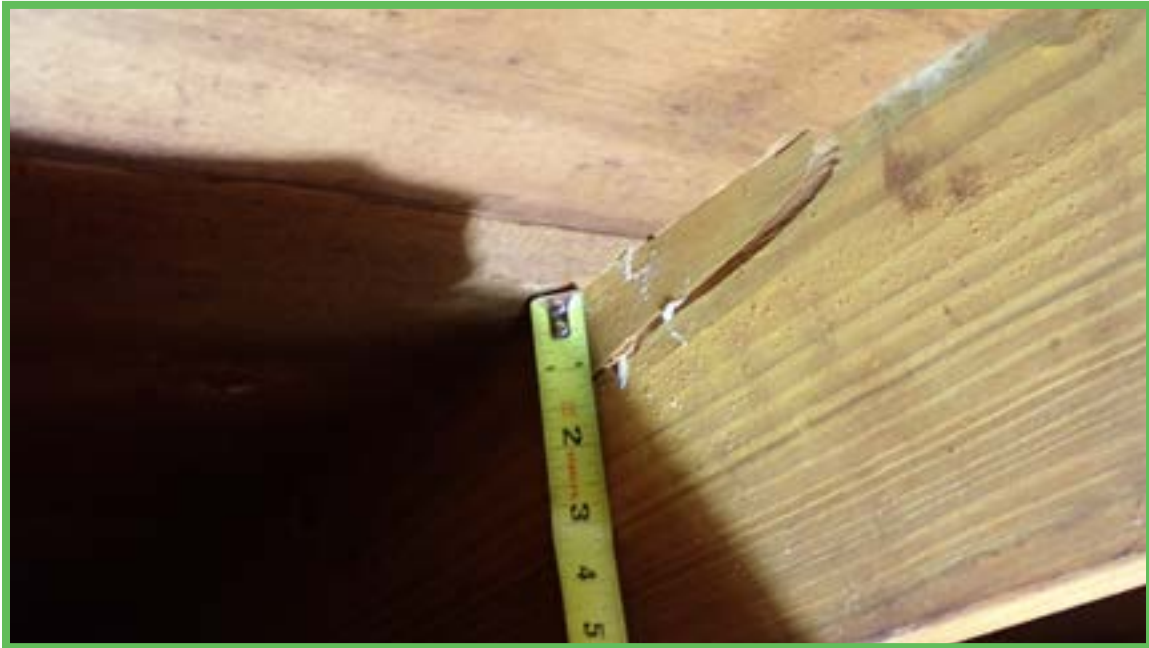
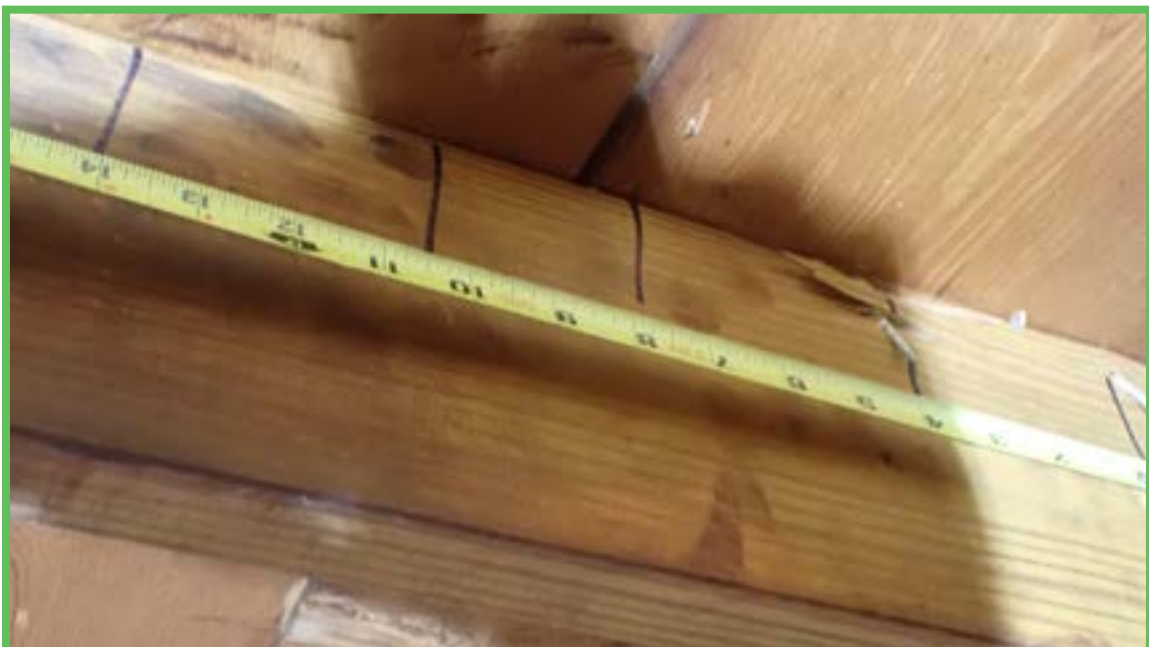
Roof Deck Attachment

- Roof Deck Attachment:** What is the weakest form of roof deck attachment? "
 - ""A. Plywood/Oriented strand board (OSB) roof sheathing attached to the roof truss/rafter (spaced a maximum of 24" inches o.c.) by staples or 6d nails spaced at 6" along the edge and 12" in the field. -OR- Batten decking supporting wood shakes or wood shingles. -OR- Any system of screws, nails, adhesives, other deck fastening system or truss/rafter spacing that has an equivalent mean uplift less than that required for Options B or C below.

- ""B. Plywood/OSB roof sheathing with a minimum thickness of 7/16" inch attached to the roof truss/rafter (spaced a maximum of 24" inches o.c.) by 8d common nails spaced a maximum of 12" inches in the field. -OR- Any system of screws, nails, adhesives, other deck fastening system or truss/rafter spacing that is shown to have an equivalent or greater resistance 8d nails spaced a maximum of 12 inches in the field or has a mean uplift resistance of at least 103 psf.

- ""C. Plywood/OSB roof sheathing with a minimum thickness of 7/16" inch attached to the roof truss/rafter (spaced a maximum of 24" inches o.c.) by 8d common nails spaced a maximum of 6" inches in the field. -OR- Dimensional lumber/Tongue & Groove decking with a minimum of 2 nails per board (or 1 nail per board if each board is equal to or less than 6 inches in width). -OR- Any system of screws, nails, adhesives, other deck fastening system or truss/rafter spacing that is shown to have an equivalent

or greater resistance than 8d common nails spaced a maximum of 6 inches in the field or has a mean uplift resistance of at least 182 psf.

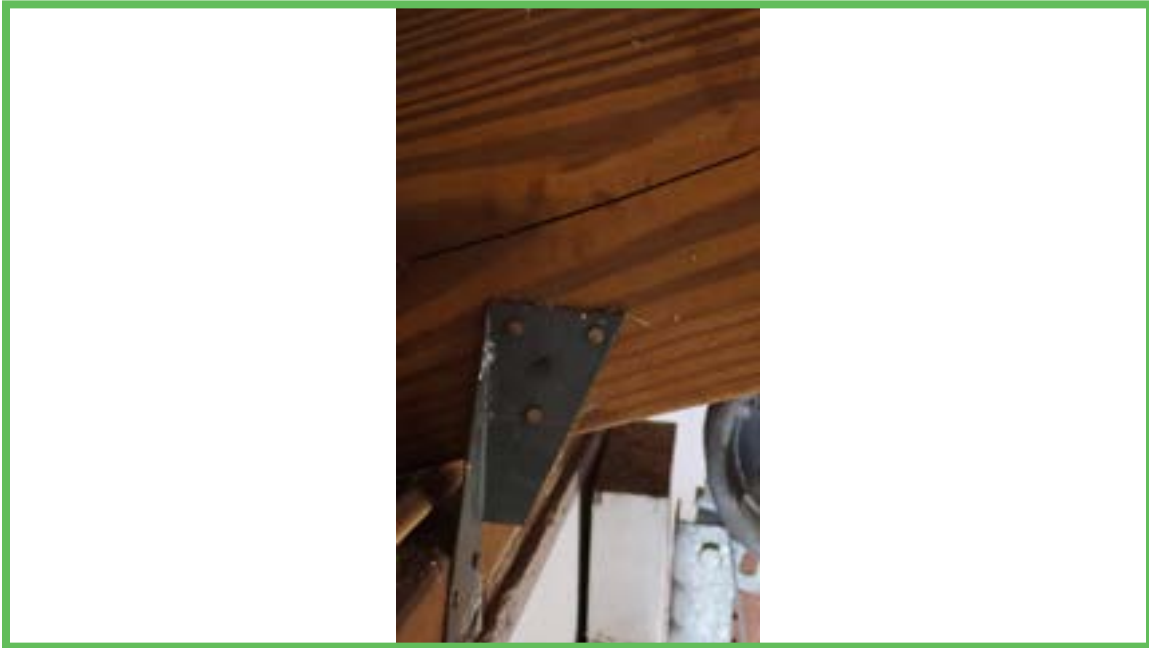
Roof to Wall Attachment

4. **Roof to Wall Attachment:** What is the **WEAKEST** roof to wall connection? (Do not include attachment of hip/valley jacks within 5 feet of the inside or outside corner of the roof in determination of WEAKEST type)

- A. Toe Nails
 - Truss/rafter anchored to top plate of wall using nails driven at an angle through the truss/rafter and attached to the top plate of the wall, or
 - Metal connectors that do not meet the minimal conditions or requirements of B, C, or D

Minimal conditions to qualify for categories B, C, or D. All visible metal connectors are:

- Secured to truss/rafter with a minimum of three (3) nails, **and**
- Attached to the wall top plate of the wall framing, or embedded in the bond beam, with less than a 1/2" gap from the blocking or truss/rafter **and** blocked no more than 1.5" of the truss/rafter, **and** free of visible severe corrosion.

- B. Clips
 - Metal connectors that do not wrap over the top of the truss/rafter, **or**
 - Metal connectors with a minimum of 1 strap that wraps over the top of the truss/rafter and does not meet the nail position requirements of C or D, but is secured with a minimum of 3 nails.

- C. Single Wraps
 - Metal connectors consisting of a single strap that wraps over the top of the truss/rafter and is secured with a minimum of 2 nails on the front side and a minimum of 1 nail on the opposing side.

- D. Double Wraps
 - Metal Connectors consisting of 2 separate straps that are attached to the wall frame, or embedded in the bond beam, on either side of the truss/rafter where each strap wraps over the top of the truss/rafter and is secured with a minimum of 2 nails on the front side, and a minimum of 1 nail on the opposing side, **or**

- Metal connectors consisting of a single strap that wraps over the top of the truss/rafter, is secured to the wall on both sides, and is secured to the top plate with a minimum of three nails on each side.

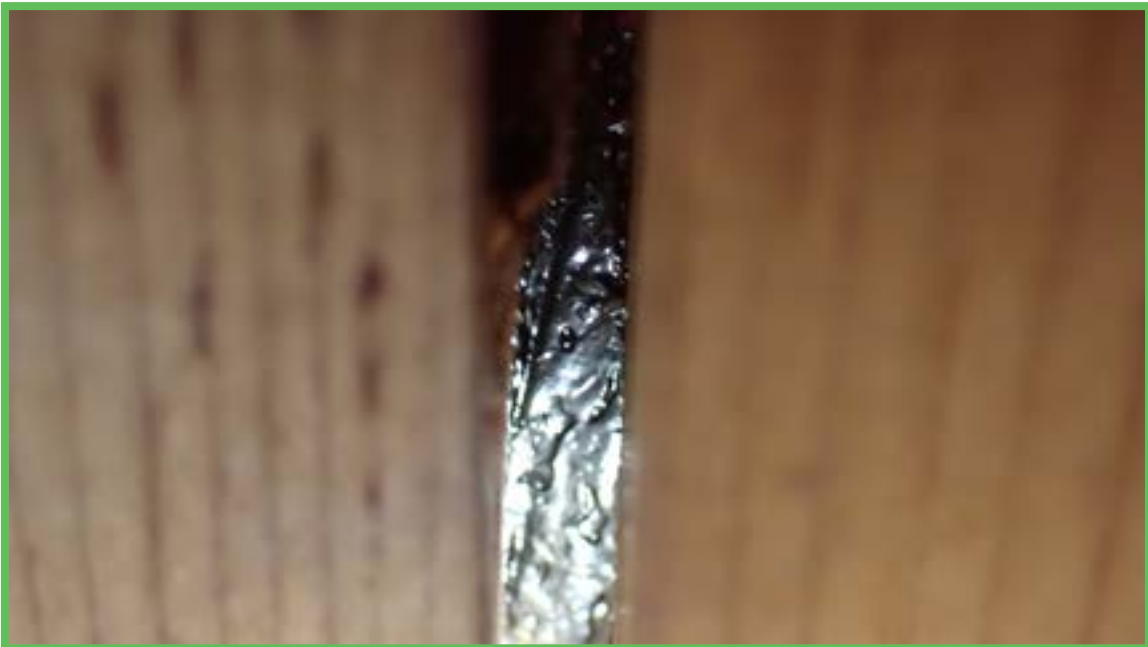
Secondary Water Resistance (SWR)

6. **Secondary Water Resistance (SWR):** (standard underlayments or hot-mopped felts do not qualify as an SWR)

- A. SWR (also called Sealed Roof Deck) Self-adhering polymer modified-bitumen roofing underlayment applied directly to the sheathing or foam adhesive SWR barrier (not foamed-on insulation) applied as a supplemental means to protect the dwelling from water intrusion in the event of roof covering loss.
- B. No SWR.
- C. Unknown or undetermined.
