Uniform Mitigation Verification Inspection Form

Inspection Date: 01/12/2022		
Owner Information		
Owner Name: Christine Winterstein		Contact Person:
Address: 708 Sahara Dr		Home Phone:
City: Sun City Center	Zip: 33573	Work Phone:
County: Hillsborough		Cell Phone: 607-343-6865
Insurance Company:		Policy #:
Year of Home: 1969	# of Stories: 1	Email: cwinterste@hotmail.com

Property Inspected:
708 Sahara Dr, Sun City Center, Florida 33573

Inspection Date: 1/12/2022

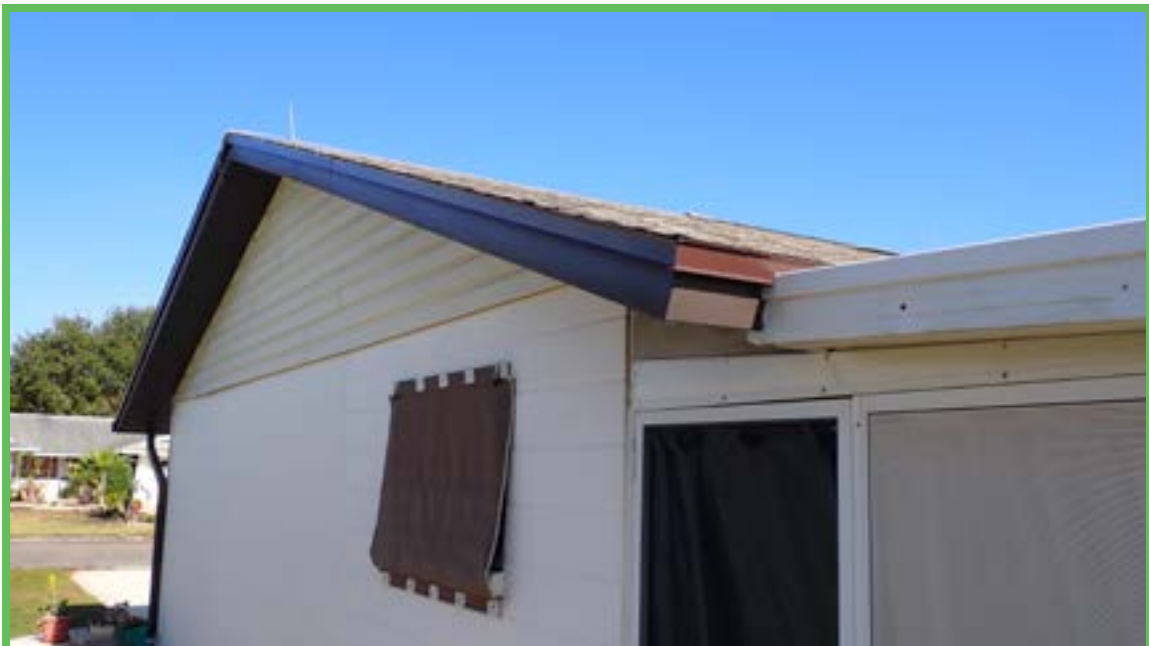
Rear and Right Elevation

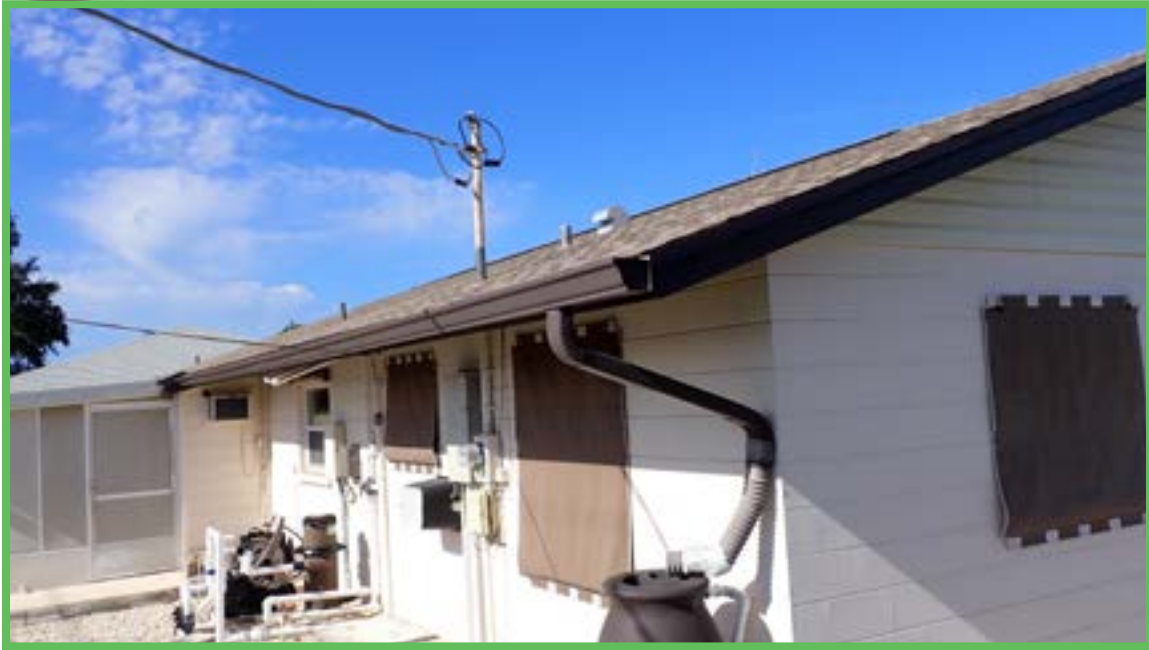
Rear and Left Elevation

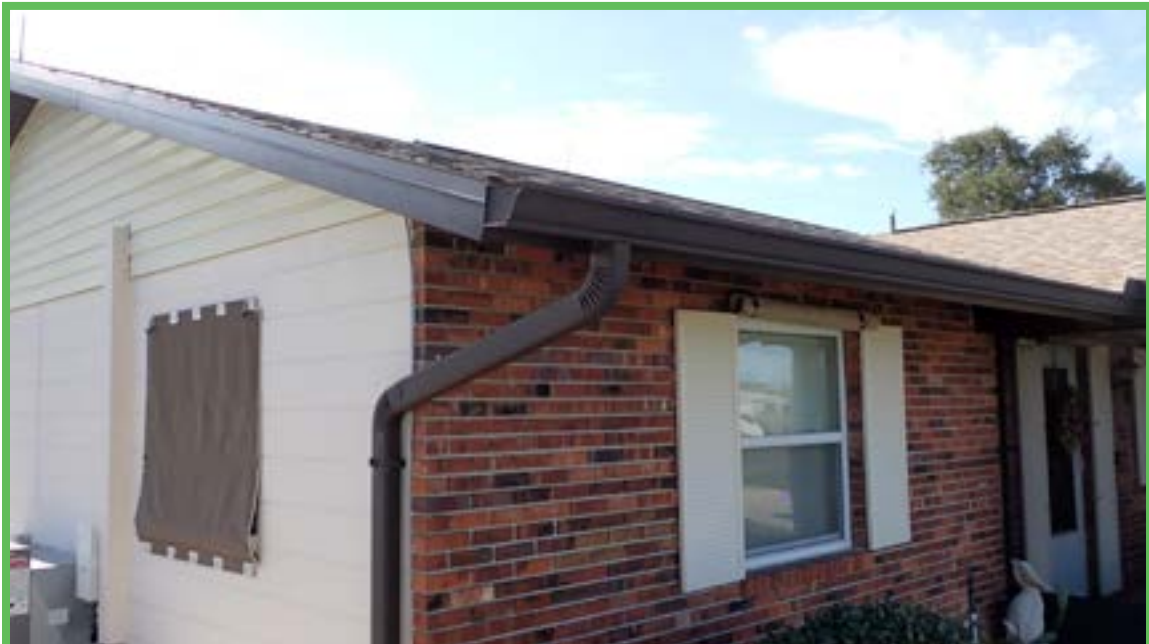
Front and Left Elevation

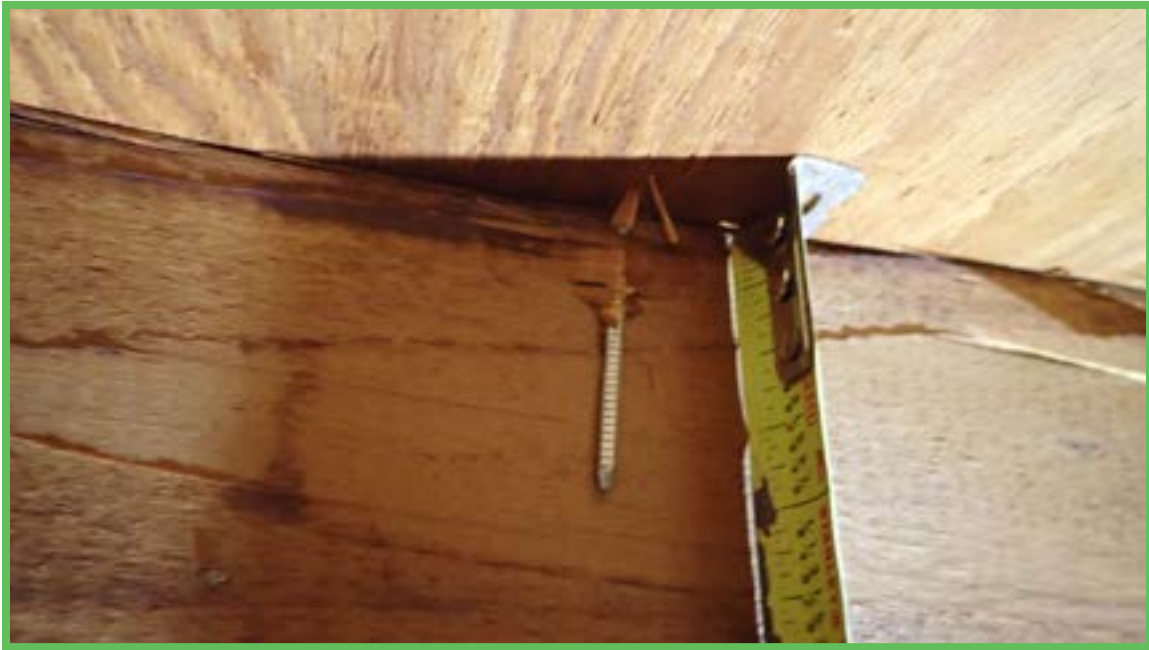
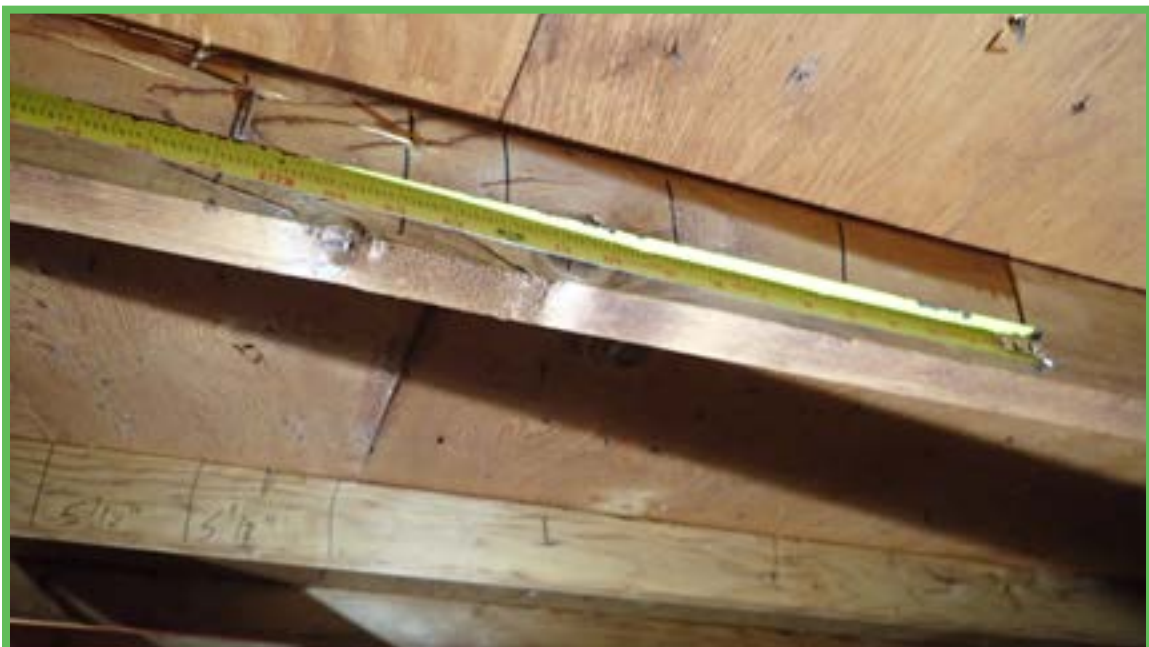
- Roof Deck Attachment:** What is the weakest form of roof deck attachment? "
 - ""A. Plywood/Oriented strand board (OSB) roof sheathing attached to the roof truss/rafter (spaced a maximum of 24" inches o.c.) by staples or 6d nails spaced at 6" along the edge and 12" in the field. -OR- Batten decking supporting wood shakes or wood shingles. -OR- Any system of screws, nails, adhesives, other deck fastening system or truss/rafter spacing that has an equivalent mean uplift less than that required for Options B or C below.

Roof Deck Attachment

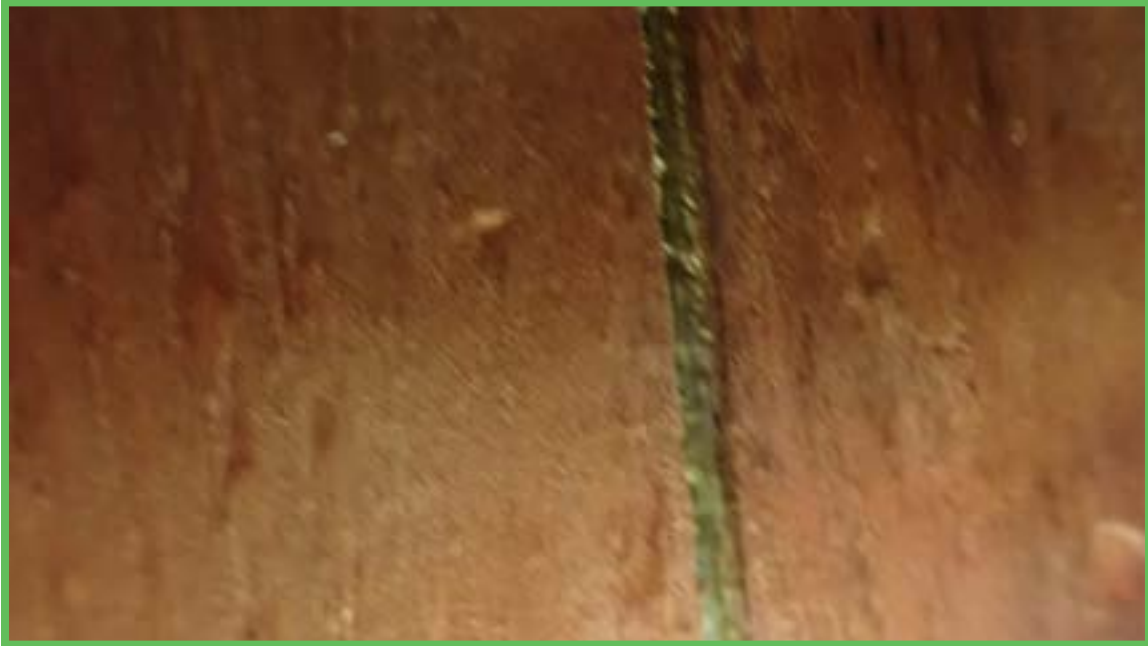
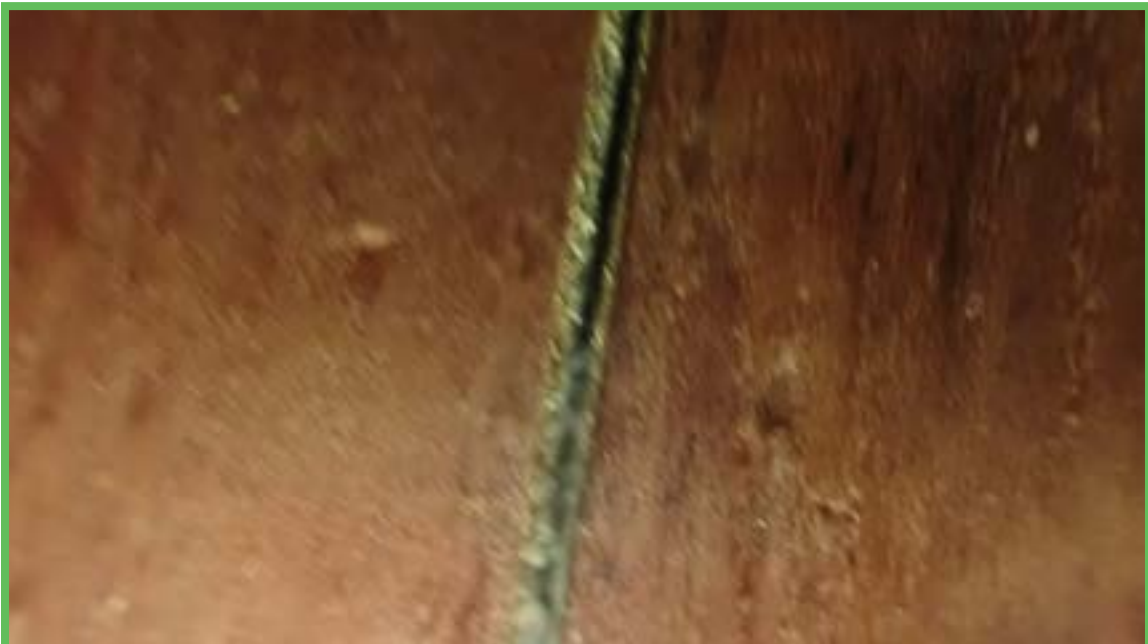
6. **Secondary Water Resistance (SWR):** (standard underlayments or hot-mopped felts do not qualify as an SWR)

Secondary Water Resistance (SWR)

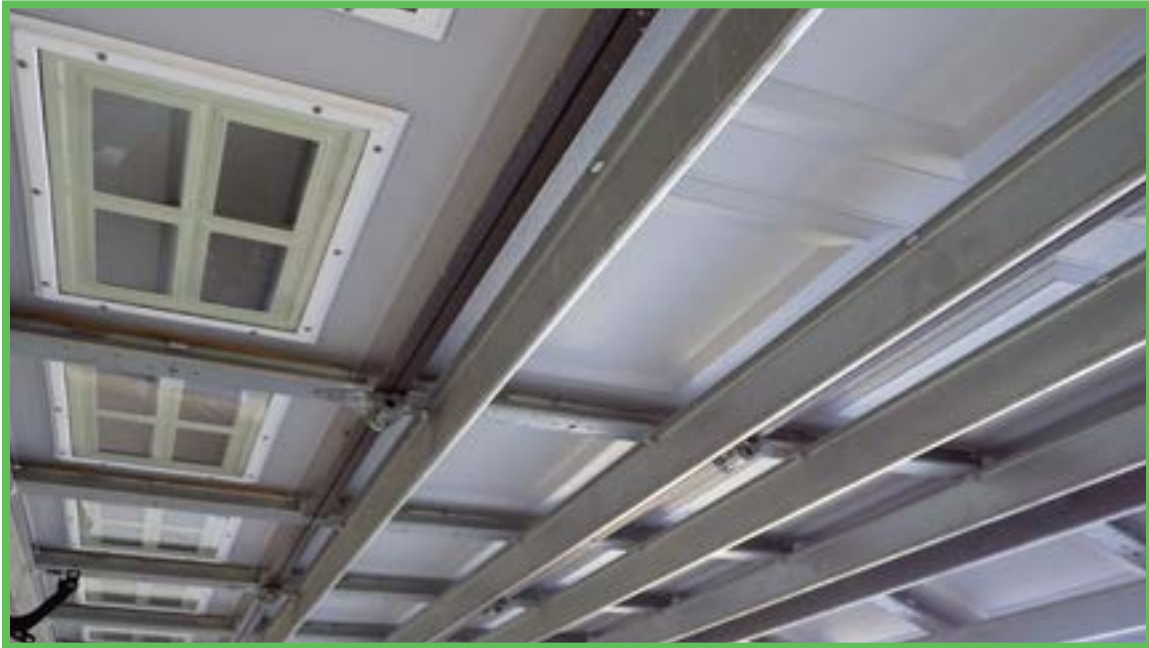
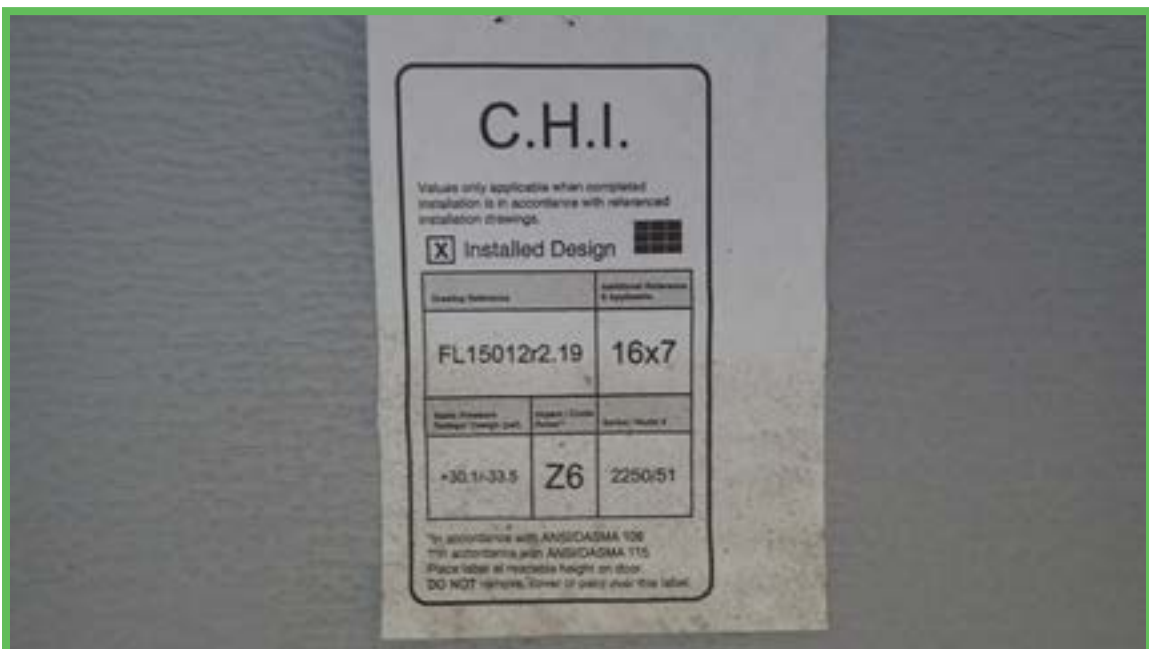
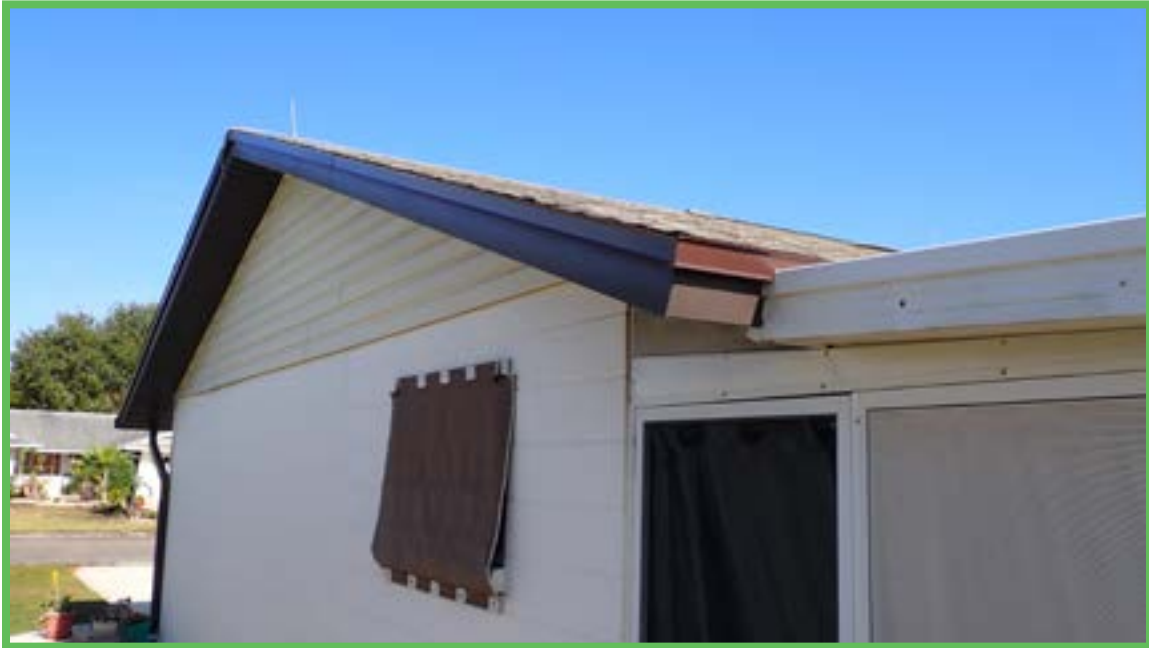
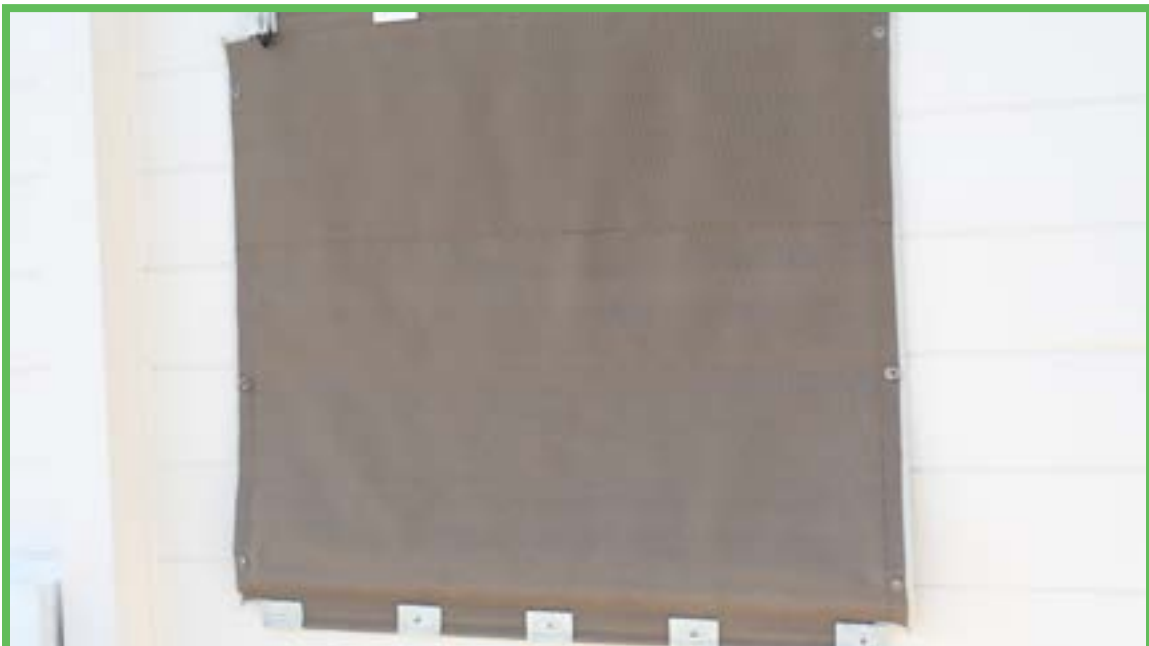
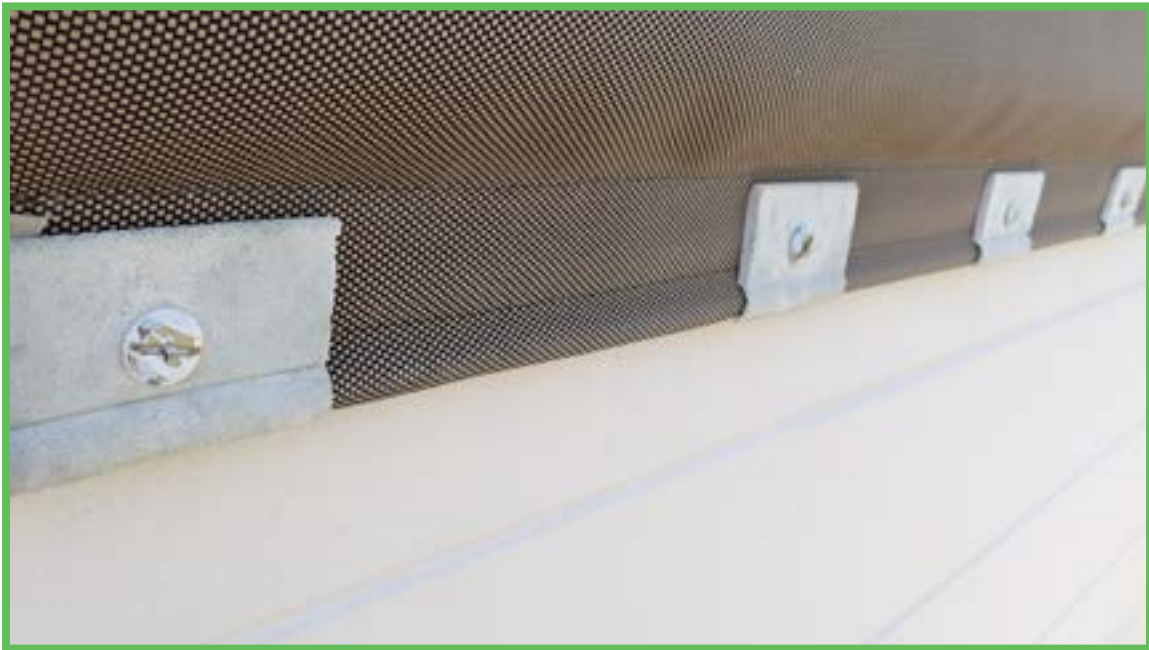
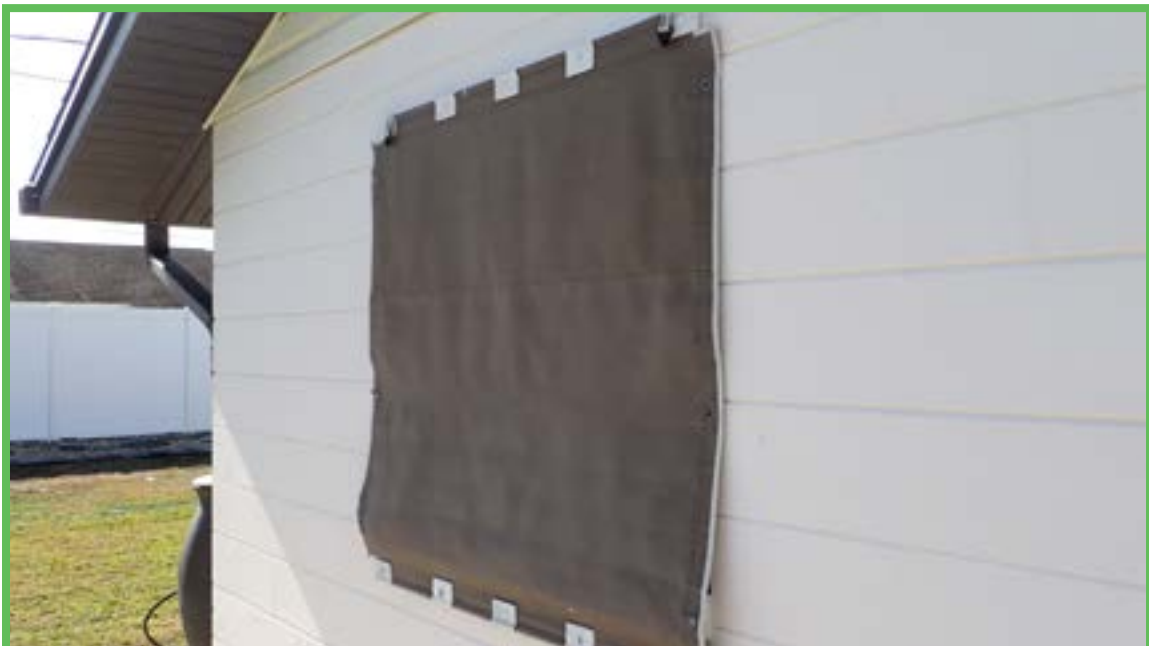
7. **Opening Protection:** What is the **weakest** form of wind borne debris protection installed on the structure? **First**, use the table to determine the weakest form of protection for each category of opening. **Second**, (a) check one answer below (A, B, C, N, or X) based upon the lowest protection level for ALL Glazed openings **and** (b) check the protection level for all Non-Glazed openings (.1, .2, or .3) as applicable.

Opening Protection
