# Uniform Mitigation Verification Inspection Form

Inspection Date: 03/18/2022		
<b>Owner Information</b>		
Owner Name: Nolen Maguire		Contact Person:
Address: 6319 Bobby Jones Ct		Home Phone:
City: Palmetto	Zip: 34221	Work Phone:
County: Manatee		Cell Phone: 813-957-6997
Insurance Company:		Policy #:
Year of Home: 2004	# of Stories: 2	Email: nmaguire3@gmail.com

Property Inspected:  
6319 Bobby Jones Ct, Palmetto, Florida 34221

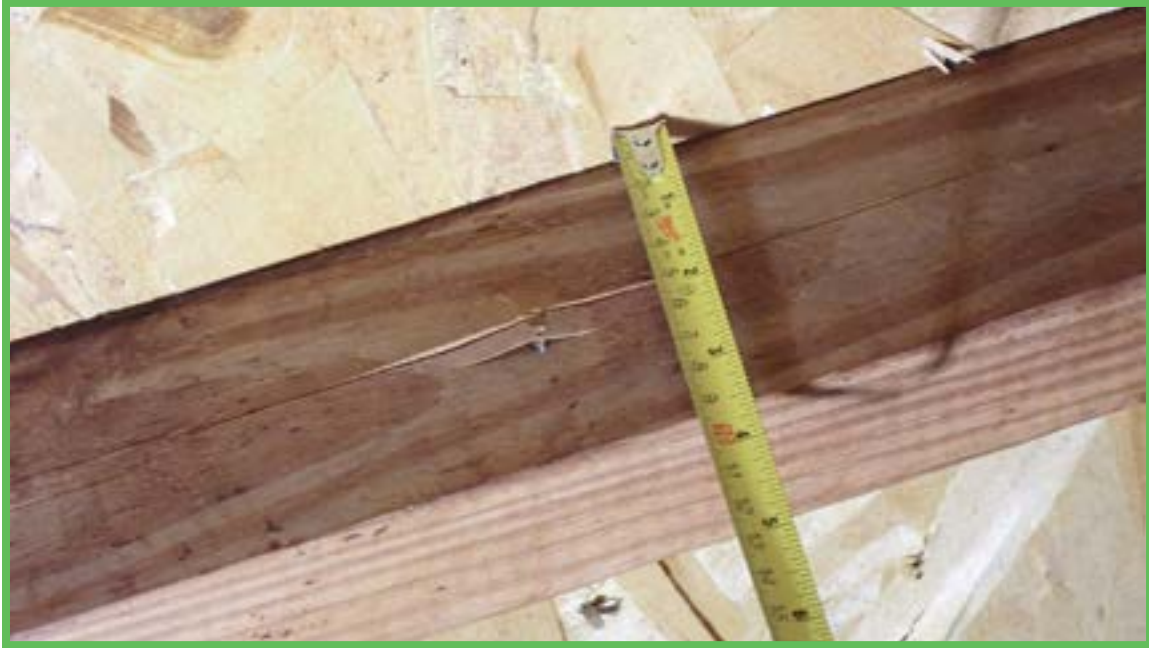
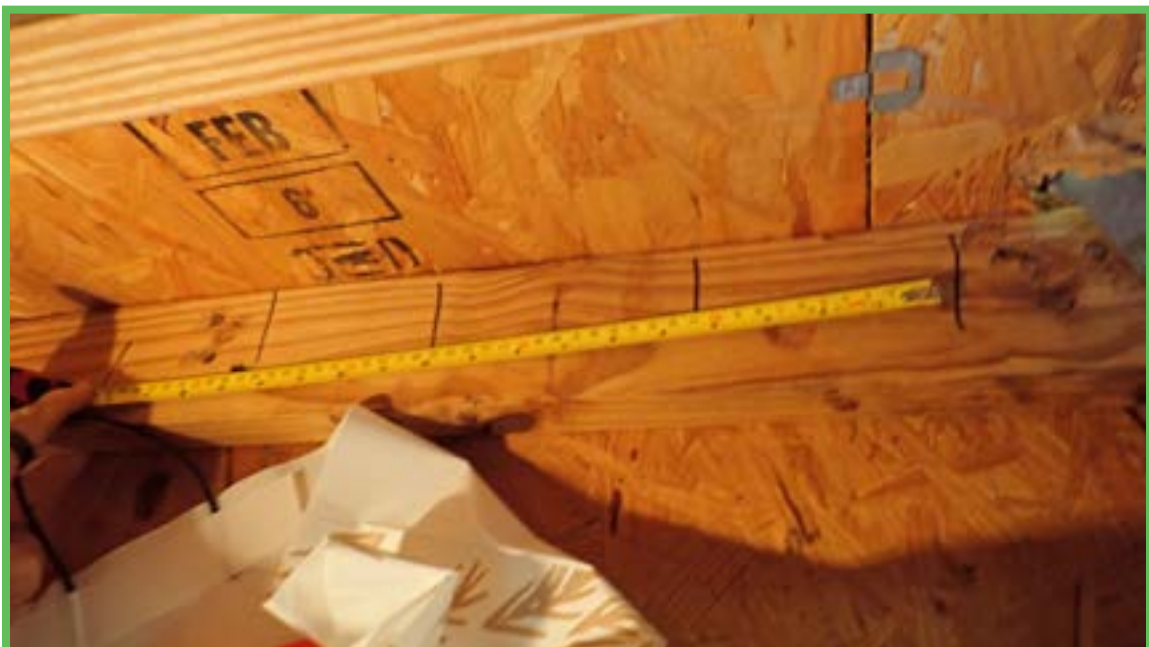
Roof Deck Attachment

- Roof Deck Attachment:** What is the weakest form of roof deck attachment? "
  - ""A. Plywood/Oriented strand board (OSB) roof sheathing attached to the roof truss/rafter (spaced a maximum of 24" inches o.c.) by staples or 6d nails spaced at 6" along the edge and 12" in the field. -OR- Batten decking supporting wood shakes or wood shingles. -OR- Any system of screws, nails, adhesives, other deck fastening system or truss/rafter spacing that has an equivalent mean uplift less than that required for Options B or C below.

- ""B. Plywood/OSB roof sheathing with a minimum thickness of 7/16" inch attached to the roof truss/rafter (spaced a maximum of 24" inches o.c.) by 8d common nails spaced a maximum of 12" inches in the field. -OR- Any system of screws, nails, adhesives, other deck fastening system or truss/rafter spacing that is shown to have an equivalent or greater resistance 8d nails spaced a maximum of 12 inches in the field or has a mean uplift resistance of at least 103 psf.

- ""C. Plywood/OSB roof sheathing with a minimum thickness of 7/16" inch attached to the roof truss/rafter (spaced a maximum of 24" inches o.c.) by 8d common nails spaced a maximum of 6" inches in the field. -OR- Dimensional lumber/Tongue & Groove decking with a minimum of 2 nails per board (or 1 nail per board if each board is equal to or less than 6 inches in width). -OR- Any system of screws, nails, adhesives, other deck fastening system or truss/rafter spacing that is shown to have an equivalent

or greater resistance than 8d common nails spaced a maximum of 6 inches in the field or has a mean uplift resistance of at least 182 psf.

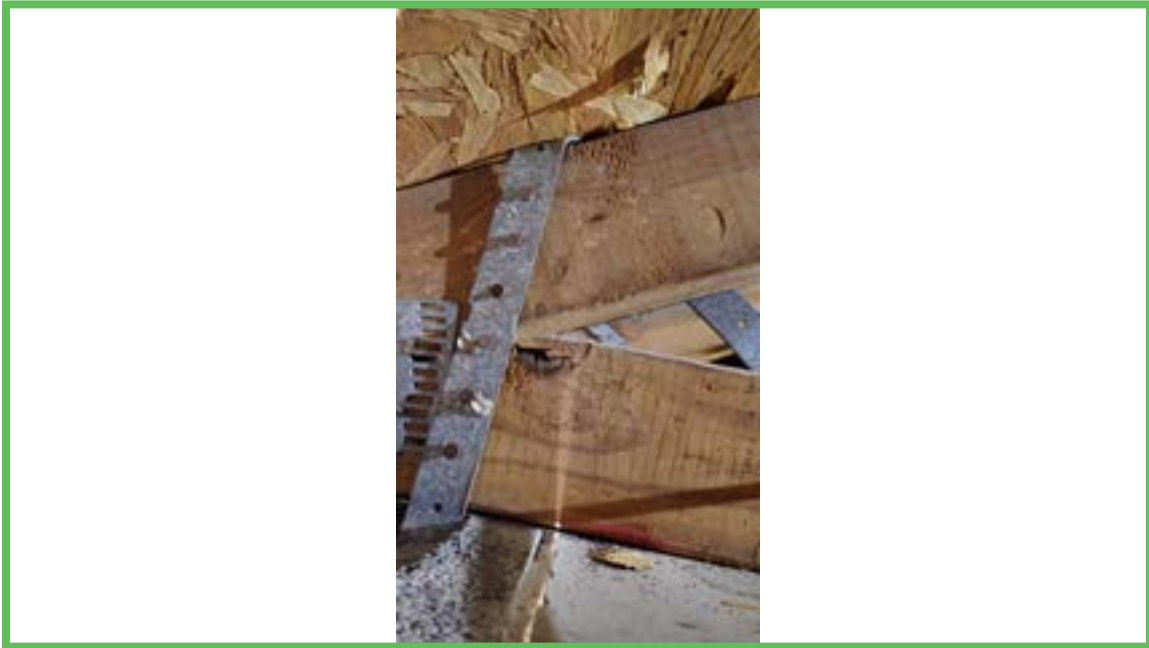
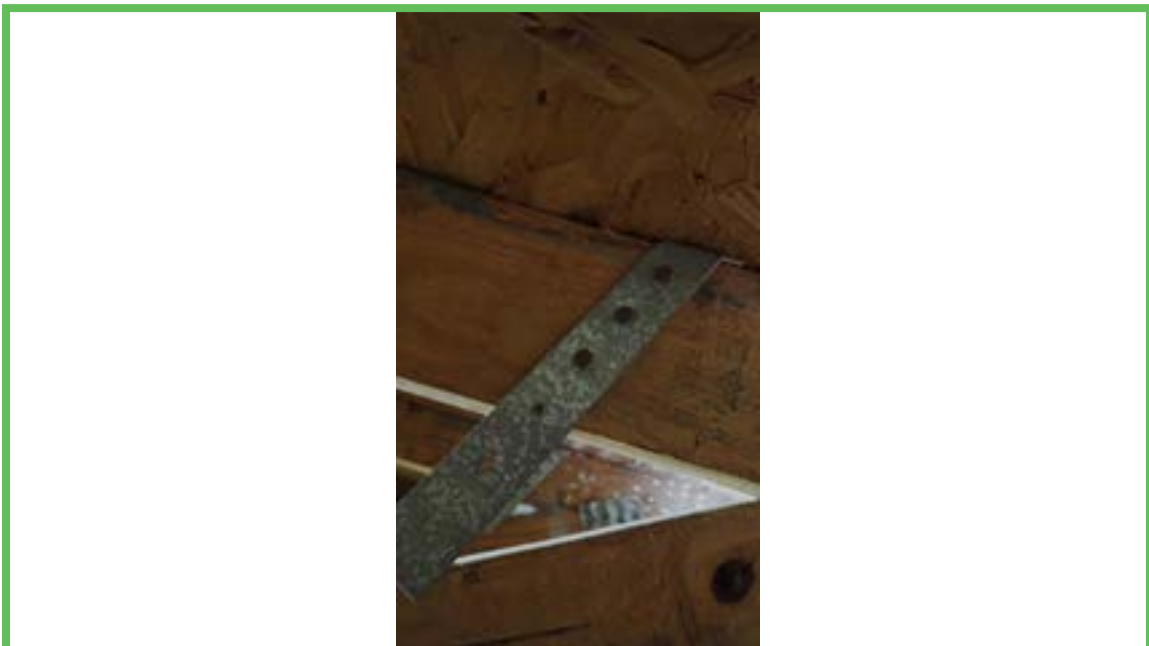
Roof to Wall Attachment

4. **Roof to Wall Attachment:** What is the **WEAKEST** roof to wall connection? (Do not include attachment of hip/valley jacks within 5 feet of the inside or outside corner of the roof in determination of WEAKEST type)

- A. Toe Nails
  - Truss/rafter anchored to top plate of wall using nails driven at an angle through the truss/rafter and attached to the top plate of the wall, or
  - Metal connectors that do not meet the minimal conditions or requirements of B, C, or D

**Minimal conditions to qualify for categories B, C, or D. All visible metal connectors are:**

- Secured to truss/rafter with a minimum of three (3) nails, **and**
- Attached to the wall top plate of the wall framing, or embedded in the bond beam, with less than a 1/2" gap from the blocking or truss/rafter **and** blocked no more than 1.5" of the truss/rafter, **and** free of visible severe corrosion.

- B. Clips
  - Metal connectors that do not wrap over the top of the truss/rafter, **or**
  - Metal connectors with a minimum of 1 strap that wraps over the top of the truss/rafter and does not meet the nail position requirements of C or D, but is secured with a minimum of 3 nails.

- C. Single Wraps
  - Metal connectors consisting of a single strap that wraps over the top of the truss/rafter and is secured with a minimum of 2 nails on the front side and a minimum of 1 nail on the opposing side.

- D. Double Wraps
  - Metal Connectors consisting of 2 separate straps that are attached to the wall frame, or embedded in the bond beam, on either side of the truss/rafter where each strap wraps over the top of the truss/rafter and is secured with a minimum of 2 nails on the front side, and a minimum of 1 nail on the opposing side, **or**

- Metal connectors consisting of a single strap that wraps over the top of the truss/rafter, is secured to the wall on both sides, and is secured to the top plate with a minimum of three nails on each side.

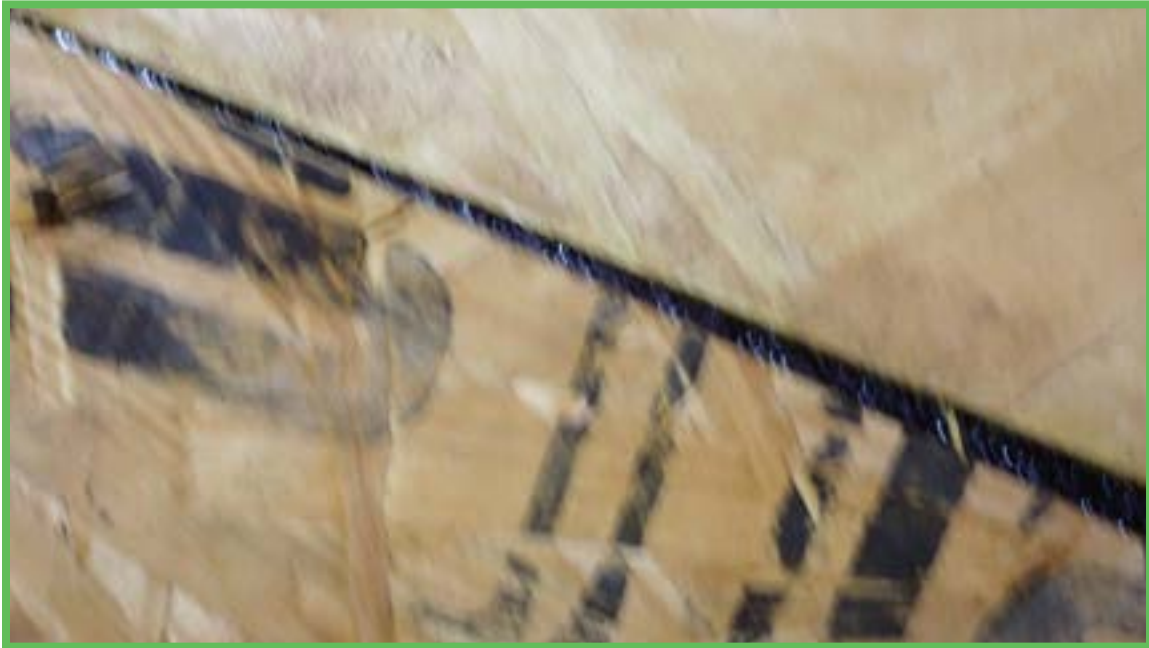
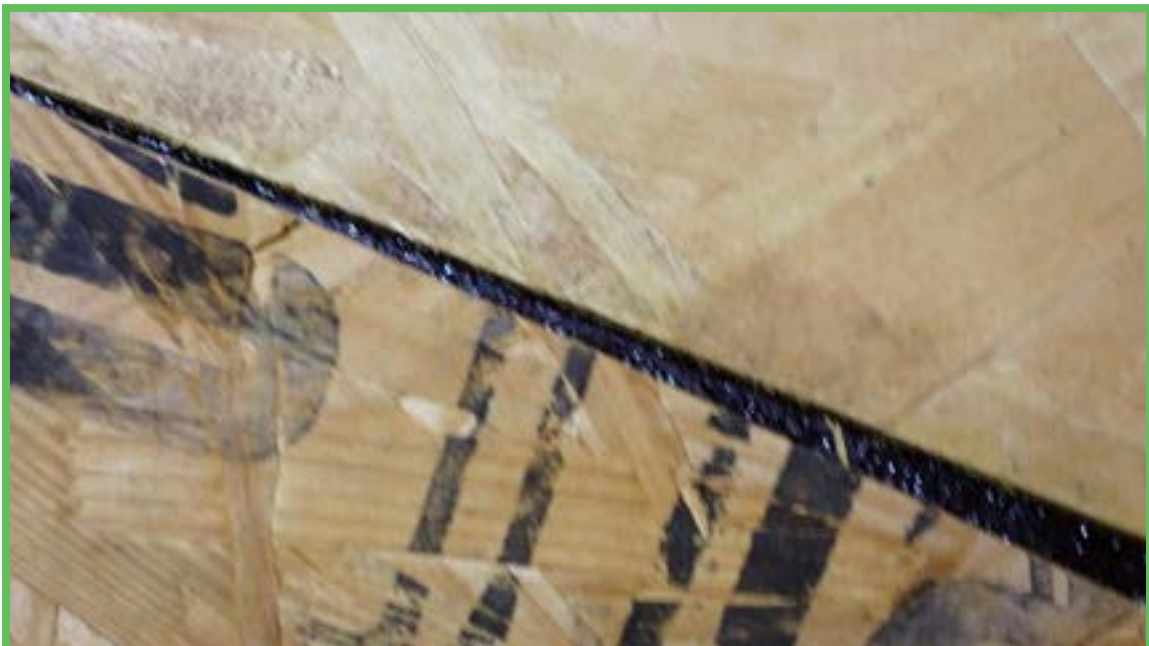
Secondary Water Resistance (SWR)

6. **Secondary Water Resistance (SWR):** (standard underlayments or hot-mopped felts do not qualify as an SWR)

- A. SWR (also called Sealed Roof Deck) Self-adhering polymer modified-bitumen roofing underlayment applied directly to the sheathing or foam adhesive SWR barrier (not foamed-on insulation) applied as a supplemental means to protect the dwelling from water intrusion in the event of roof covering loss.
- B. No SWR.
- C. Unknown or undetermined.

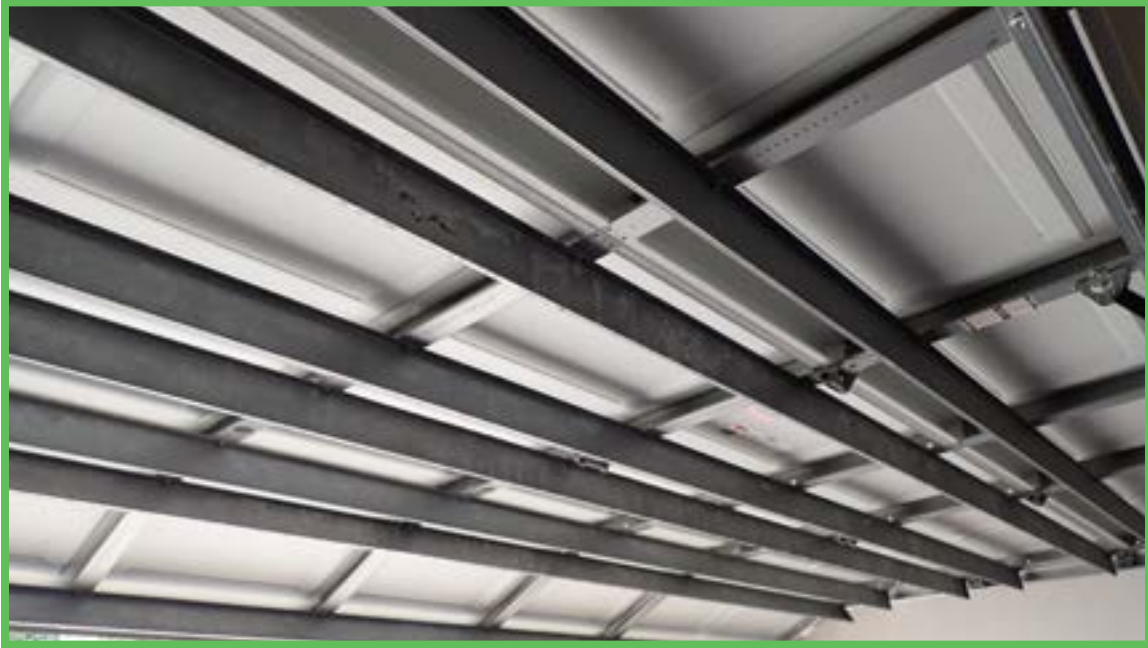
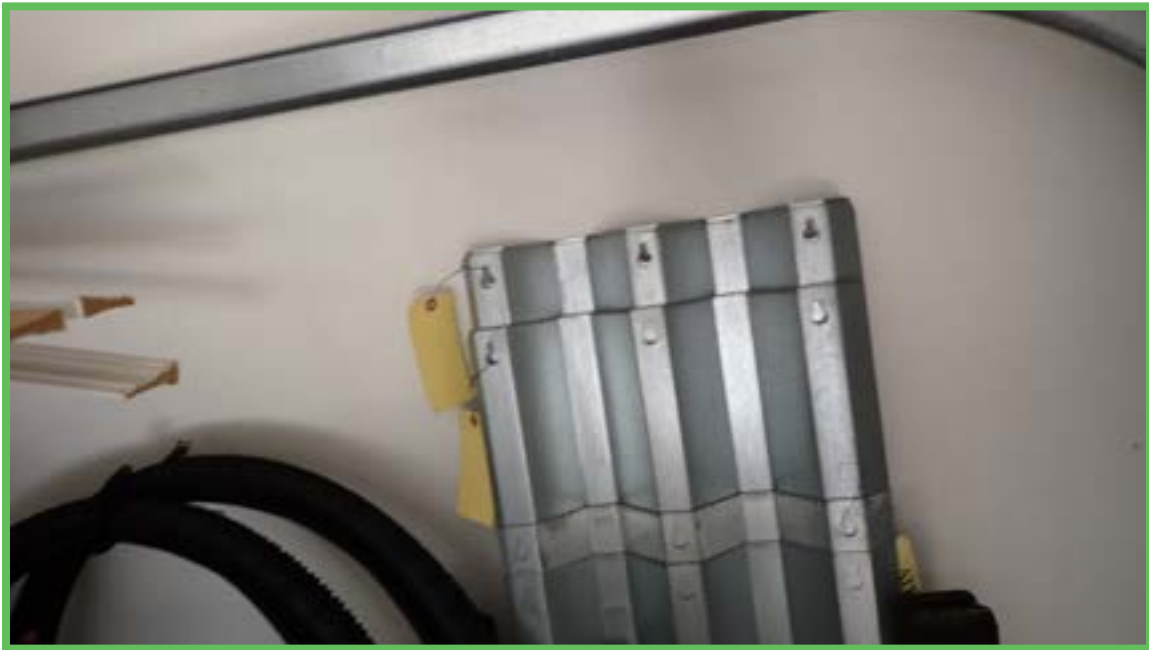
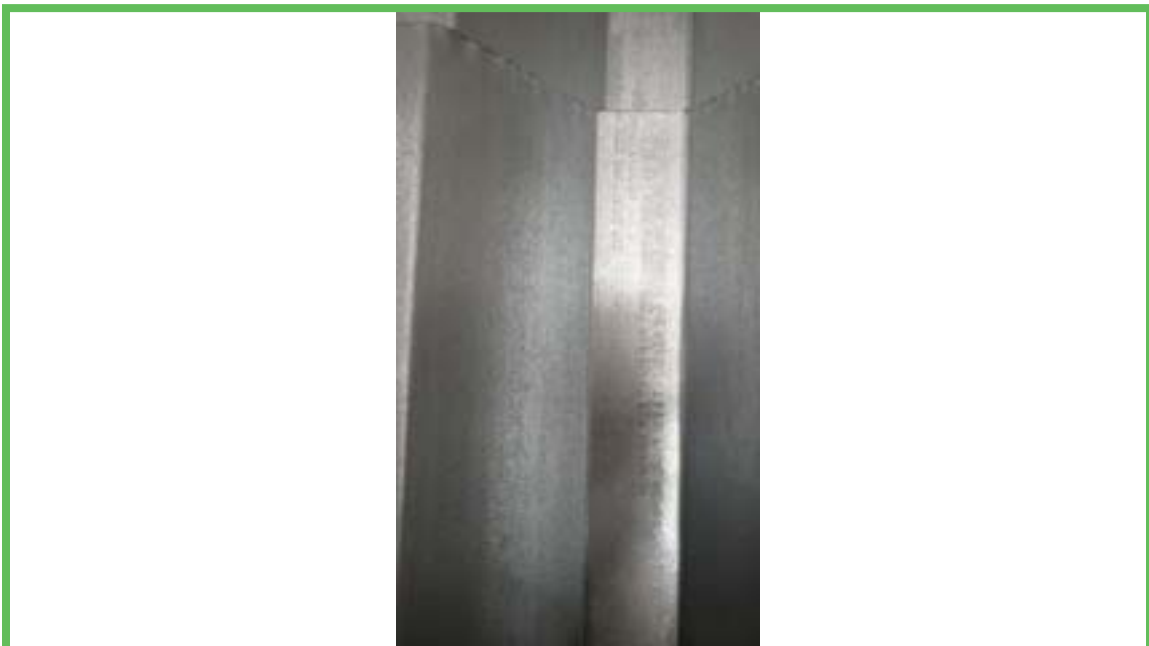
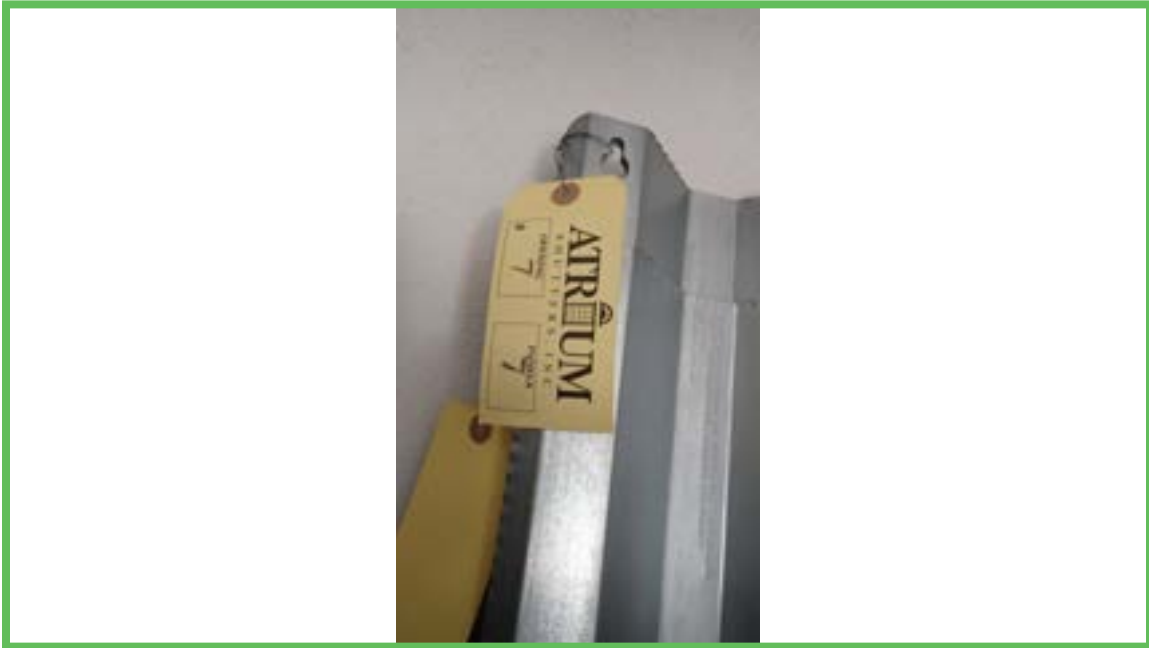
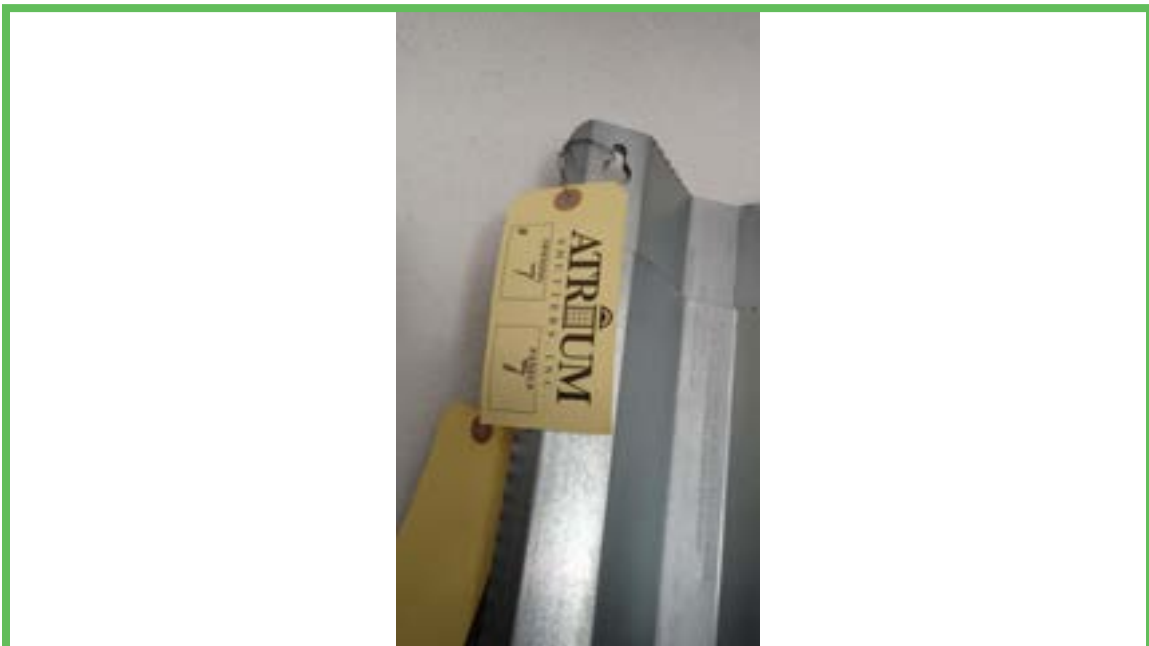
7. **Opening Protection:** What is the **weakest** form of wind borne debris protection installed on the structure? **First**, use the table to determine the weakest form of protection for each category of opening. **Second**, (a) check one answer below (A, B, C, N, or X) based upon the lowest protection level for ALL Glazed openings **and** (b) check the protection level for all Non-Glazed openings (.1, .2, or .3) as applicable.

Opening Protection Level Chart Place an "X" in each row to identify all forms of protection in use for each opening type. Check only one answer below (A thru X), based on the weakest form of protection (lowest row) for any of the Glazed openings and indicate the weakest form of protection (lowest row) for Non-Glazed openings.		Glazed Openings				Non-Glazed Openings	
		Windows or Entry Doors	Garage Doors	Skylights	Glass Block	Entry Doors	Garage Doors
N/A	Not Applicable- there are no openings of this type on the structure		X	X	X		
A	Verified cyclic pressure & large missile (9-lb for windows doors/4.5 lb for skylights)	X				X	
B	Verified cyclic pressure & large missile (4-8 lb for windows doors/2 lb for skylights)						
C	Verified plywood/OSB meeting Table 1609.1.2 of the FBC 2007						
D	Verified Non-Glazed Entry or Garage doors indicating compliance with ASTM E 330, ANSI/DASMA 108, or PA/TAS 202 for wind pressure resistance						X

N	Opening Protection products that appear to be A or B but are not verified						
	Other protective coverings that cannot be identified as A, B, or C						
X	No Windborne Debris Protection
