Uniform Mitigation Verification Inspection Form

Inspection Date: 04/21/2022		
Owner Information		
Owner Name: Pearl Merrill		Contact Person:
Address: 10609 Forest Run Dr		Home Phone:
City: Bradenton	Zip: 34211	Work Phone:
County: Manatee		Cell Phone:
Insurance Company:		Policy #:
Year of Home: 1992	# of Stories: 1	Email: smerrillb@comcast.net

Property Inspected:
10609 Forest Run Dr, Bradenton, Florida 34211

Inspection Date: 4/21/2022

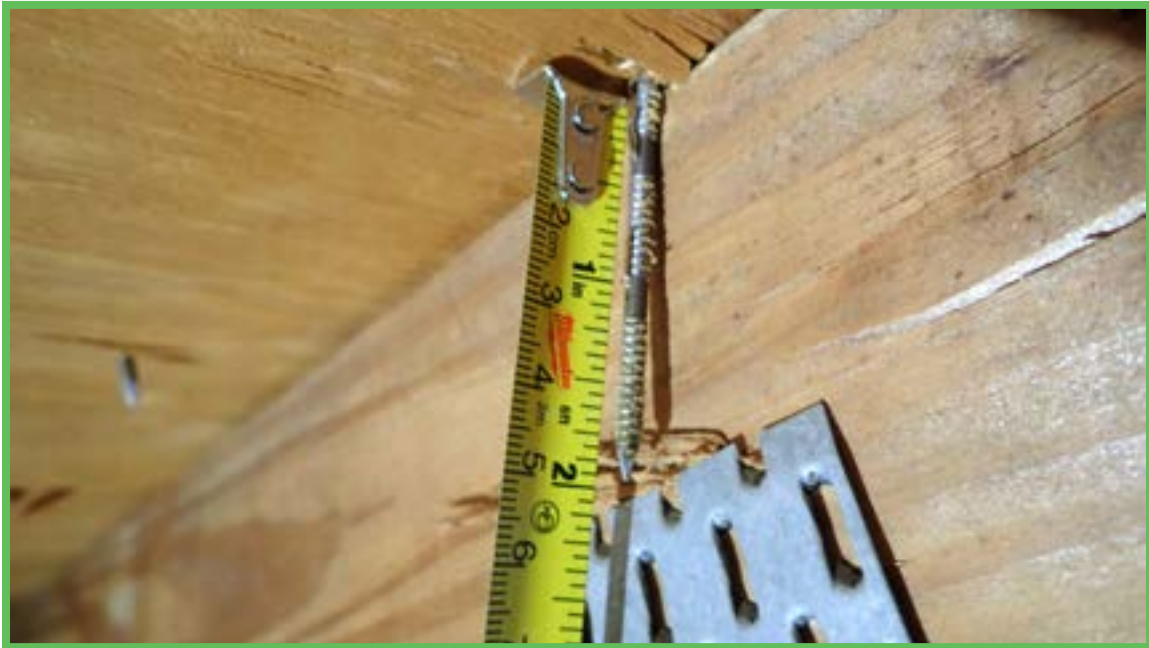
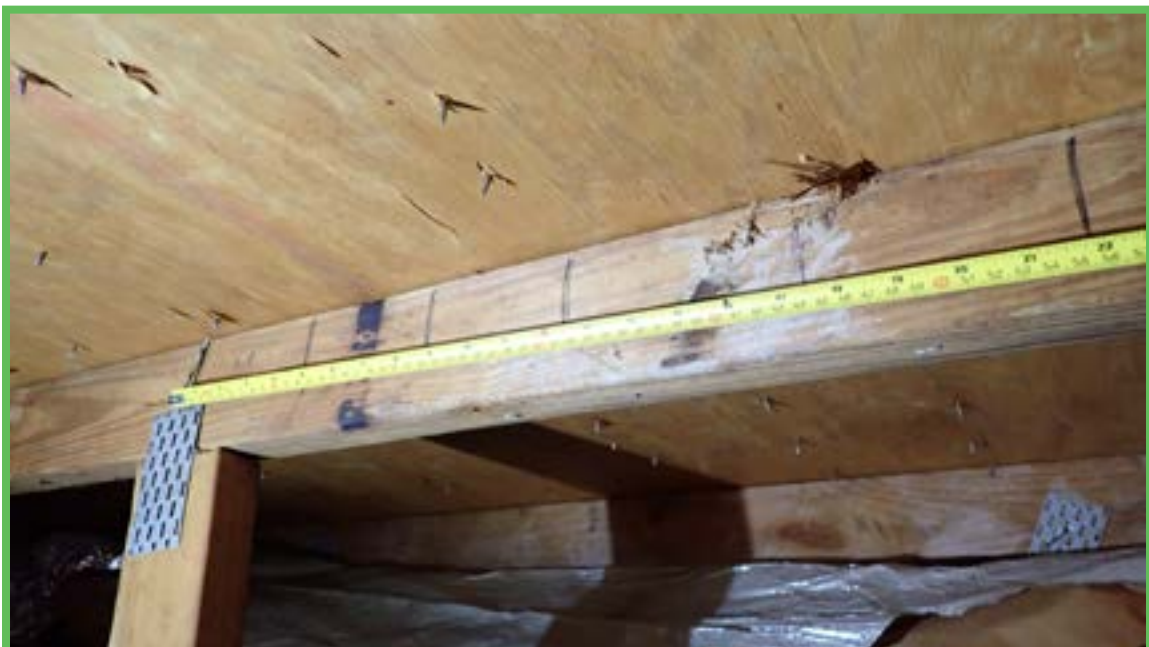
Roof Deck Attachment

- Roof Deck Attachment:** What is the weakest form of roof deck attachment? "
 - ""A. Plywood/Oriented strand board (OSB) roof sheathing attached to the roof truss/rafter (spaced a maximum of 24" inches o.c.) by staples or 6d nails spaced at 6" along the edge and 12" in the field. -OR- Batten decking supporting wood shakes or wood shingles. -OR- Any system of screws, nails, adhesives, other deck fastening system or truss/rafter spacing that has an equivalent mean uplift less than that required for Options B or C below.

- ""B. Plywood/OSB roof sheathing with a minimum thickness of 7/16" inch attached to the roof truss/rafter (spaced a maximum of 24" inches o.c.) by 8d common nails spaced a maximum of 12" inches in the field. -OR- Any system of screws, nails, adhesives, other deck fastening system or truss/rafter spacing that is shown to have an equivalent or greater resistance 8d nails spaced a maximum of 12 inches in the field or has a mean uplift resistance of at least 103 psf.

- ""C. Plywood/OSB roof sheathing with a minimum thickness of 7/16" inch attached to the roof truss/rafter (spaced a maximum of 24" inches o.c.) by 8d common nails spaced a maximum of 6" inches in the field. -OR- Dimensional lumber/Tongue & Groove decking with a minimum of 2 nails per board (or 1 nail per board if each board is equal to or less than 6 inches in width). -OR- Any system of screws, nails, adhesives, other deck fastening system or truss/rafter spacing that is shown to have an equivalent

or greater resistance than 8d common nails spaced a maximum of 6 inches in the field or has a mean uplift resistance of at least 182 psf.

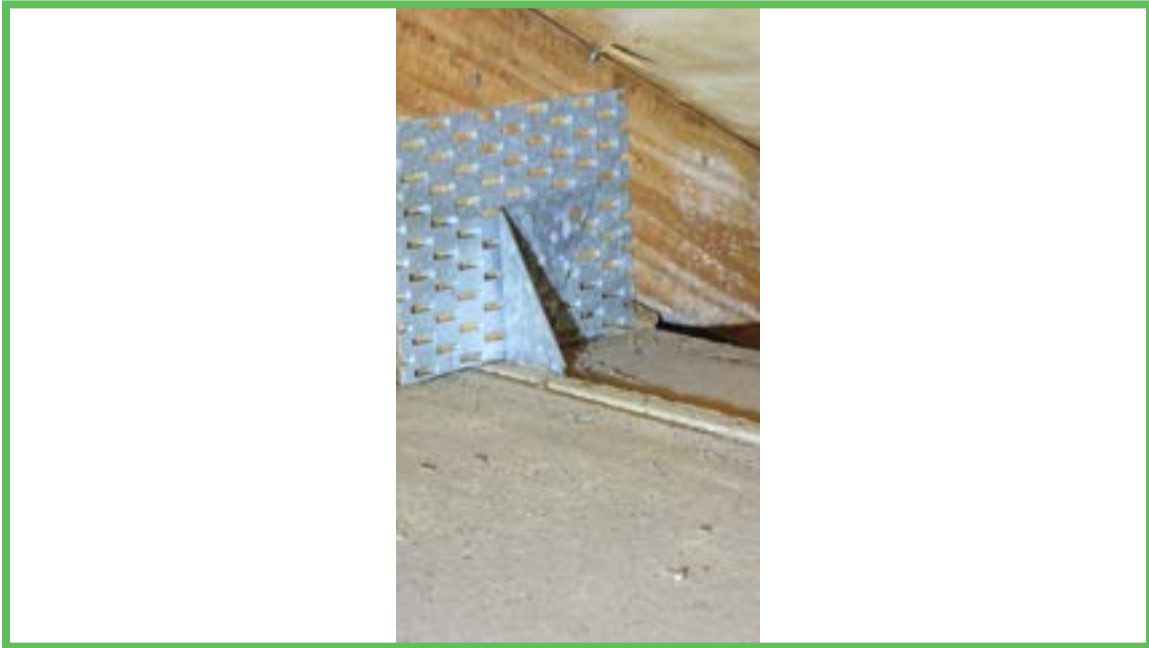
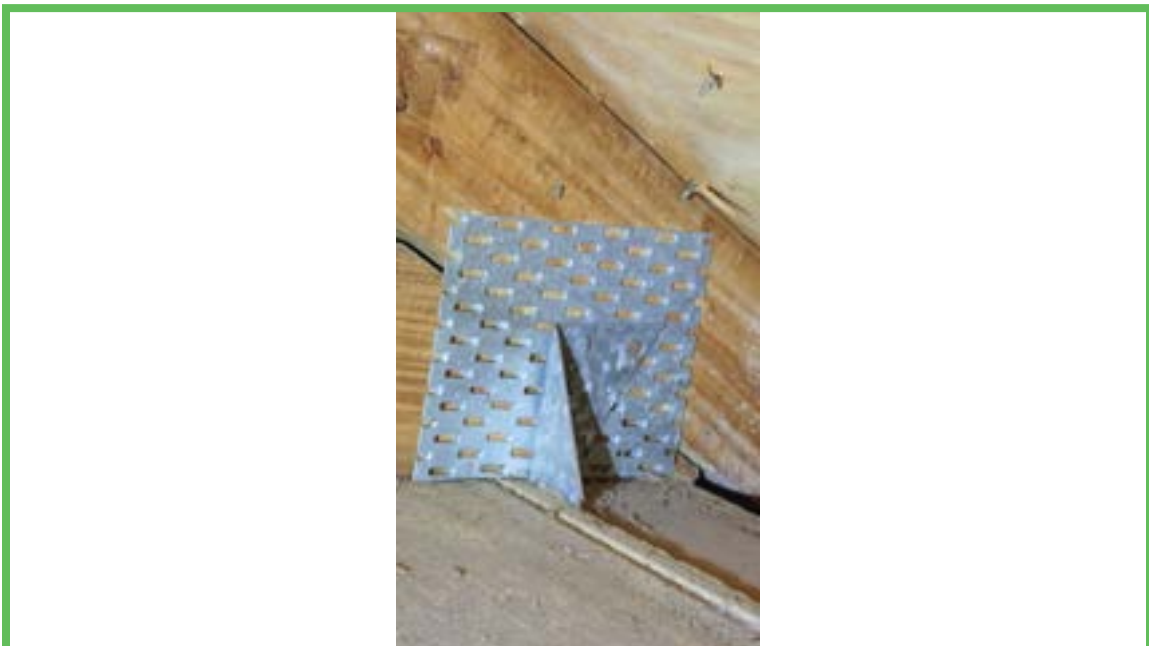
Roof to Wall Attachment

4. **Roof to Wall Attachment:** What is the **WEAKEST** roof to wall connection? (Do not include attachment of hip/valley jacks within 5 feet of the inside or outside corner of the roof in determination of WEAKEST type)

- A. Toe Nails
 - Truss/rafter anchored to top plate of wall using nails driven at an angle through the truss/rafter and attached to the top plate of the wall, or
 - Metal connectors that do not meet the minimal conditions or requirements of B, C, or D

Minimal conditions to qualify for categories B, C, or D. All visible metal connectors are:

- Secured to truss/rafter with a minimum of three (3) nails, **and**
- Attached to the wall top plate of the wall framing, or embedded in the bond beam, with less than a 1/2" gap from the blocking or truss/rafter **and** blocked no more than 1.5" of the truss/rafter, **and** free of visible severe corrosion.

- B. Clips
 - Metal connectors that do not wrap over the top of the truss/rafter, **or**
 - Metal connectors with a minimum of 1 strap that wraps over the top of the truss/rafter and does not meet the nail position requirements of C or D, but is secured with a minimum of 3 nails.

- C. Single Wraps
 - Metal connectors consisting of a single strap that wraps over the top of the truss/rafter and is secured with a minimum of 2 nails on the front side and a minimum of 1 nail on the opposing side.

- D. Double Wraps
 - Metal Connectors consisting of 2 separate straps that are attached to the wall frame, or embedded in the bond beam, on either side of the truss/rafter where each strap wraps over the top of the truss/rafter and is secured with a minimum of 2 nails on the front side, and a minimum of 1 nail on the opposing side, **or**

- Metal connectors consisting of a single strap that wraps over the top of the truss/rafter, is secured to the wall on both sides, and is secured to the top plate with a minimum of three nails on each side.

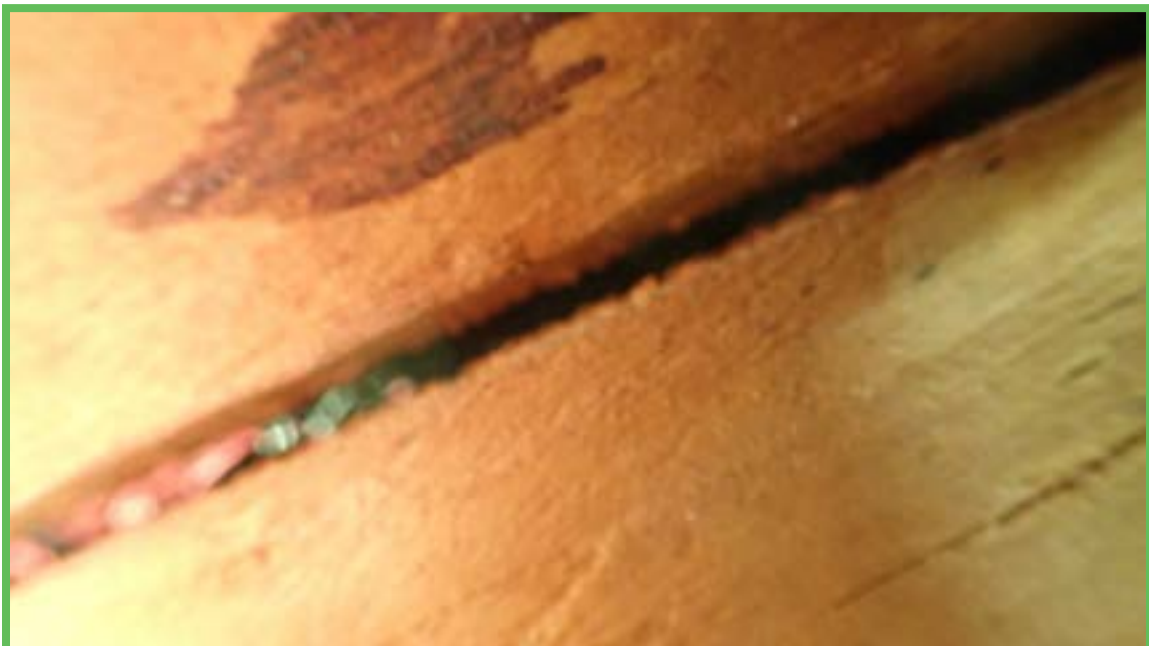
Secondary Water Resistance (SWR)

6. **Secondary Water Resistance (SWR):** (standard underlayments or hot-mopped felts do not qualify as an SWR)

- A. SWR (also called Sealed Roof Deck) Self-adhering polymer modified-bitumen roofing underlayment applied directly to the sheathing or foam adhesive SWR barrier (not foamed-on insulation) applied as a supplemental means to protect the dwelling from water intrusion in the event of roof covering loss.
- B. No SWR.
- C. Unknown or undetermined.
