# Uniform Mitigation Verification Inspection Form

Inspection Date: 04/01/2022		
<b>Owner Information</b>		
Owner Name: Gary Paiano		Contact Person:
Address: 1507 Kelliowd Ct		Home Phone:
City: Sun City Center	Zip: 33573	Work Phone:
County: Hillsborough		Cell Phone: 724-498-5297
Insurance Company:		Policy #:
Year of Home: 1994	# of Stories: 1	Email: garykosta@yahoo.com

Property Inspected:  
1507 Kelliwood Ct, Sun City Center, Florida 33573

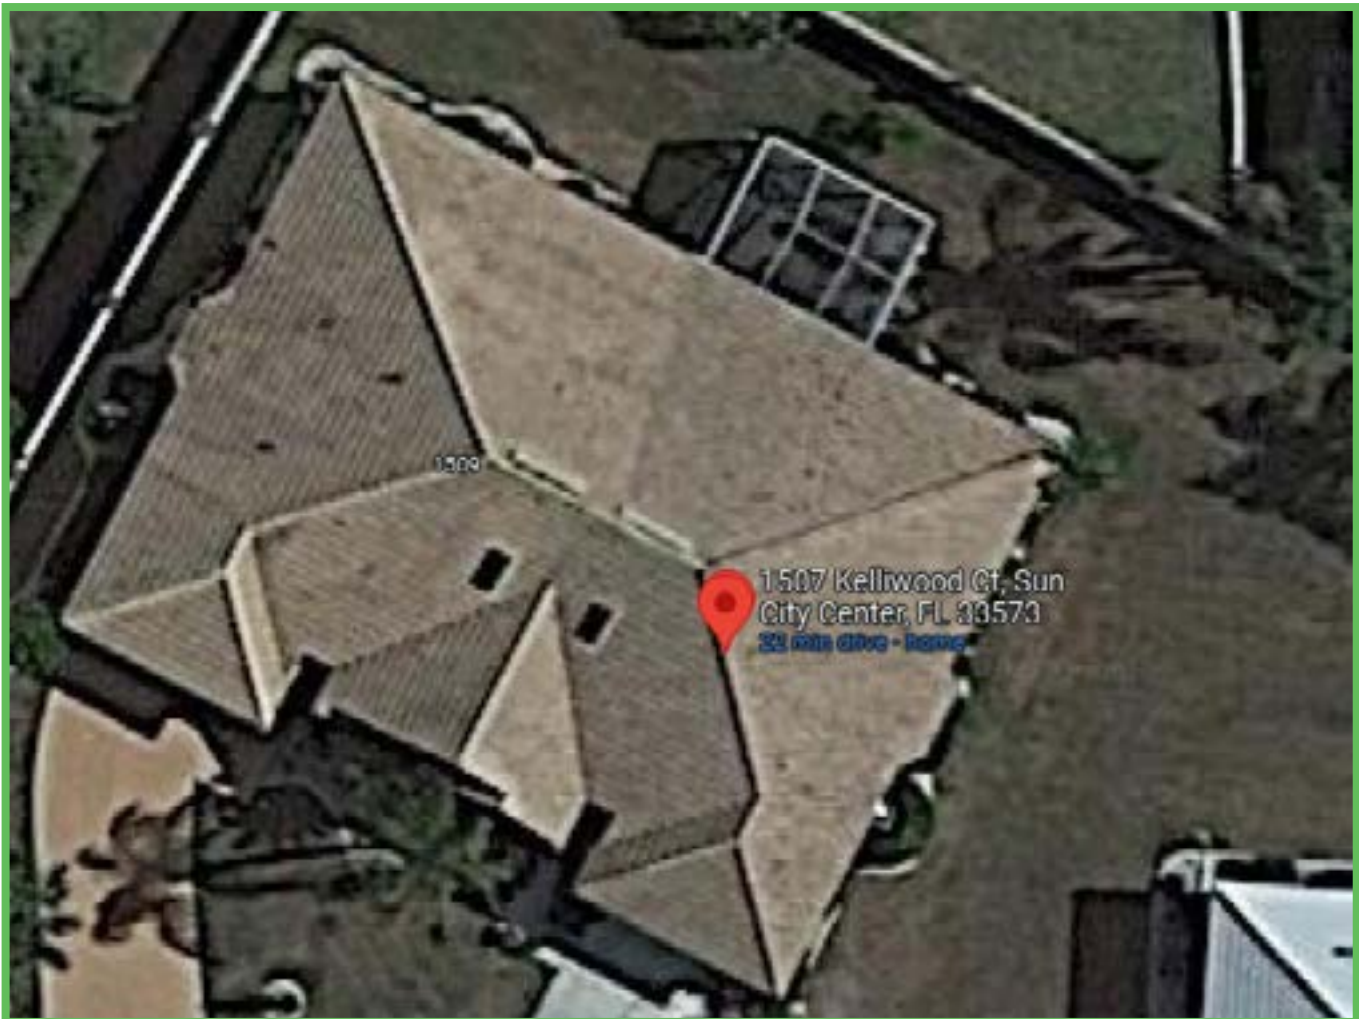
Aerial Photo

- A. Hip Roof Hip roof with no other roof shapes greater than 10% of the total roof system perimeter.  
Total length of non-hip features: 11 feet; Total roof system perimeter: 158 feet
- B. Flat Roof Roof on a building with 5 or more units where at least 90% of the main roof area has a roof slope of less than 2:12. Roof area with slope less than 2:12 \_\_\_\_\_ sq ft; Total roof area \_\_\_\_\_ sq ft
- C. Other Roof Any roof that does not qualify as either (A) or (B) above.

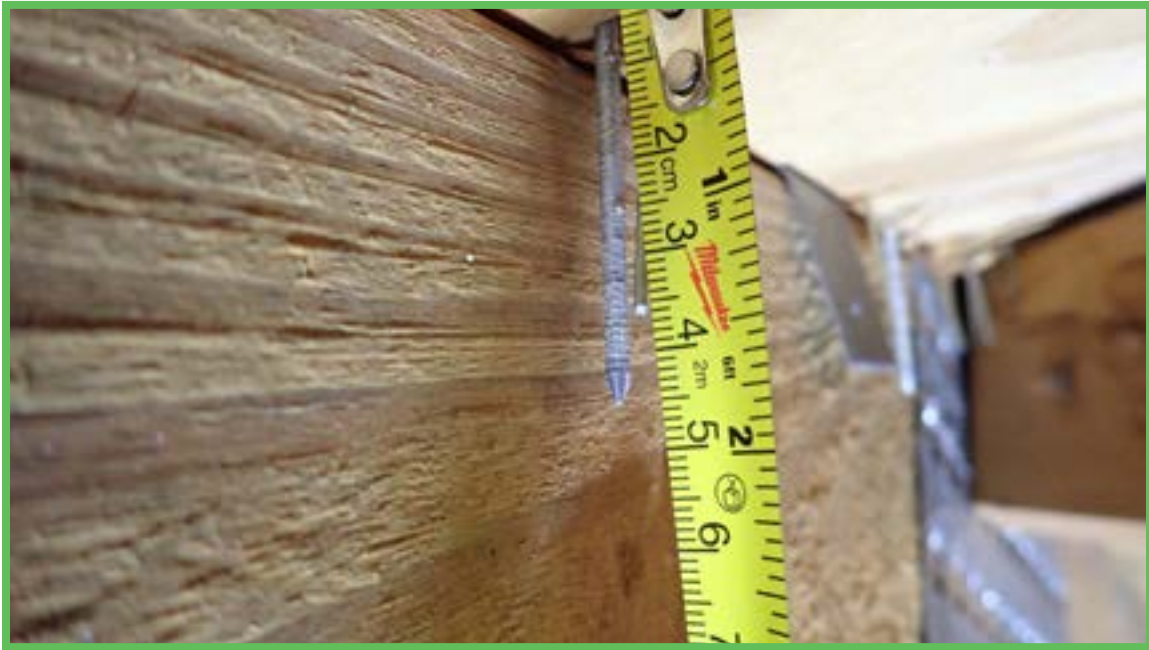
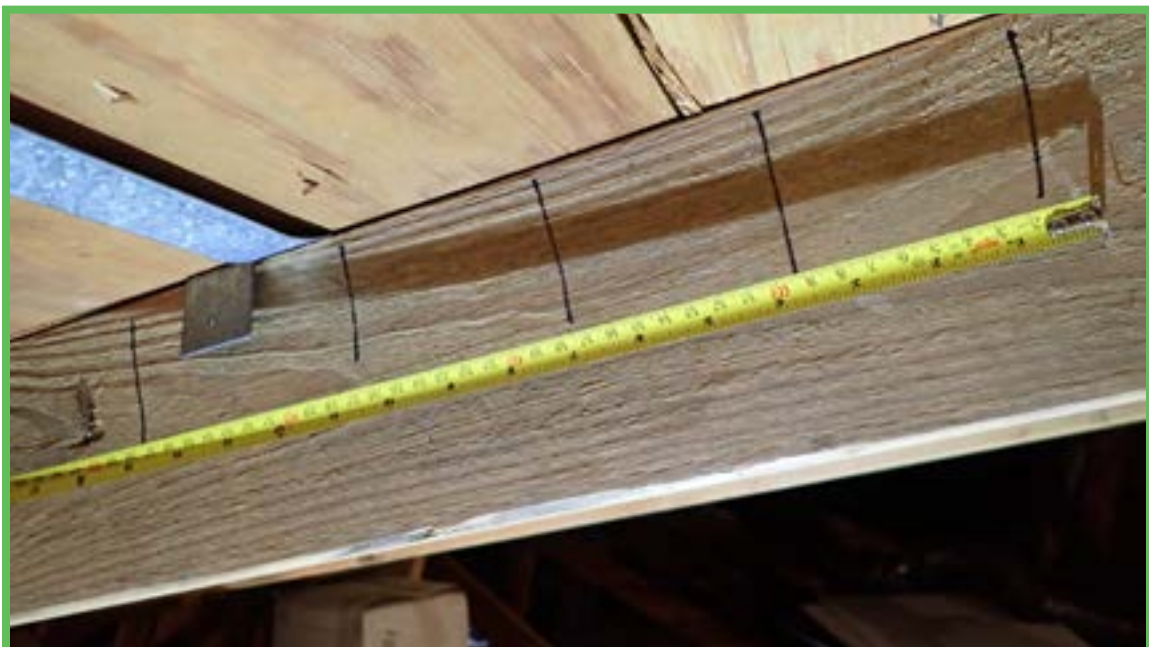
Roof Deck Attachment

- Roof Deck Attachment:** What is the weakest form of roof deck attachment? "
  - ""A. Plywood/Oriented strand board (OSB) roof sheathing attached to the roof truss/rafter (spaced a maximum of 24" inches o.c.) by staples or 6d nails spaced at 6" along the edge and 12" in the field. -OR- Batten decking supporting wood shakes or wood shingles. -OR- Any system of screws, nails, adhesives, other deck fastening system or truss/rafter spacing that has an equivalent mean uplift less than that required for Options B or C below.

- ""B. Plywood/OSB roof sheathing with a minimum thickness of 7/16" inch attached to the roof truss/rafter (spaced a maximum of 24" inches o.c.) by 8d common nails spaced a maximum of 12" inches in the field. -OR- Any system of screws, nails, adhesives, other deck fastening system or truss/rafter spacing that is shown to have an equivalent or greater resistance 8d nails spaced a maximum of 12 inches in the field or has a mean uplift resistance of at least 103 psf.

- ""C. Plywood/OSB roof sheathing with a minimum thickness of 7/16" inch attached to the roof truss/rafter (spaced a maximum of 24" inches o.c.) by 8d common nails spaced a maximum of 6" inches in the field. -OR- Dimensional lumber/Tongue & Groove decking with a minimum of 2 nails per board (or 1 nail per board if each board is equal to or less than 6 inches in width). -OR- Any system of screws, nails, adhesives, other deck fastening system or truss/rafter spacing that is shown to have an equivalent

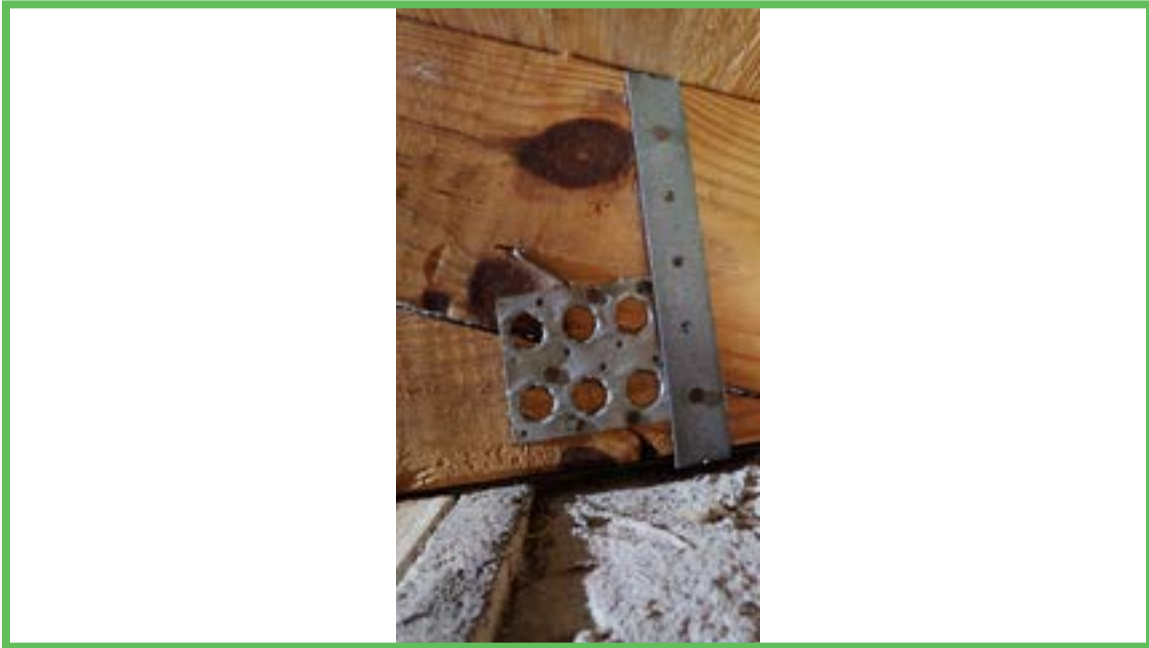
Roof to Wall Attachment

4. **Roof to Wall Attachment:** What is the **WEAKEST** roof to wall connection? (Do not include attachment of hip/valley jacks within 5 feet of the inside or outside corner of the roof in determination of WEAKEST type)

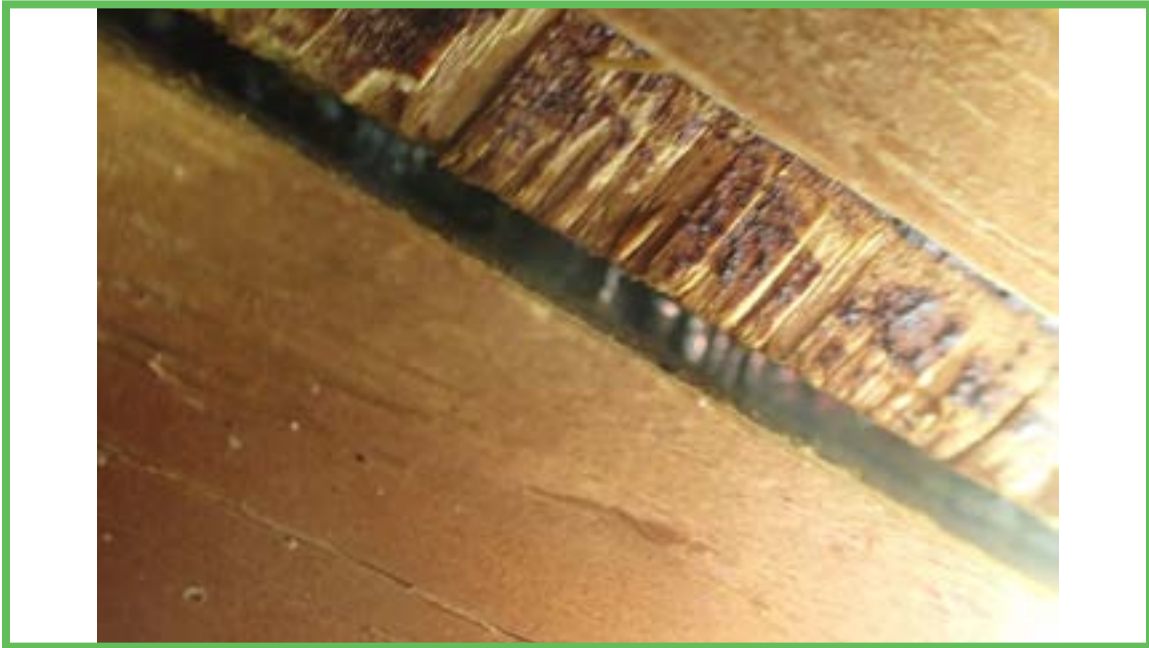
Secondary Water Resistance (SWR)

6. **Secondary Water Resistance (SWR):** (standard underlayments or hot-mopped felts do not qualify as an SWR)

- A. SWR (also called Sealed Roof Deck) Self-adhering polymer modified-bitumen roofing underlayment applied directly to the sheathing or foam adhesive SWR barrier (not foamed-on insulation) applied as a supplemental means to protect the dwelling from water intrusion in the event of roof covering loss.
- B. No SWR.
- C. Unknown or undetermined.
