Uniform Mitigation Verification Inspection Form

Inspection Date: 05/02/2022		
Owner Information		
Owner Name: Glenn Surkont		Contact Person:
Address: 1907 Sterling Glen Ct		Home Phone:
City: Sun City Center	Zip: 33573	Work Phone:
County: Hillborough		Cell Phone: 401-261-6907
Insurance Company:		Policy #:
Year of Home: 2004	# of Stories: 1	Email: glenden.s@gmail.com

Property Inspected:
1907 Sterling Glen Ct, Sun City Center, Florida 33573

Inspection Date: 5/2/2022

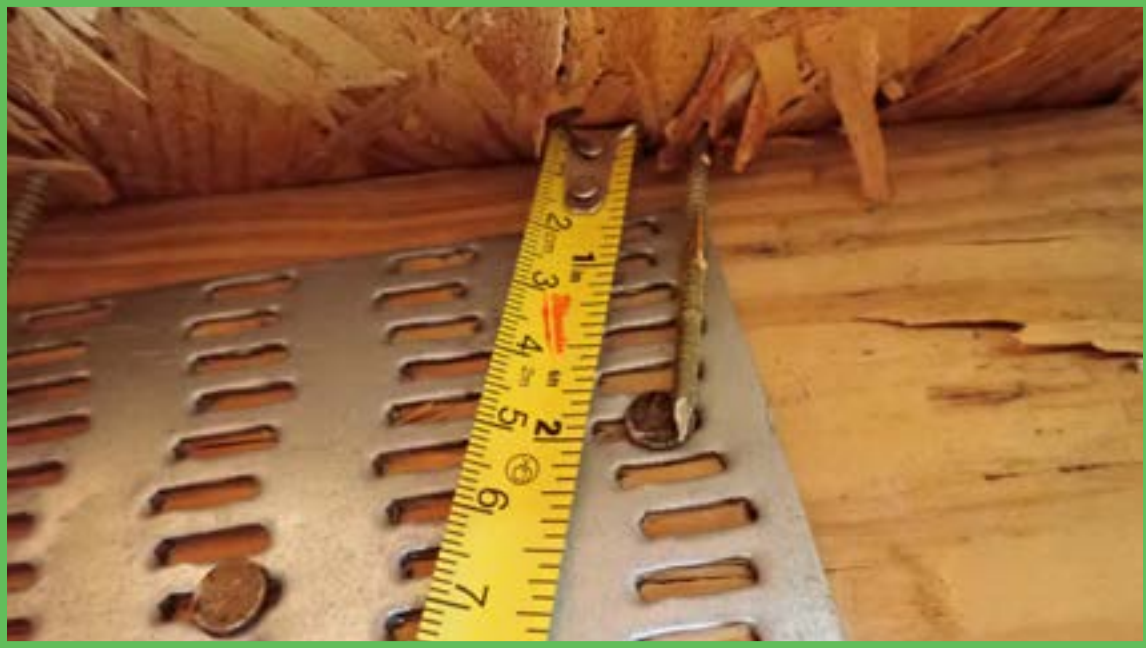
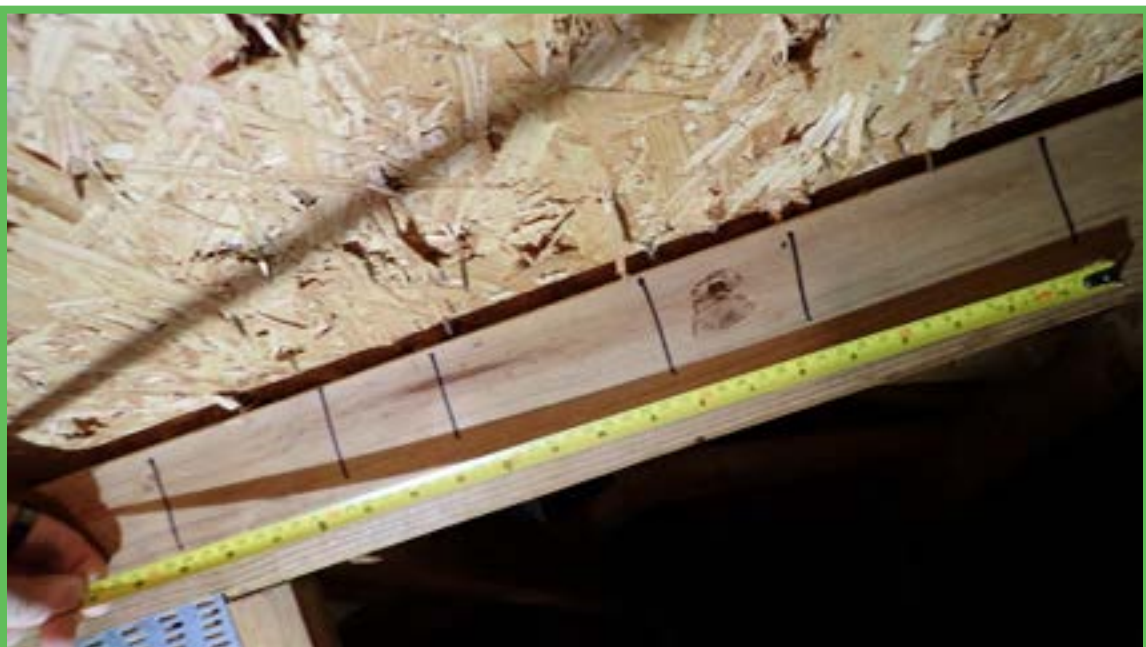
Roof Deck Attachment

- Roof Deck Attachment:** What is the weakest form of roof deck attachment? "
 - ""A. Plywood/Oriented strand board (OSB) roof sheathing attached to the roof truss/rafter (spaced a maximum of 24" inches o.c.) by staples or 6d nails spaced at 6" along the edge and 12" in the field. -OR- Batten decking supporting wood shakes or wood shingles. -OR- Any system of screws, nails, adhesives, other deck fastening system or truss/rafter spacing that has an equivalent mean uplift less than that required for Options B or C below.

- ""B. Plywood/OSB roof sheathing with a minimum thickness of 7/16" inch attached to the roof truss/rafter (spaced a maximum of 24" inches o.c.) by 8d common nails spaced a maximum of 12" inches in the field. -OR- Any system of screws, nails, adhesives, other deck fastening system or truss/rafter spacing that is shown to have an equivalent or greater resistance 8d nails spaced a maximum of 12 inches in the field or has a mean uplift resistance of at least 103 psf.

- ""C. Plywood/OSB roof sheathing with a minimum thickness of 7/16" inch attached to the roof truss/rafter (spaced a maximum of 24" inches o.c.) by 8d common nails spaced a maximum of 6" inches in the field. -OR- Dimensional lumber/Tongue & Groove decking with a minimum of 2 nails per board (or 1 nail per board if each board is equal to or less than 6 inches in width). -OR- Any system of screws, nails, adhesives, other deck fastening system or truss/rafter spacing that is shown to have an equivalent

or greater resistance than 8d common nails spaced a maximum of 6 inches in the field or has a mean uplift resistance of at least 182 psf.

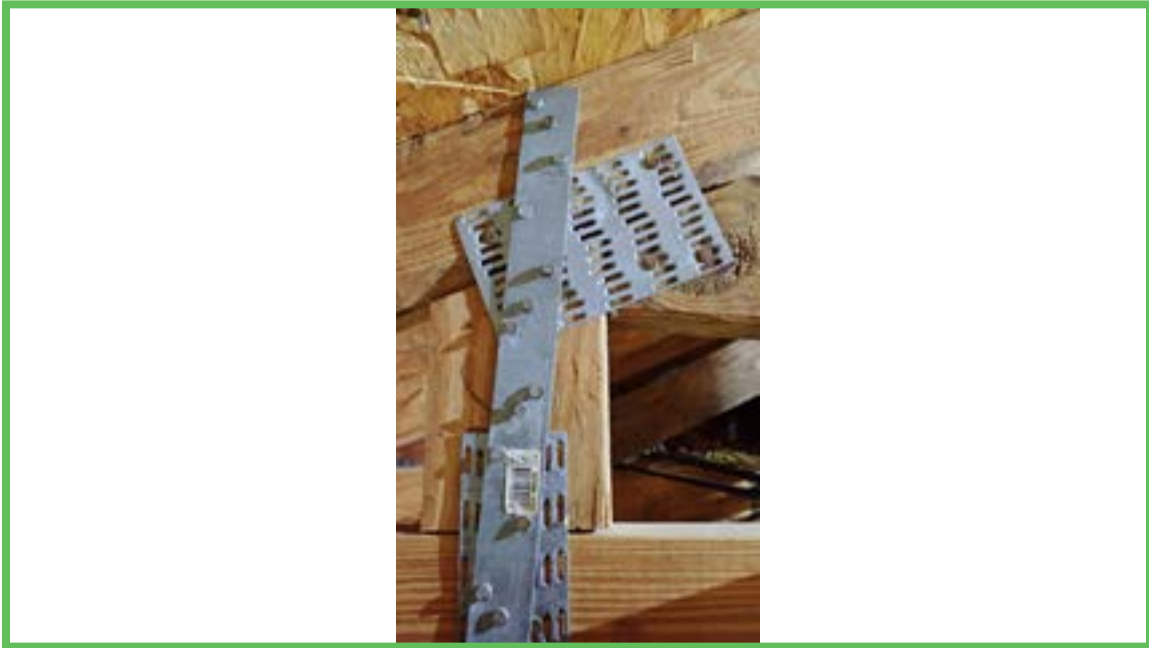
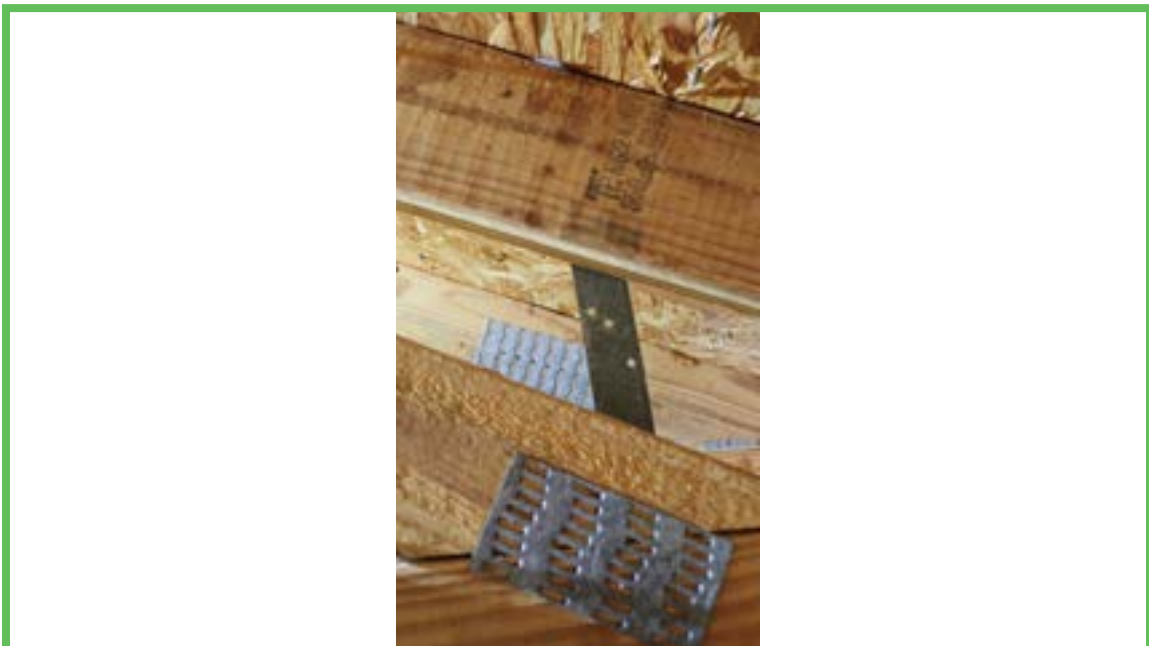
Roof to Wall Attachment

4. **Roof to Wall Attachment:** What is the **WEAKEST** roof to wall connection? (Do not include attachment of hip/valley jacks within 5 feet of the inside or outside corner of the roof in determination of WEAKEST type)

- A. Toe Nails
 - Truss/rafter anchored to top plate of wall using nails driven at an angle through the truss/rafter and attached to the top plate of the wall, or
 - Metal connectors that do not meet the minimal conditions or requirements of B, C, or D

Minimal conditions to qualify for categories B, C, or D. All visible metal connectors are:

- Secured to truss/rafter with a minimum of three (3) nails, **and**
- Attached to the wall top plate of the wall framing, or embedded in the bond beam, with less than a 1/2" gap from the blocking or truss/rafter **and** blocked no more than 1.5" of the truss/rafter, **and** free of visible severe corrosion.

- B. Clips
 - Metal connectors that do not wrap over the top of the truss/rafter, **or**
 - Metal connectors with a minimum of 1 strap that wraps over the top of the truss/rafter and does not meet the nail position requirements of C or D, but is secured with a minimum of 3 nails.

- C. Single Wraps
 - Metal connectors consisting of a single strap that wraps over the top of the truss/rafter and is secured with a minimum of 2 nails on the front side and a minimum of 1 nail on the opposing side.

- D. Double Wraps
 - Metal Connectors consisting of 2 separate straps that are attached to the wall frame, or embedded in the bond beam, on either side of the truss/rafter where each strap wraps over the top of the truss/rafter and is secured with a minimum of 2 nails on the front side, and a minimum of 1 nail on the opposing side, **or**

- Metal connectors consisting of a single strap that wraps over the top of the truss/rafter, is secured to the wall on both sides, and is secured to the top plate with a minimum of three nails on each side.

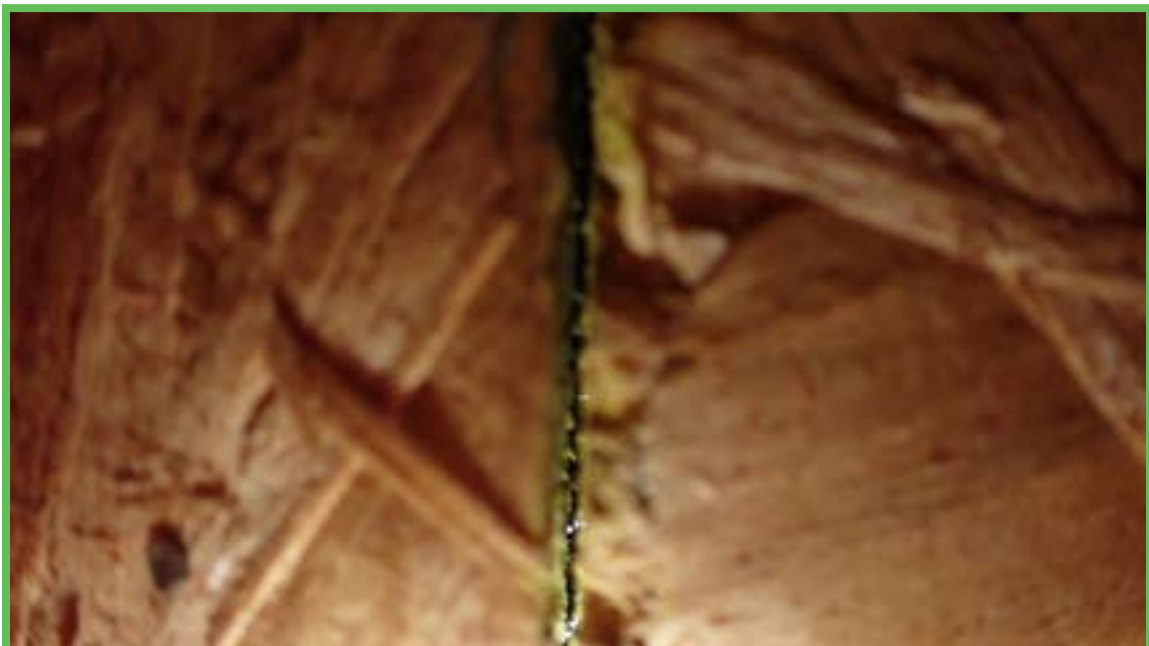
Secondary Water Resistance (SWR)

6. **Secondary Water Resistance (SWR):** (standard underlayments or hot-mopped felts do not qualify as an SWR)

- A. SWR (also called Sealed Roof Deck) Self-adhering polymer modified-bitumen roofing underlayment applied directly to the sheathing or foam adhesive SWR barrier (not foamed-on insulation) applied as a supplemental means to protect the dwelling from water intrusion in the event of roof covering loss.
- B. No SWR.
- C. Unknown or undetermined.

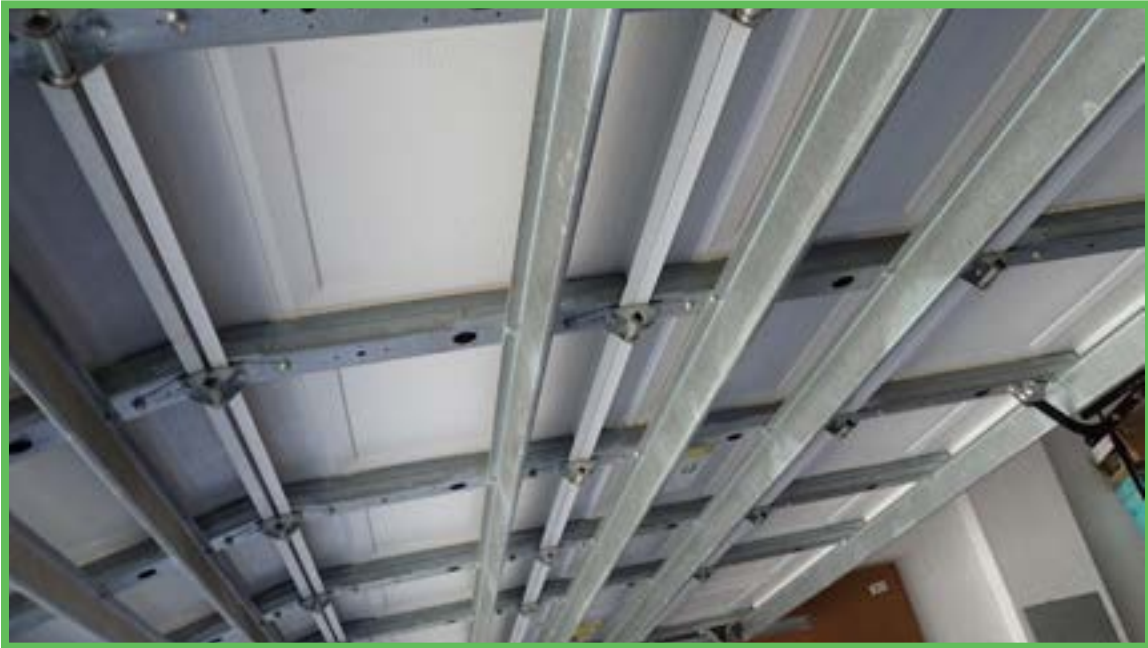
7. **Opening Protection:** What is the **weakest** form of wind borne debris protection installed on the structure? **First**, use the table to determine the weakest form of protection for each category of opening. **Second**, (a) check one answer below (A, B, C, N, or X) based upon the lowest protection level for ALL Glazed openings **and** (b) check the protection level for all Non-Glazed openings (.1, .2, or .3) as applicable.

Opening Protection Level Chart Place an "X" in each row to identify all forms of protection in use for each opening type. Check only one answer below (A thru X), based on the weakest form of protection (lowest row) for any of the Glazed openings and indicate the weakest form of protection (lowest row) for Non-Glazed openings.		Glazed Openings				Non-Glazed Openings	
		Windows or Entry Doors	Garage Doors	Skylights	Glass Block	Entry Doors	Garage Doors
N/A	Not Applicable- there are no openings of this type on the structure		X	X	X		
A	Verified cyclic pressure & large missile (9-lb for windows doors/4.5 lb for skylights)						
B	Verified cyclic pressure & large missile (4-8 lb for windows doors/2 lb for skylights)						
C	Verified plywood/OSB meeting Table 1609.1.2 of the FBC 2007						
D	Verified Non-Glazed Entry or Garage doors indicating compliance with ASTM E 330, ANSI/DASMA 108, or PA/TAS 202 for wind pressure resistance						X

N	Opening Protection products that appear to be A or B but are not verified						
	Other protective coverings that cannot be identified as A, B, or C						
X	No Windborne Debris Protection	X				X
