Wind Mitigation Report

2118 15th Ave E

7/7/2022

Uniform Mitigation Verification Inspection Form

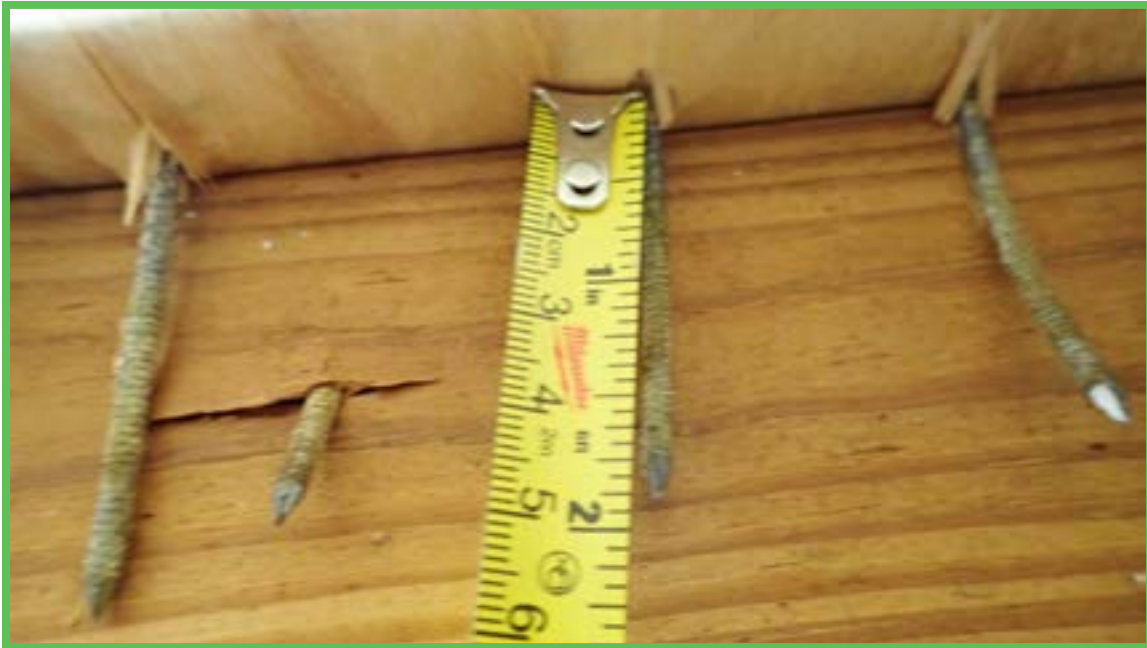
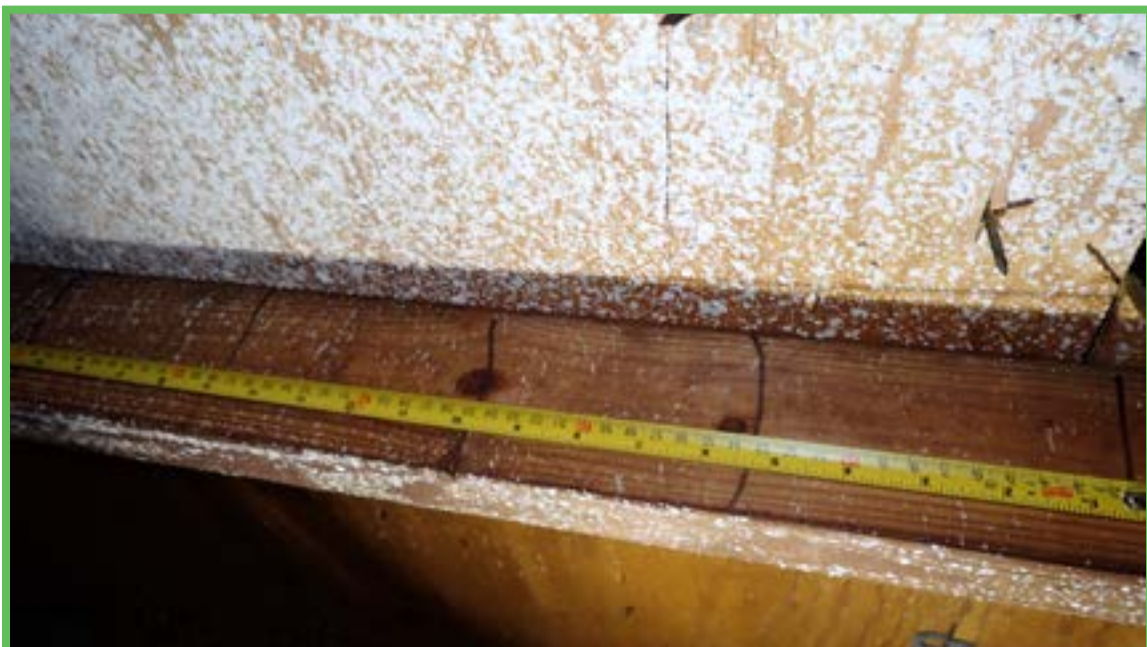
Roof Deck Attachment

- "A. All roof coverings listed above meet the FBC with a FBC or Miami-Dade Product Approval listing current at time of installation OR have a roofing permit application date on or after 3/1/02 OR the roof is original and built in 2004 or later.
 - "B. All roof coverings have a Miami-Dade Product Approval listing current at time of installation OR (for the HVHZ only) a roofing permit application after 9/1/1994 and before 3/1/2002 OR the roof is original and built in 1997 or later.
 - "C. One or more roof coverings do not meet the requirements of Answer "A" or "B".
 - "D. No roof coverings meet the requirements of Answer "A" or "B".
- Roof Deck Attachment:** What is the weakest form of roof deck attachment? "

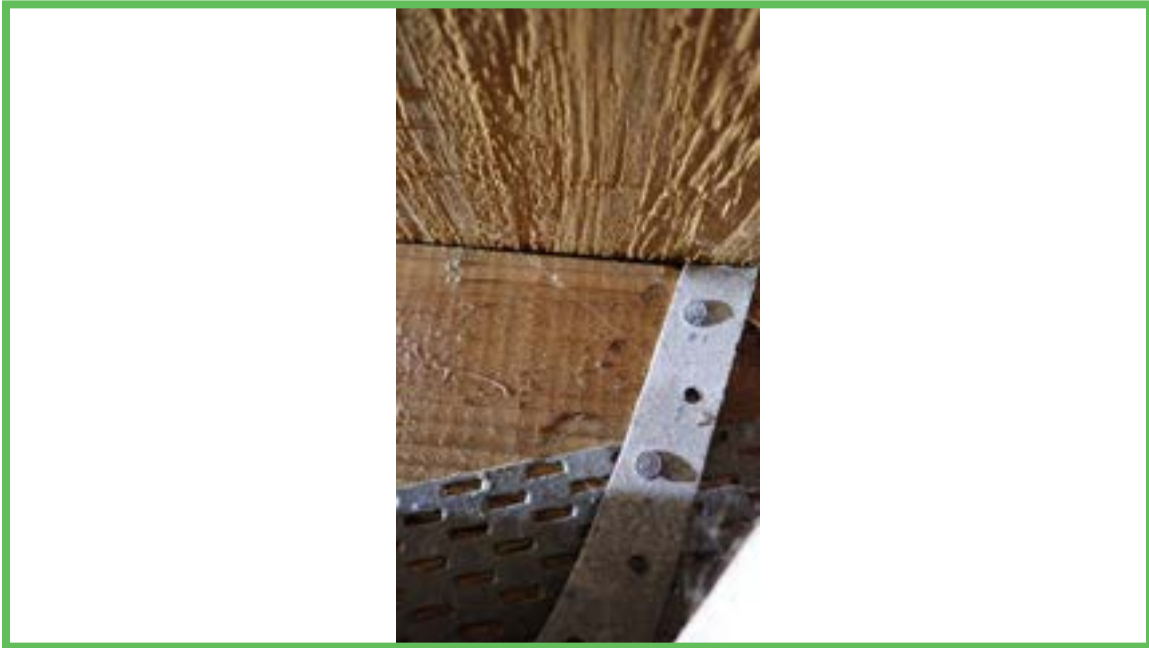
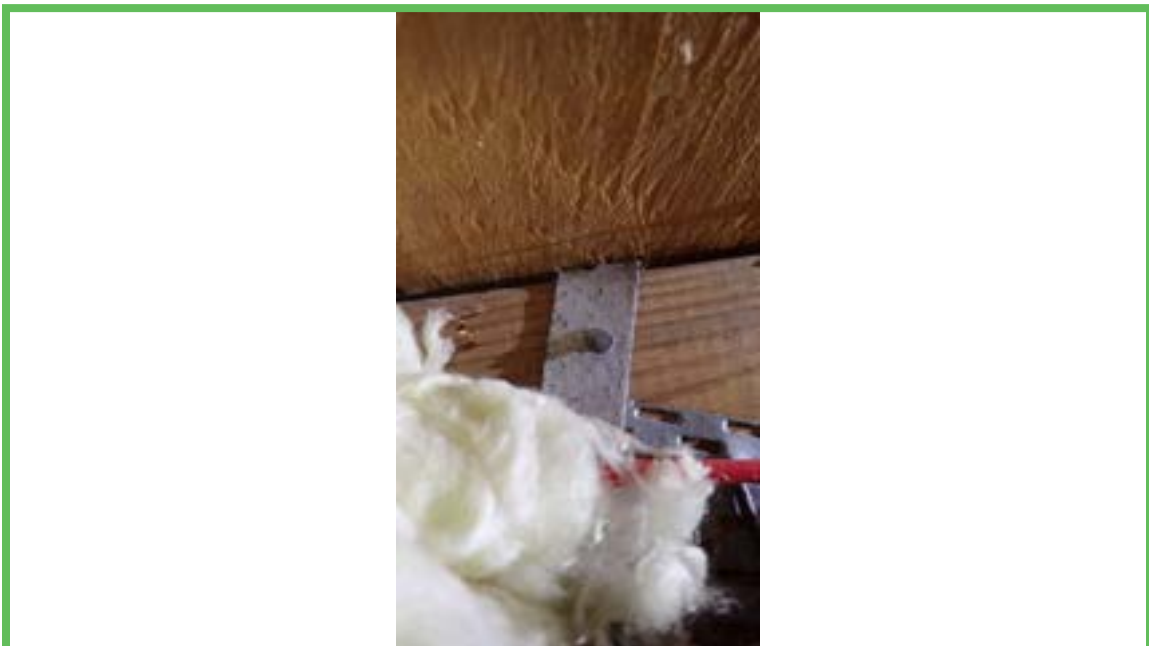
Roof to Wall Attachment

4. **Roof to Wall Attachment:** What is the **WEAKEST** roof to wall connection? (Do not include attachment of hip/valley jacks within 5 feet of the inside or outside corner of the roof in determination of WEAKEST type)
