Wind Mitigation Report

5915 Willow Bridge Loop

Uniform Mitigation Verification Inspection Form

Property Inspected:
5915 Willow Bridge Loop, Ellenton, Florida 34222

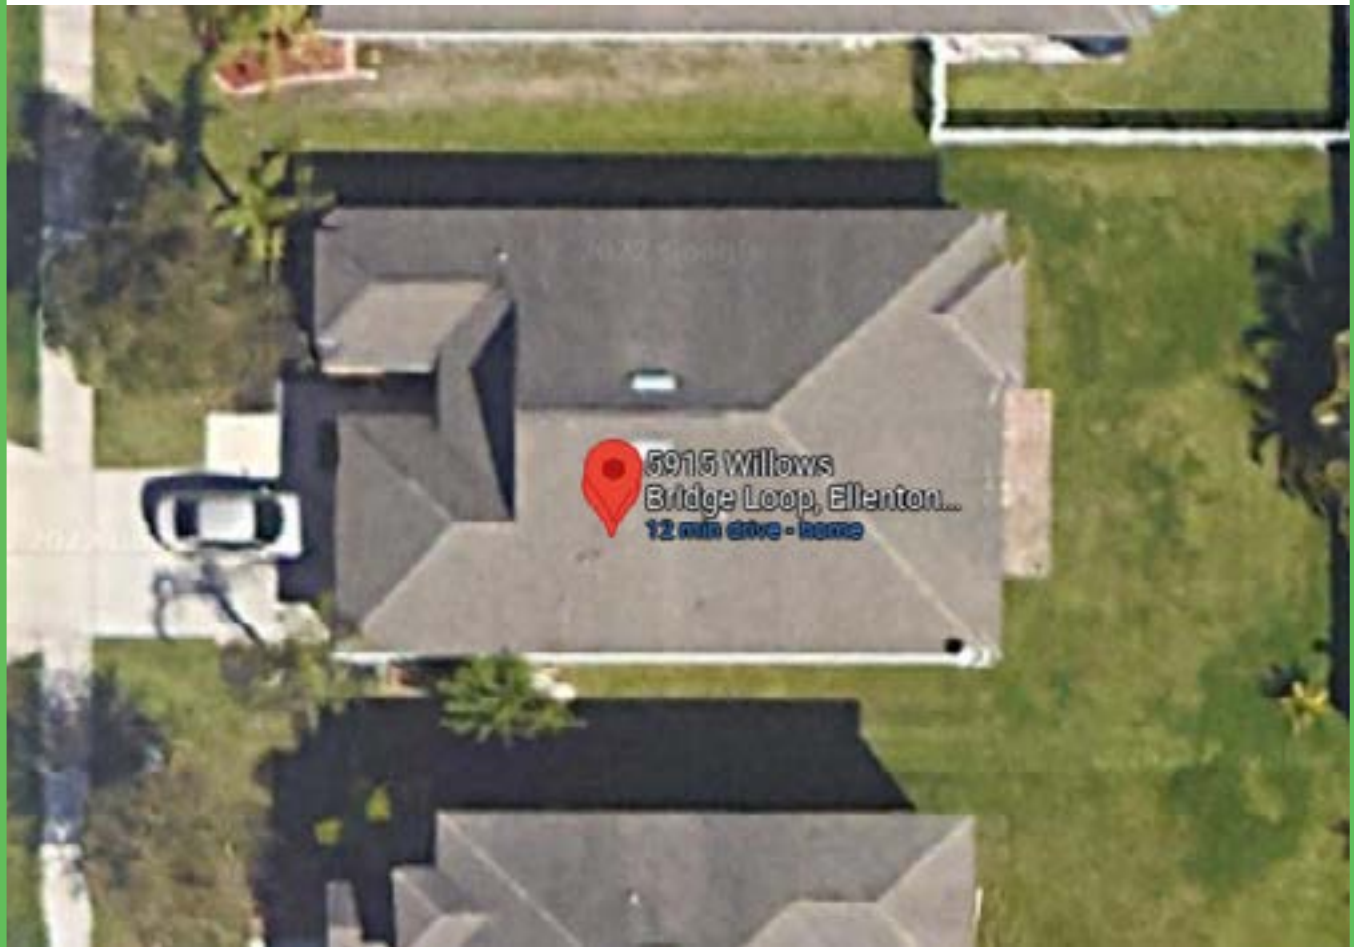
Aerial Photo

- A. Hip Roof Hip roof with no other roof shapes greater than 10% of the total roof system perimeter.
Total length of non-hip features: 18 feet; Total roof system perimeter: 240 feet
- B. Flat Roof Roof on a building with 5 or more units where at least 90% of the main roof area has a roof slope of less than 2:12. Roof area with slope less than 2:12 _____ sq ft; Total roof area _____ sq ft
- C. Other Roof Any roof that does not qualify as either (A) or (B) above.
