# Wind Mitigation Report

Loretta Ottenberg  
549 Boundary Blvd  
1/23/2023

### Uniform Mitigation Verification Inspection Form

Property Inspected:  
549 Boundary Blvd, Rotonda West, Florida 33947

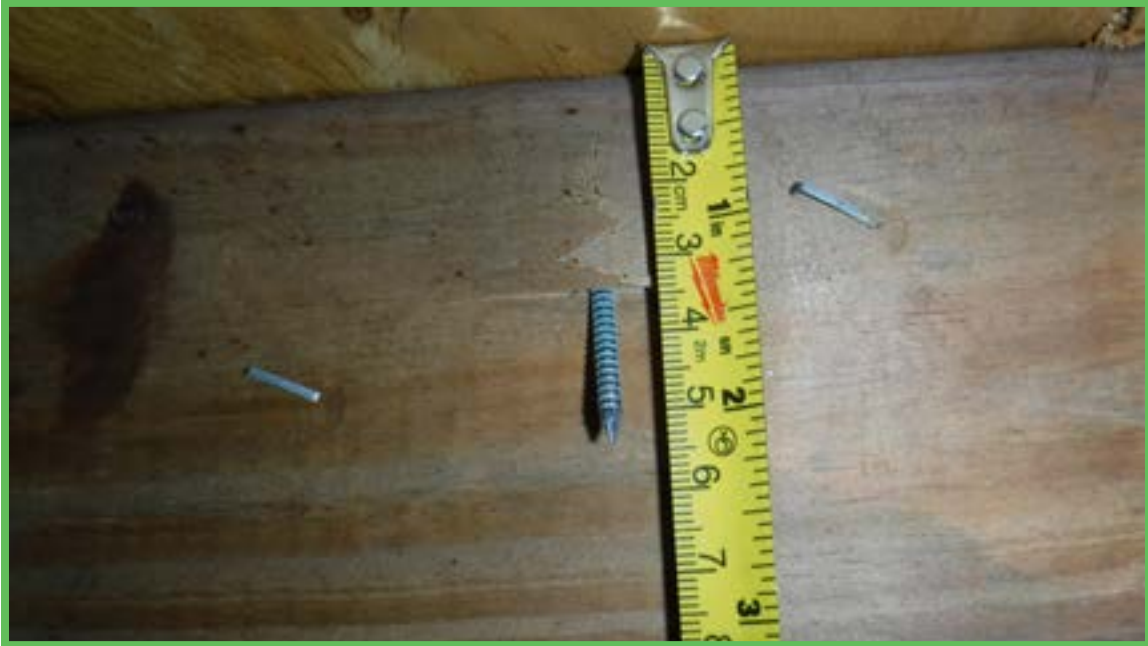
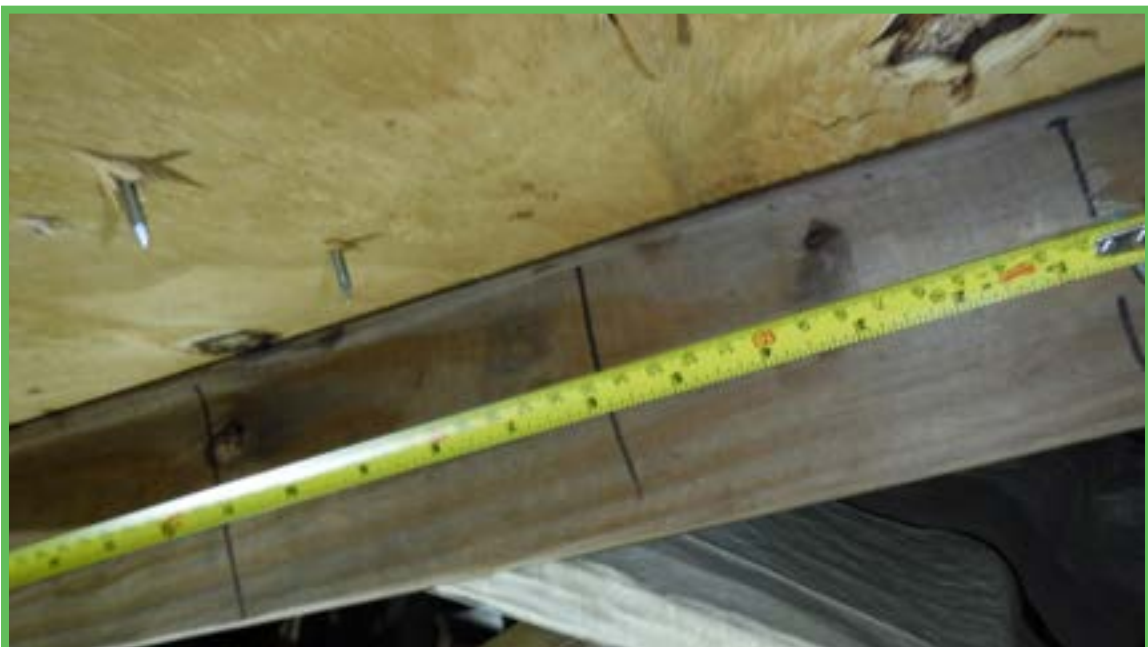
Roof Deck Attachment

- "A. All roof coverings listed above meet the FBC with a FBC or Miami-Dade Product Approval listing current at time of installation OR have a roofing permit application date on or after 3/1/02 OR the roof is original and built in 2004 or later.
  - "B. All roof coverings have a Miami-Dade Product Approval listing current at time of installation OR (for the HVHZ only) a roofing permit application after 9/1/1994 and before 3/1/2002 OR the roof is original and built in 1997 or later.
  - "C. One or more roof coverings do not meet the requirements of Answer "A" or "B".
  - "D. No roof coverings meet the requirements of Answer "A" or "B".
- Roof Deck Attachment:** What is the weakest form of roof deck attachment? "

- "A. Plywood/Oriented strand board (OSB) roof sheathing attached to the roof truss/rafter (spaced a maximum of 24" inches o.c.) by staples or 6d nails spaced at 6" along the edge and 12" in the field. -OR- Batten decking supporting wood shakes or wood shingles. -OR- Any system of screws, nails, adhesives, other deck fastening system or truss/rafter spacing that has an equivalent mean uplift less than that required for Options B or C below.

- "B. Plywood/OSB roof sheathing with a minimum thickness of 7/16" inch attached to the roof truss/rafter (spaced a maximum of 24" inches o.c.) by 8d common nails spaced a maximum of 12" inches in the field. -OR- Any system of screws, nails, adhesives, other deck fastening system or truss/rafter spacing that is shown to have an equivalent or greater resistance 8d nails spaced a maximum of 12 inches in the field or has a mean uplift resistance of at least 103 psf.

- "C. Plywood/OSB roof sheathing with a minimum thickness of 7/16" inch attached to the roof truss/rafter (spaced a maximum of 24" inches o.c.) by 8d common nails spaced a maximum of 6" inches in the field. -OR- Dimensional lumber/Tongue & Groove decking with a minimum of 2 nails per board (or 1 nail per board if each board is equal to or less than 6 inches in width). -OR- Any system \_\_\_\_\_ews, nails, adhesives, other deck fastening system or truss/rafter spacing that is shown to have an equivalent

or greater resistance than 8d common nails spaced a maximum of 6 inches in the field or has a mean uplift resistance of at least 182 psf.

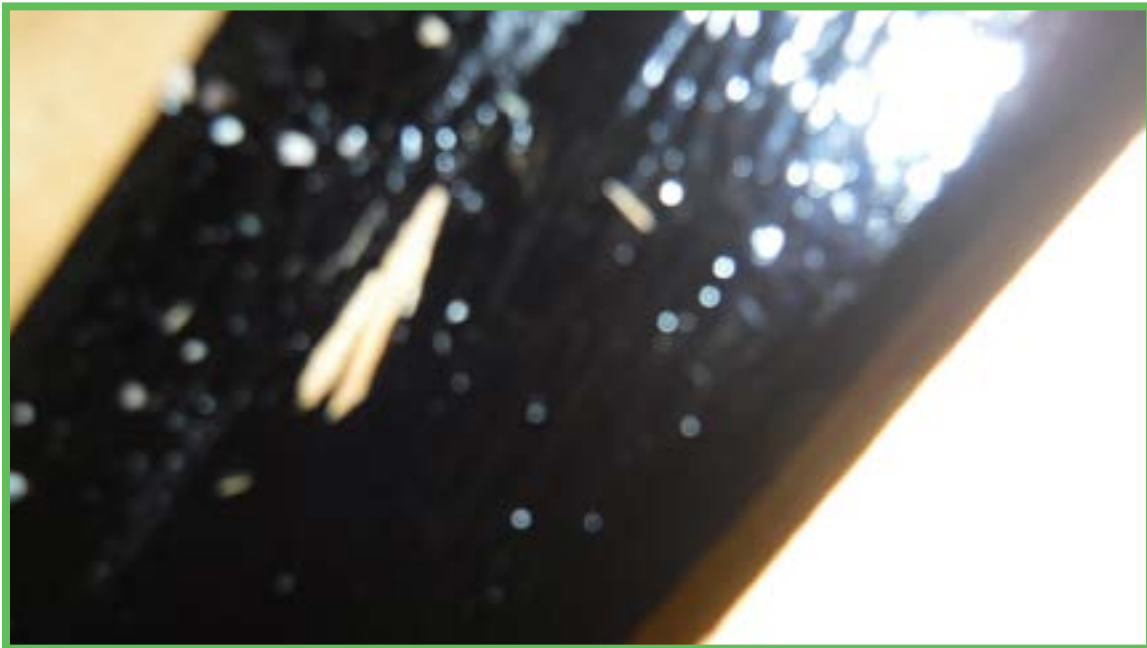
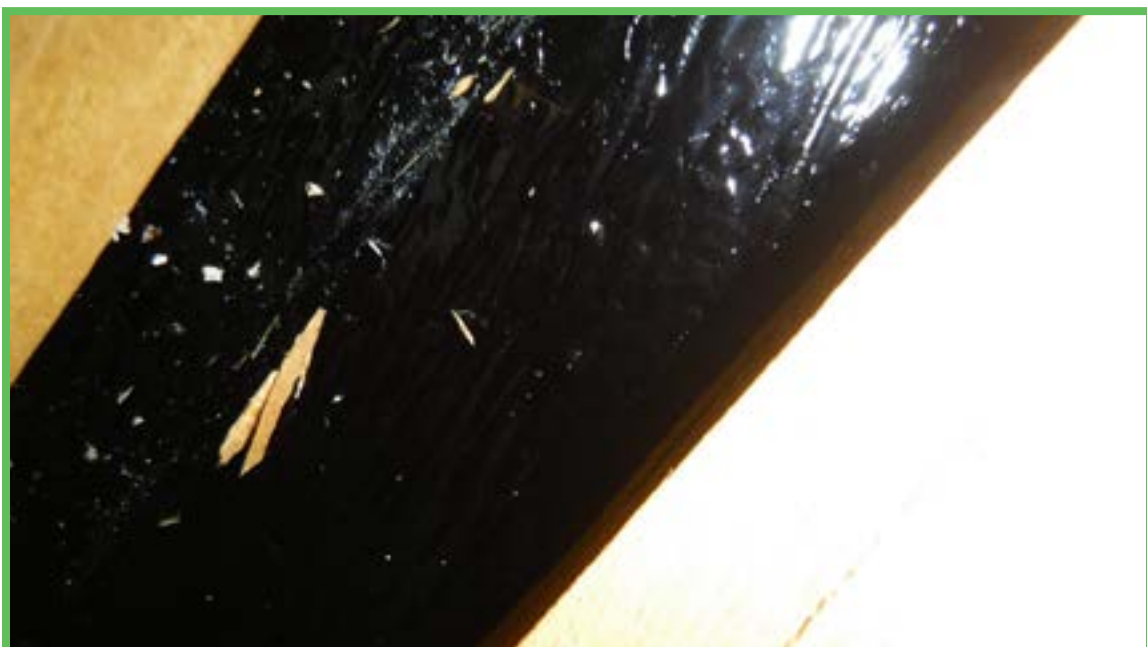
Secondary Water Resistance (SWR)

6. **Secondary Water Resistance (SWR):** (standard underlayments or hot-mopped felts do not qualify as an SWR)

- A. SWR (also called Sealed Roof Deck) Self-adhering polymer modified-bitumen roofing underlayment applied directly to the sheathing or foam adhesive SWR barrier (not foamed-on insulation) applied as a supplemental means to protect the dwelling from water intrusion in the event of roof covering loss.
- B. No SWR.
- C. Unknown or undetermined.

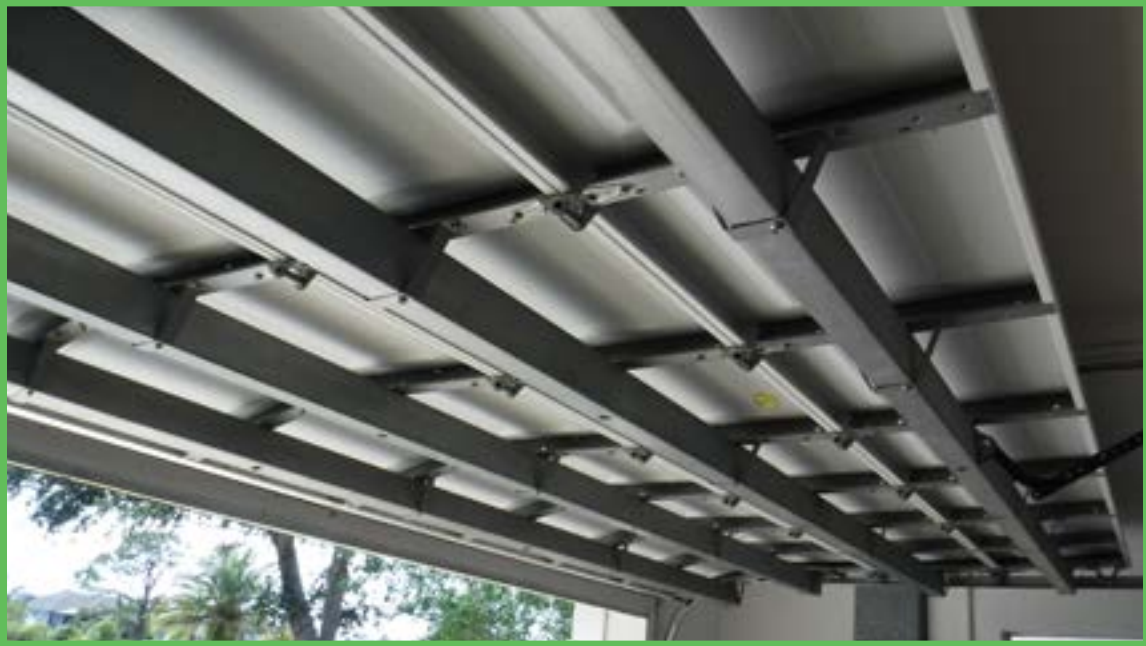
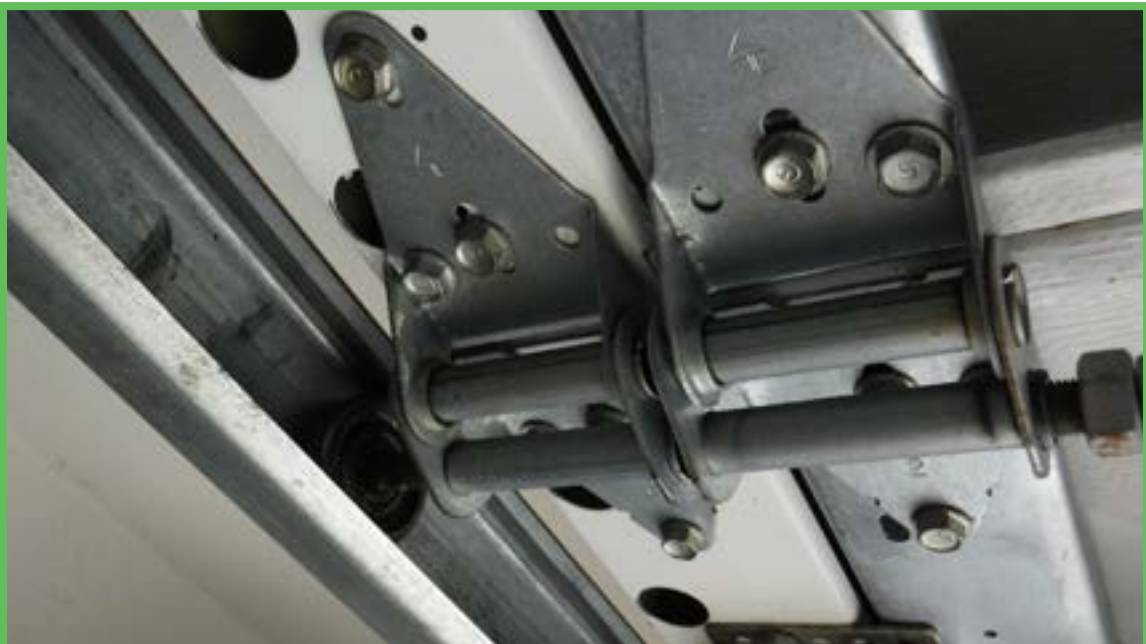
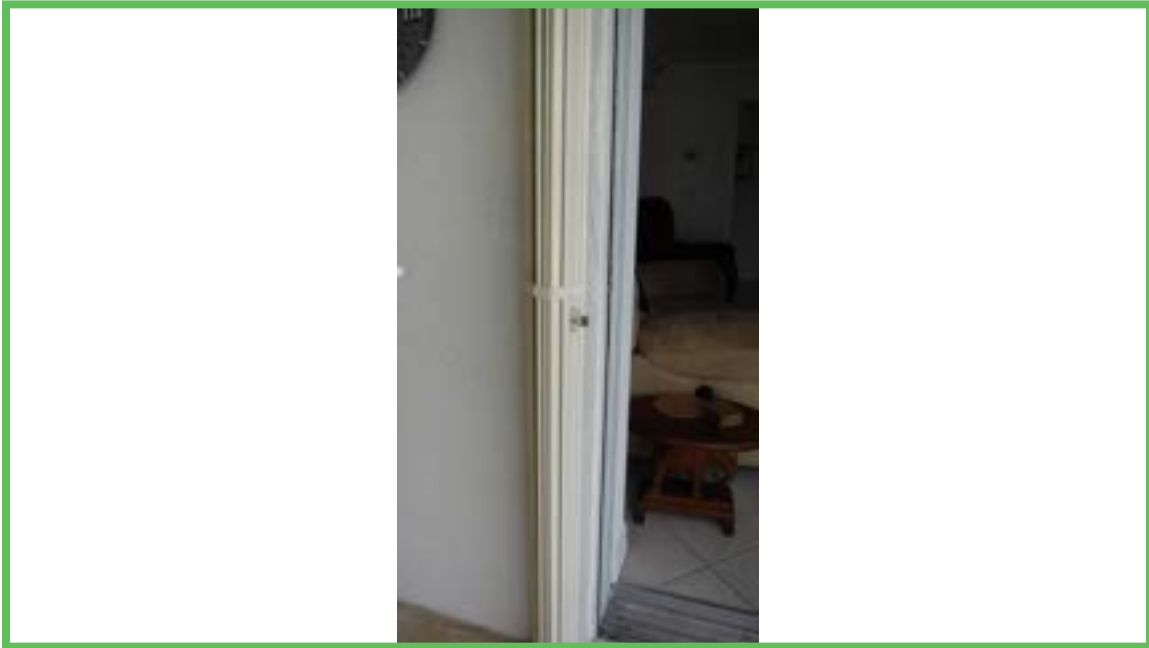
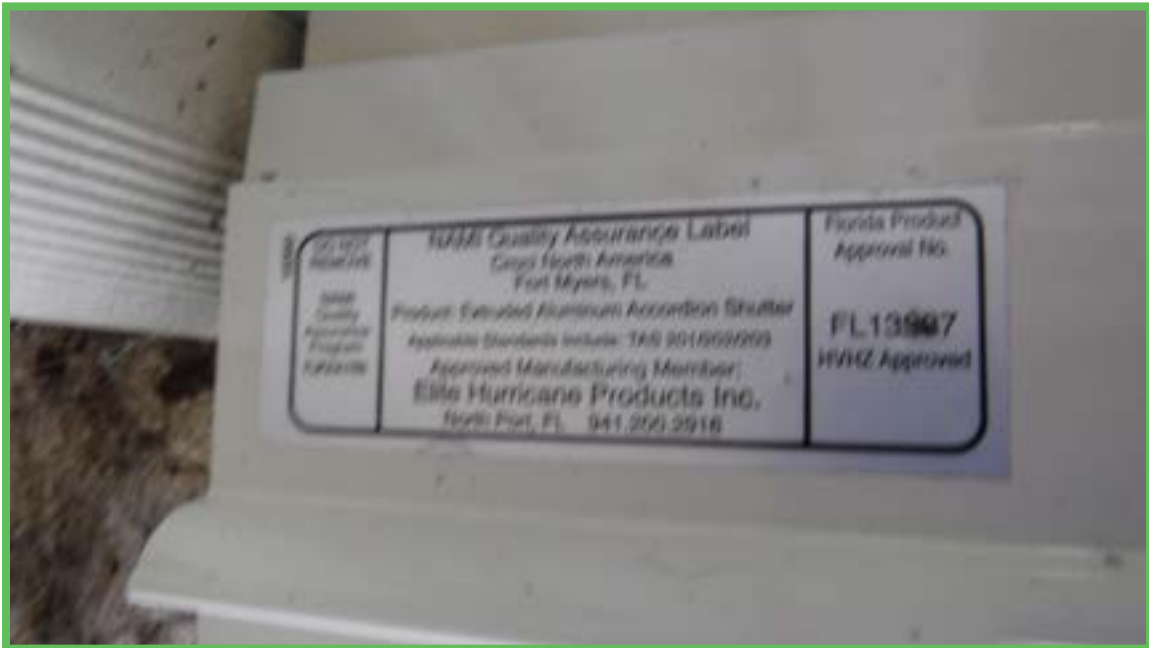
7. **Opening Protection:** What is the **weakest** form of wind borne debris protection installed on the structure? **First**, use the table to determine the weakest form of protection for each category of opening. **Second**, (a) check one answer below (A, B, C, N, or X) based upon the lowest protection level for ALL Glazed openings **and** (b) check the protection level for all Non-Glazed openings (.1, .2, or .3) as applicable.

Opening Protection Level Chart Place an "X" in each row to identify all forms of protection in use for each opening type. Check only one answer below (A thru X), based on the weakest form of protection (lowest row) for any of the Glazed openings and indicate the weakest form of protection (lowest row) for Non-Glazed openings.		Glazed Openings				Non-Glazed Openings	
		Windows or Entry Doors	Garage Doors	Skylights	Glass Block	Entry Doors	Garage Doors
N/A	Not Applicable- there are no openings of this type on the structure	<input type="checkbox"/>	<input checked="" type="checkbox"/>	<input checked="" type="checkbox"/>	<input checked="" type="checkbox"/>	<input type="checkbox"/>	<input type="checkbox"/>
A	Verified cyclic pressure & large missile (9-lb for windows doors/4.5 lb for skylights)	<input checked="" type="checkbox"/>	<input type="checkbox"/>	<input type="checkbox"/>	<input type="checkbox"/>	<input type="checkbox"/>	<input checked="" type="checkbox"/>

- A. Exterior Openings Cyclic Pressure and 9-lb Large Missile (4.5 lb for skylights only)** All Glazed openings are protected at a minimum, with impact resistant coverings or products listed as wind borne debris protection devices in the product approval system of the State of Florida or Miami-Dade County and meet the requirements of one of the following for "Cyclic Pressure and Large Missile Impact" (Level A in the table above).
