# PROPERTY INSPECTION REPORT

1521 Music Lane  
Inspection Prepared For: Shawna Wilkins  
Agent

Date of Inspection 4/21/2026  
Year Built 2025 Size 1464

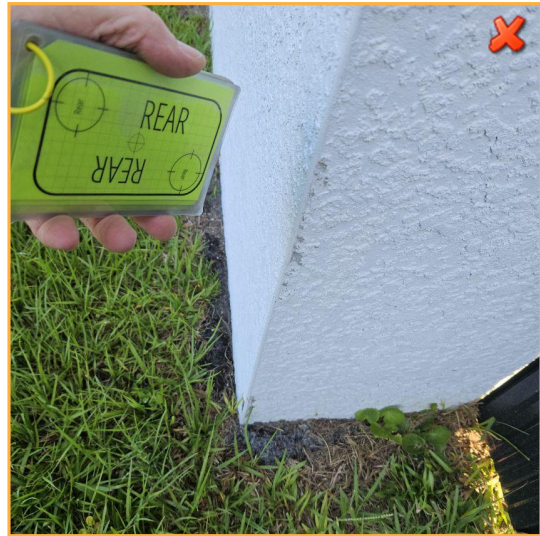
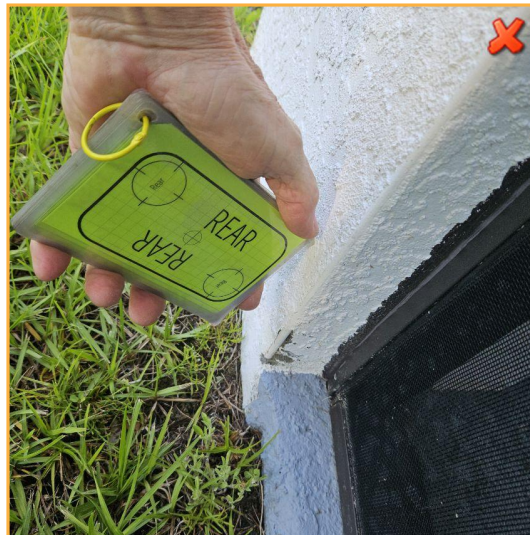
Rear wall

1.1. Walls in the rear of the home exhibited minor damage or deterioration at the time of the inspection.

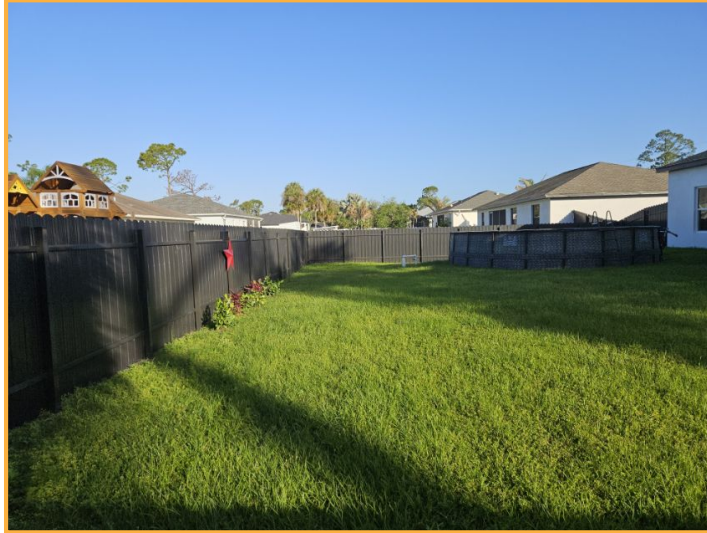
1.1. The building site was moderately sloped with banks.

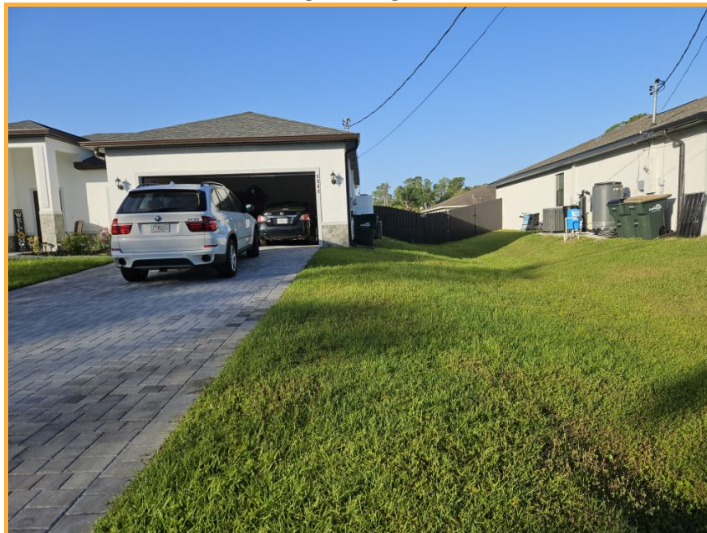
2.1. At the time of the inspection, the Inspector observed no deficiencies in the condition of the exterior grading.

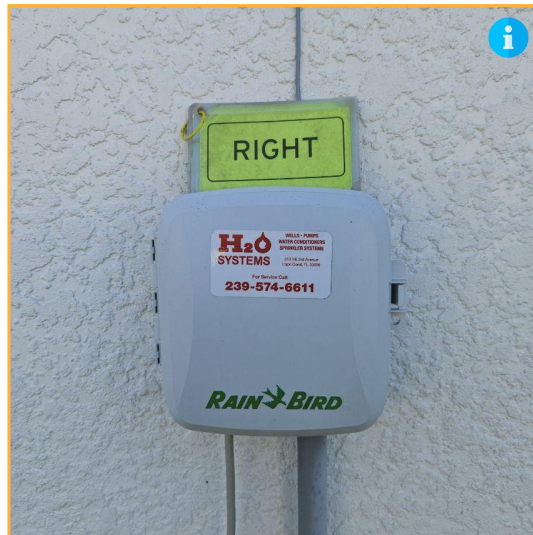
4.1. During the inspection it was observed that an irrigation system is installed and responded to basic testing at the time of the inspection. No functional issues were noted. Recommendation: Continue normal use and routine maintenance as needed.

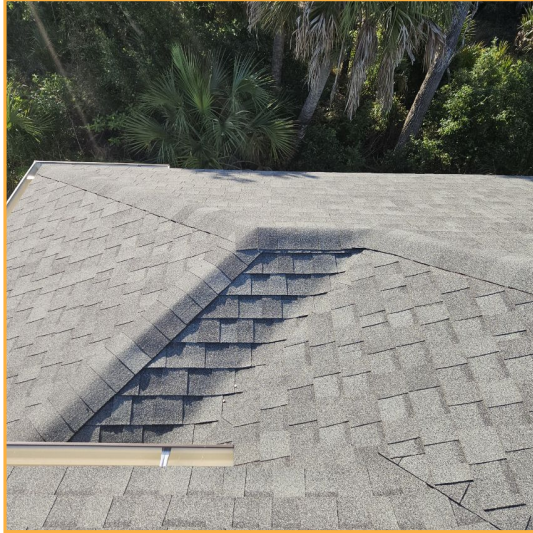
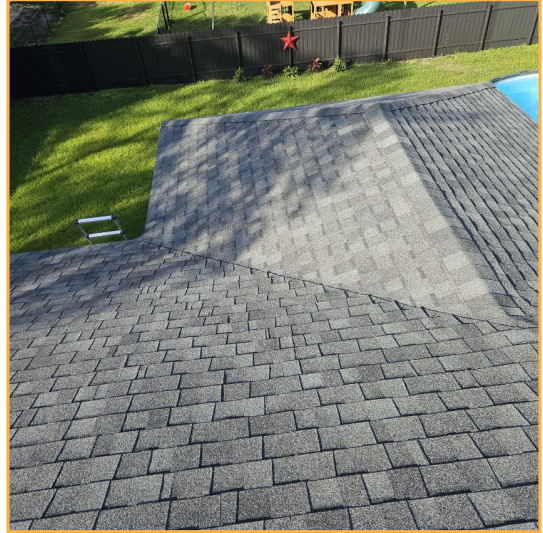
1.1. The Inspector observed no deficiencies in the condition of the shingles, flashing and vents.

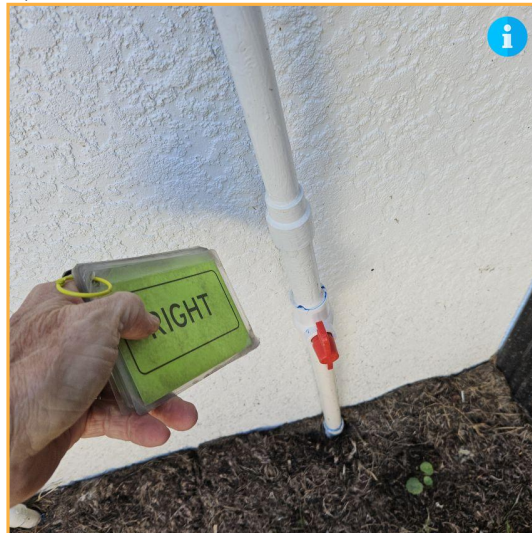
2.2. At the time of the inspection, the Inspector observed no deficiencies in the condition of the main water supply shut-off valve. It was not operated but was visually inspected.

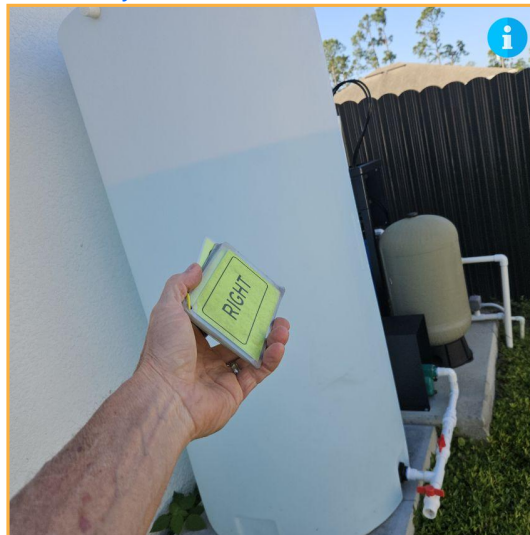
3.1. During the inspection it was observed that the home was equipped with a water softening system. Inspection of water treatment and softening systems is beyond the scope of a general home inspection. Recommendation: Have the system evaluated and serviced by a qualified contractor, and request instruction on its proper operation.

3.2. The home was outfitted with a water filtration system. The proper installation and use of a water filtration system is beyond the scope of a standard home inspection. Recommend before the end of your inspection objection deadline you have a qualified contractor evaluate the system and instruct you on the operation of the system.

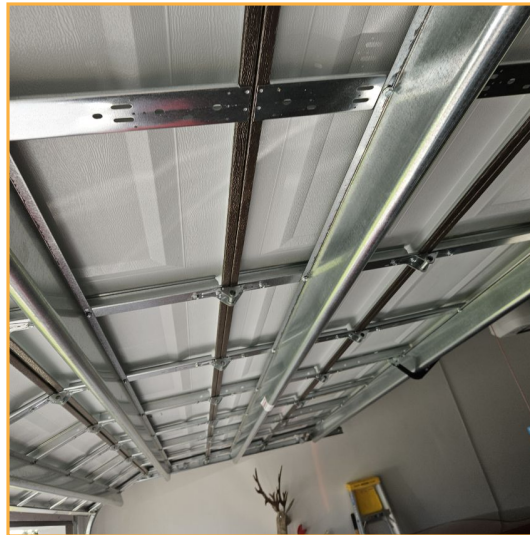
1.1. At the time of the inspection, the Inspector observed no deficiencies in the condition of the overhead vehicle doors.

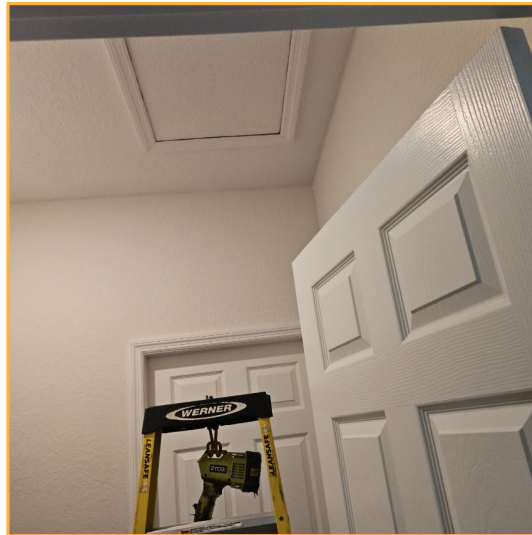
2.2. The attic space lacked adequate headroom for complete access and a limited inspection was performed from the areas accessible. Defective conditions may exist in the attic that were not readily observable or accessible.

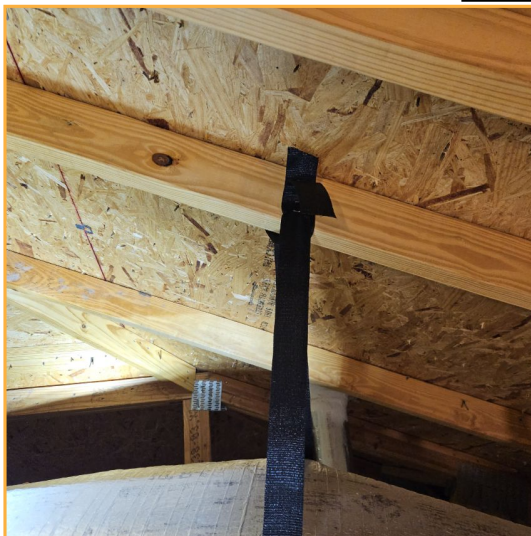
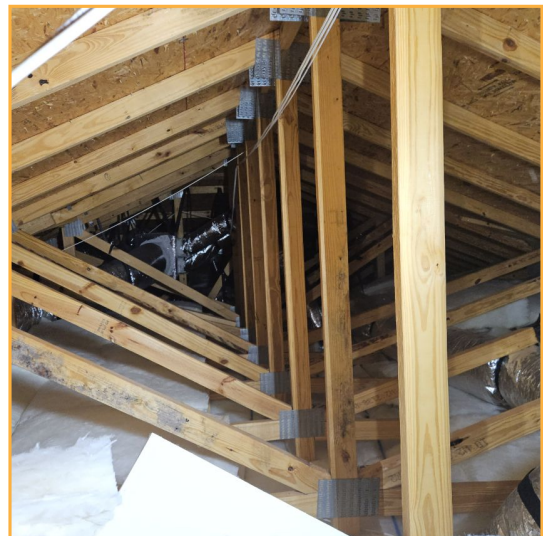
3.2. The inspector observed no deficiencies in the condition of the visible portions of the roof trusses. At the time of the inspection, portions of the trusses were hidden beneath thermal insulation.

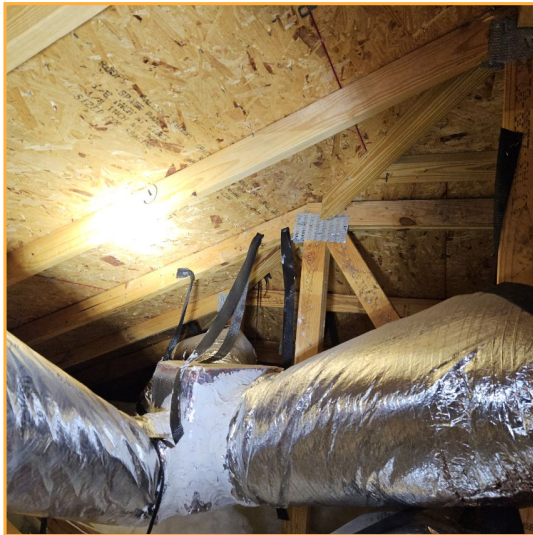
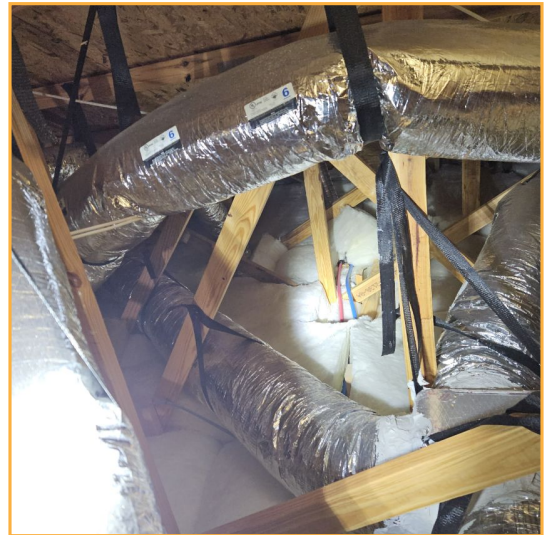
4.1. At the time of the inspection, the Inspector observed no deficiencies in the condition of the attic HVAC.

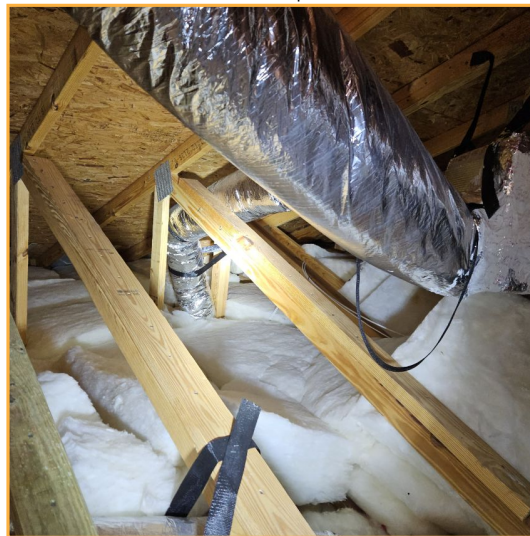
5.1. The Inspector observed no deficiencies in the condition of the roof sheathing at the time of the inspection.

6.1. The inspector observed no deficiencies in the condition of the thermal insulation at the time of the inspection.

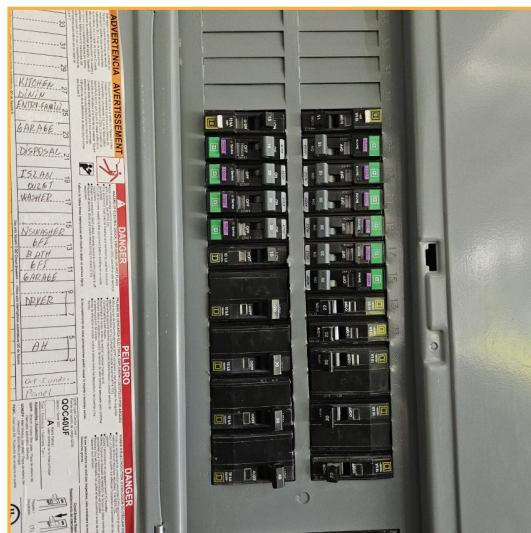
- 3.1. Overcurrent protection was located in the service panel.
- 3.2. Overcurrent protection of branch circuits was provided by circuit breakers located in the service panel.
- 3.3. At the time of the inspection, the Inspector observed no deficiencies in the condition of circuit breakers in the electrical service panel.
- 3.4. The service panel contained Ground Fault Circuit Interrupter (GFCI) breakers designed to provide protection by shutting off current flow should sensors indicate a difference between incoming and outgoing voltage in outlets at protected circuits.
- 3.5. The service panel contained Arc Fault Circuit Interrupter (GFCI) breakers designed to provide fire protection by shutting off current flow should sensors detect arcing at outlets on the protected circuit. AFCI protection of electrical outlets in sleeping rooms is required in new construction.

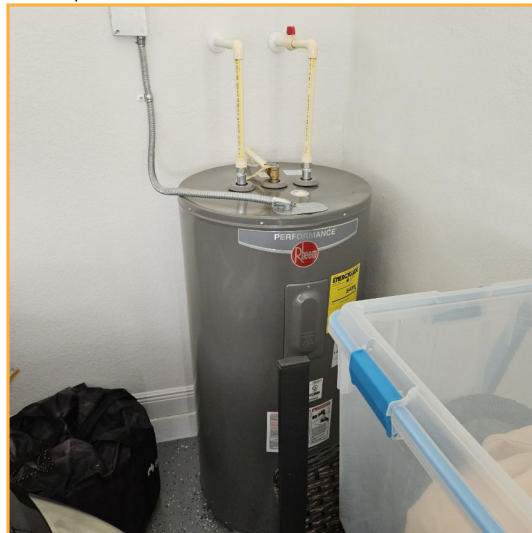
1.1. At the time of the inspection, the Inspector observed no deficiencies in the condition or operation of the water heater.

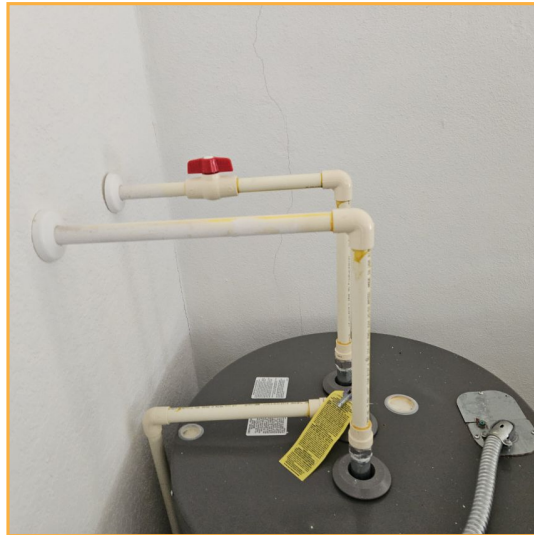
2.1. At the time of the inspection, the Inspector observed no deficiencies in the condition of water pipe fitings connected to this water heater.
